SELBY CREEK – SILVERADO TRAIL CULVERT FISH PASSAGE ASSESSMENT

NAPA COUNTY, CALIFORNIA

OCTOBER, 2006

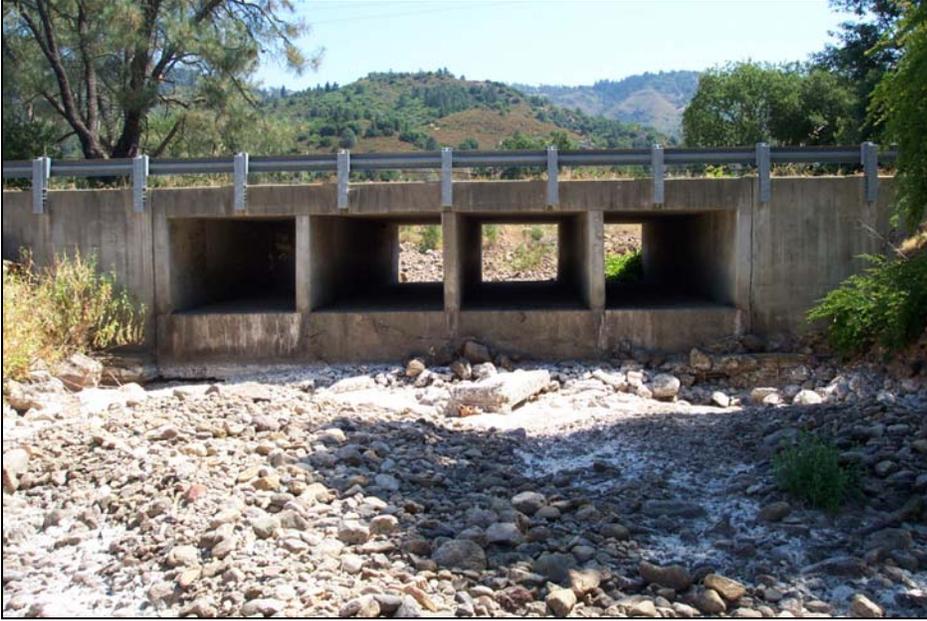
The main obstacles for fish passage are lack of water depth within the culvert and high velocities from the steep slope (3.7%). The culvert is relatively wide, which promotes sheet flow (shallow, fast moving water) during most low to moderate flows. Under all conditions, the culvert is a complete barrier to juvenile upstream movement due to high velocities and the excessively high jump into the culvert outlet (Table 1).

The Silverado Trail culvert outlet is perched above the downstream pool, requiring a substantial leap into the culvert. Leap heights range from approximately 3.1 feet at the low passage flow (3 cfs) to about 2.1 feet at the high passage flow (258 cfs). These leap heights are well within documented adult steelhead leaping abilities of six feet or greater. However, the downstream jump pool is not deep enough to allow for efficient leaping. If a perched outlet is unavoidable, the downstream jump pool depth should be at least 1.25 times the leap height to create favorable hydraulic conditions for leaping. NOAA Fisheries and DFG guidelines recommend that all culverts be installed slightly below grade to eliminate leaping at the outlet. Repeated leap attempts cause exhaustion, injury, and even mortality to migrating fish.

Silverado Trail culvert facing upstream (5-17-2006)

The Silverado Trail culvert represents a major obstacle for steelhead migration, and likely has a significant impact on fish movement to high quality upstream habitat. The culvert should be either replaced or modified to reduce water velocities, concentrate flows into a deeper low-flow lane, and eliminate the leap at the outlet. Since the culvert appears to be undersized, it is not advisable to improve passage by installing roughness elements (e.g. boulders, baffles, concrete berms, etc.) inside the culvert to decrease velocities and create resting areas.

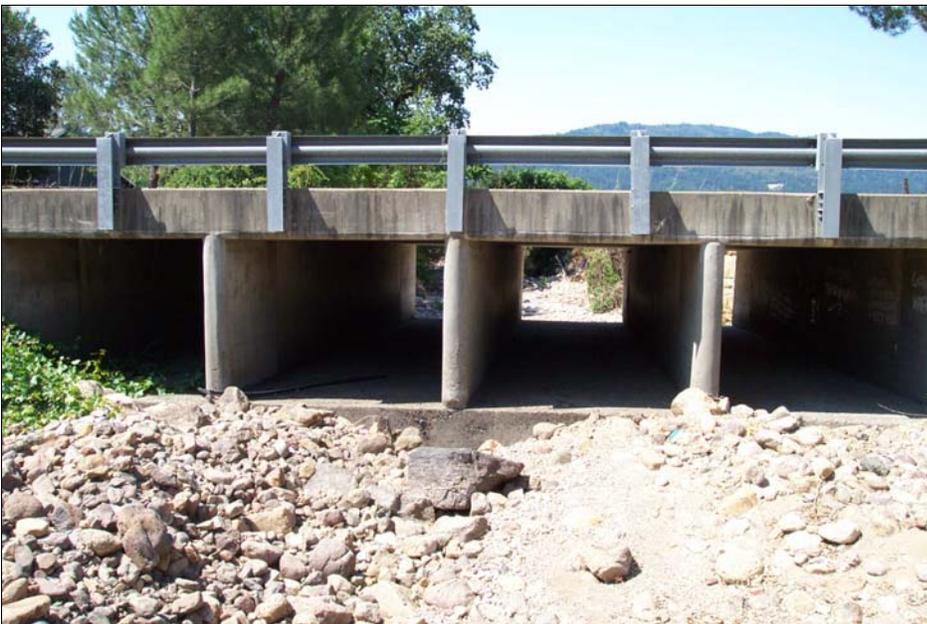
Silverado Trail culvert inlet facing downstream (5-17-2006)

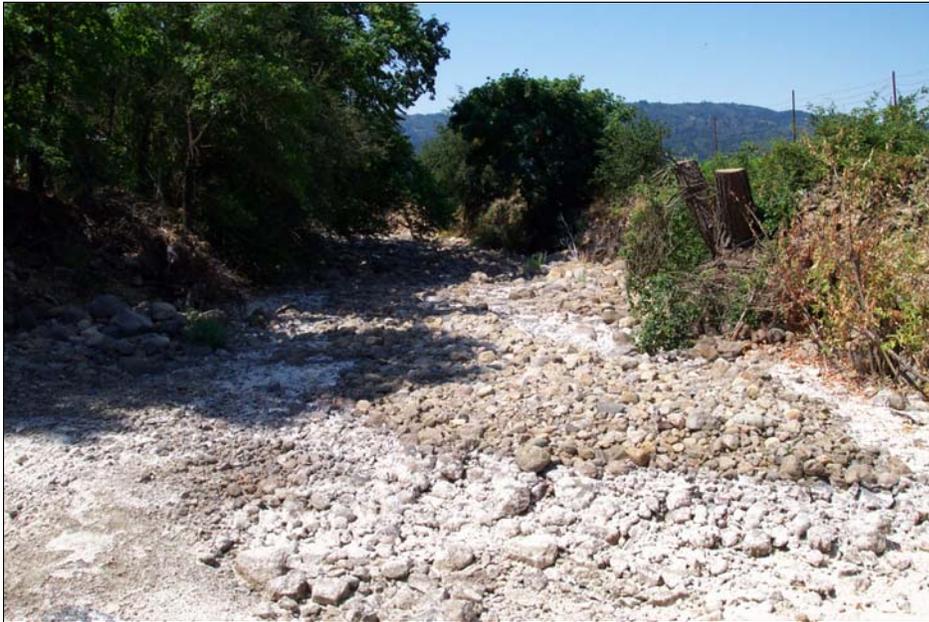
The channel downstream of the Silverado Trail culvert shows evidence of incision, and is characterized by steep, unstable banks. The culvert is currently providing grade control to the channel, preventing incision from traveling upstream into Dutch Henry and Biter Creeks. Restoration efforts in this downstream reach could include elements that sequentially raise the bed elevation over several hundred feet of channel. This may include a series of constructed step pools or other instream structures that promote bed aggradation. If the culvert remained in place and an improved approach route was created, the culvert itself would still remain a significant barrier, requiring modification to reduce velocities and increase depth. This may be partially accomplished by creating a notched lane in the concrete that concentrates flow through the culvert. This lane would likely only be effective at lower flows when velocities are lowest.

Selby Creek downstream of Silverado Trail facing downstream (5-17-2006)

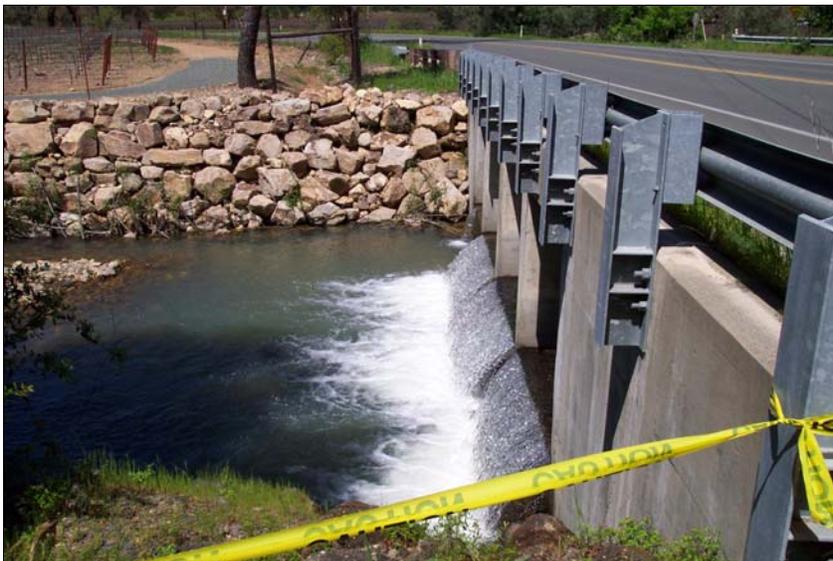
Silverado Trail culvert downstream standing on left bank (3-10-2006)

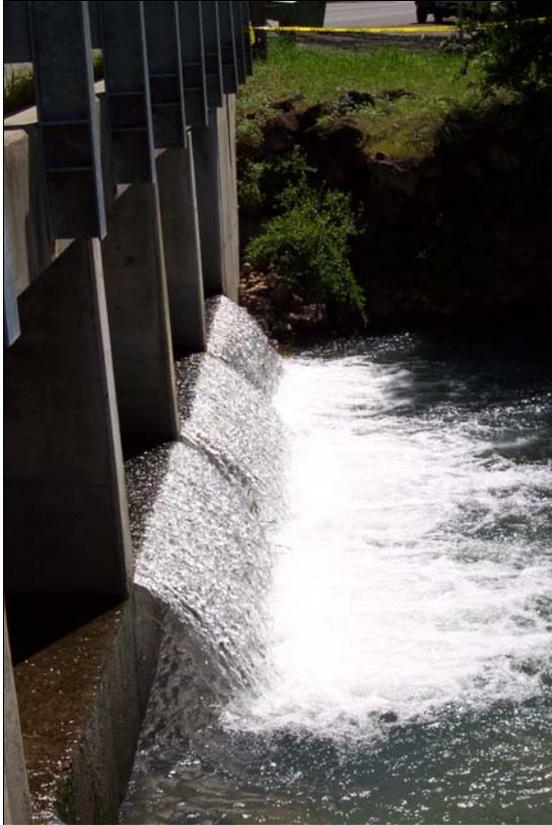
Silverado Trail culvert downstream standing right bank (3-10-2006)

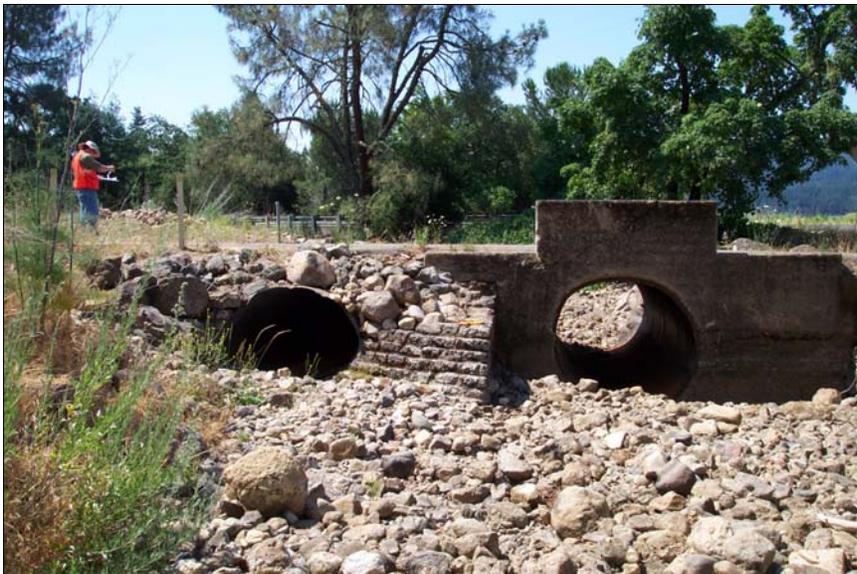
Based on field observations and Fish X-ing analysis, this culvert does not represent a significant obstacle to steelhead migration. The culvert was given a “GREEN” value based on DFG criteria, which indicates that conditions are adequate for passage of all salmonid life stages.

The main culvert is installed slightly below streambed level, maintains sufficiently low velocities during a wide range of flows, and is relatively short. The passage window analyzed was 3–70 cfs with Fish X-ing. The results of this analysis suggest that the culvert is passable during all but the lowest passage flows (< 5 cfs) for adults and passable during all passage flows for juveniles. Shallow conditions with water depths less than 0.5 feet in the culvert exist during low flows, which may slightly hinder fish passage. However, such shallow water depths are also expected in the natural channel above and below the culvert during such flows.

Dutch Henry Culvert inlet facing downstream (5-17-2006)

The culvert on Dutch Henry Creek does not warrant further action to improve fish passage. The current two-pipe configuration allows full passage during all expected steelhead migration flows and the structures appear to be in good physical condition.
