Northern Napa River Tributary Streams Survey Report May 2012

Prepared for:
City of St. Helena
1480 Main Street
St. Helena, CA 94574

NAPA COUNTY
RCD

PRUNUSKE CHATHAM, INC.

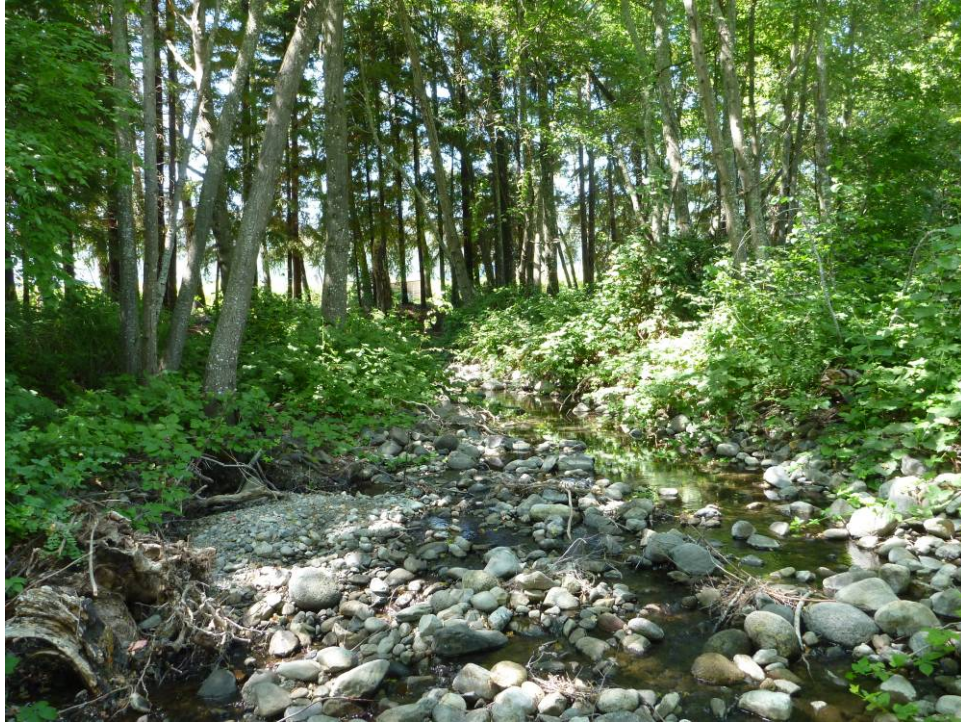
4.1a. Stream conditions in the lower reach of Mill Creek. 7/29/11

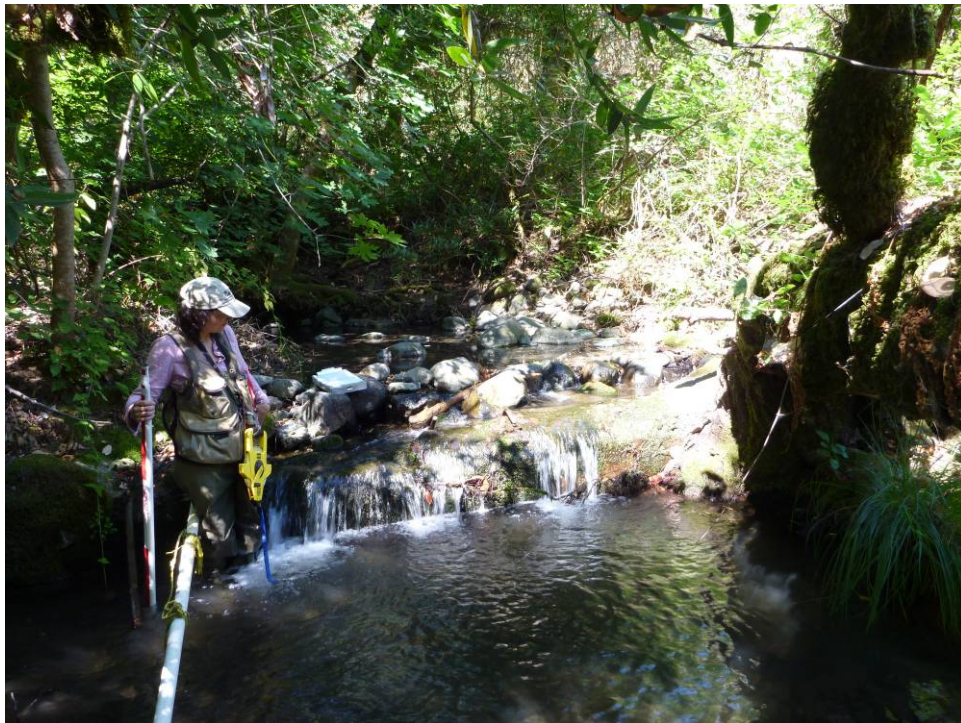
4.1b. In-stream stone wall. 8/2/11

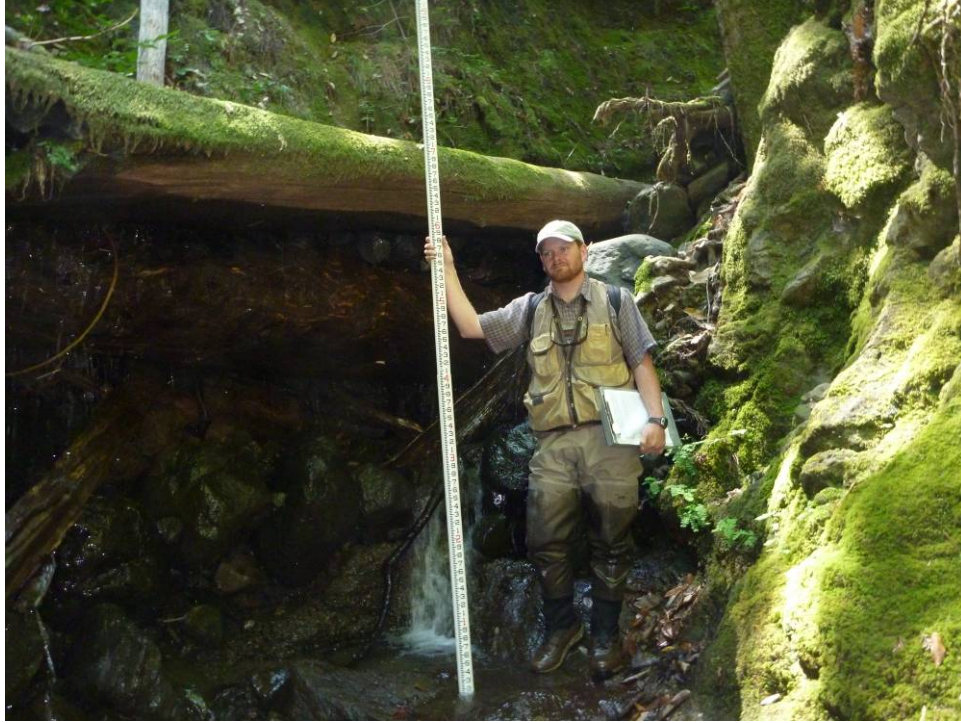
4.1e. Complete fish passage barrier. 8/9/11

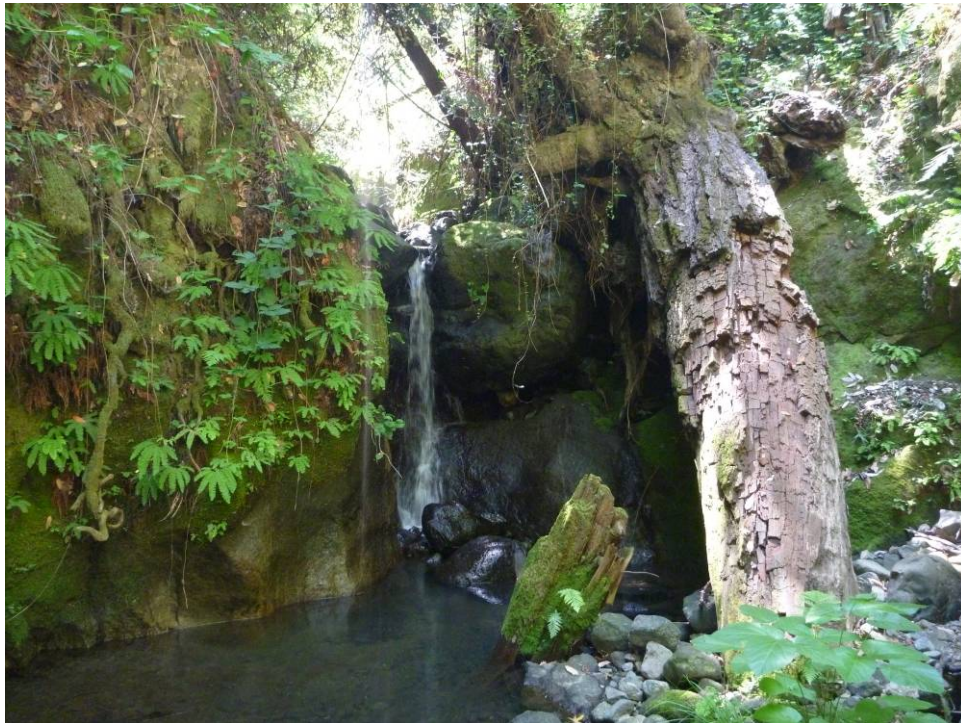
4.1f. Waterfall above limits of survey. 8/9/11

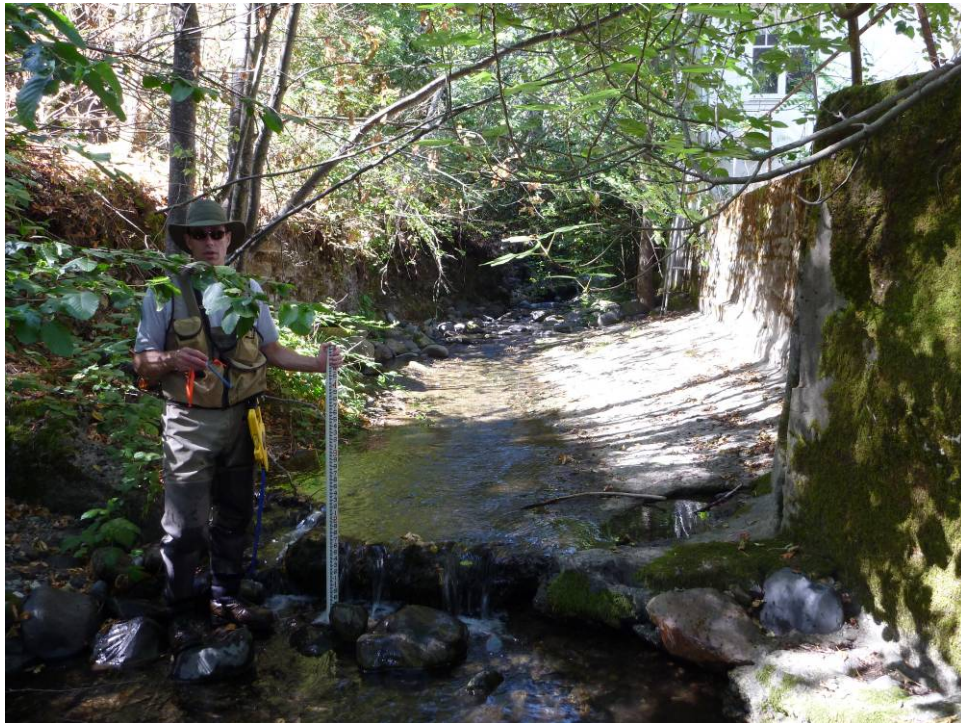
4.2d. Remnants of the diversion dam removed in 2003. 8/10/11

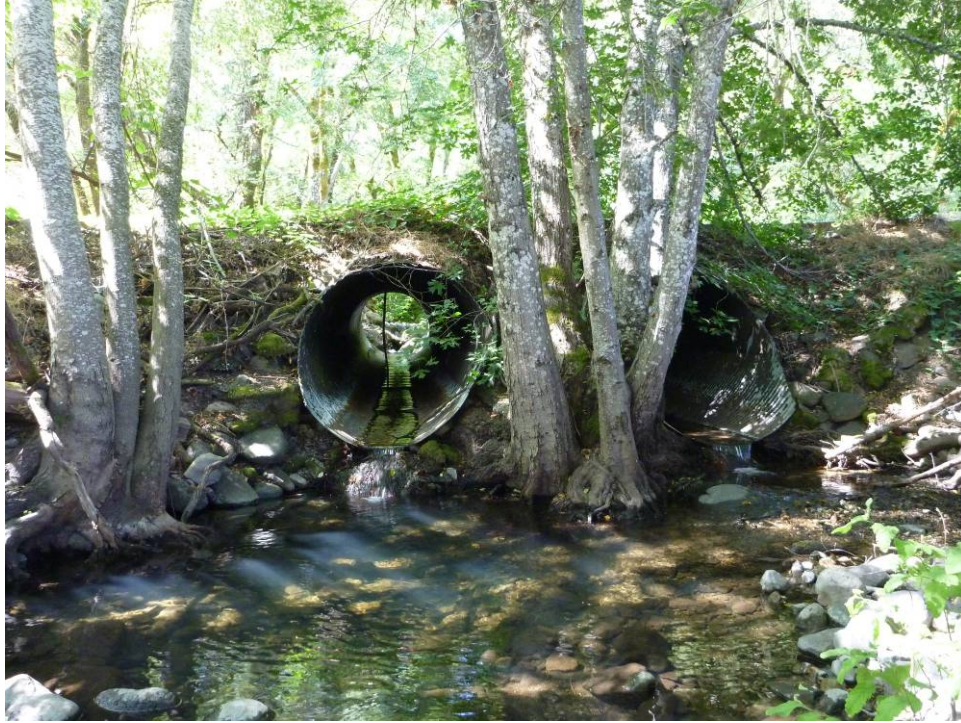
4.2e. Road crossing within Bothe-Napa Valley State Park. 8/10/11

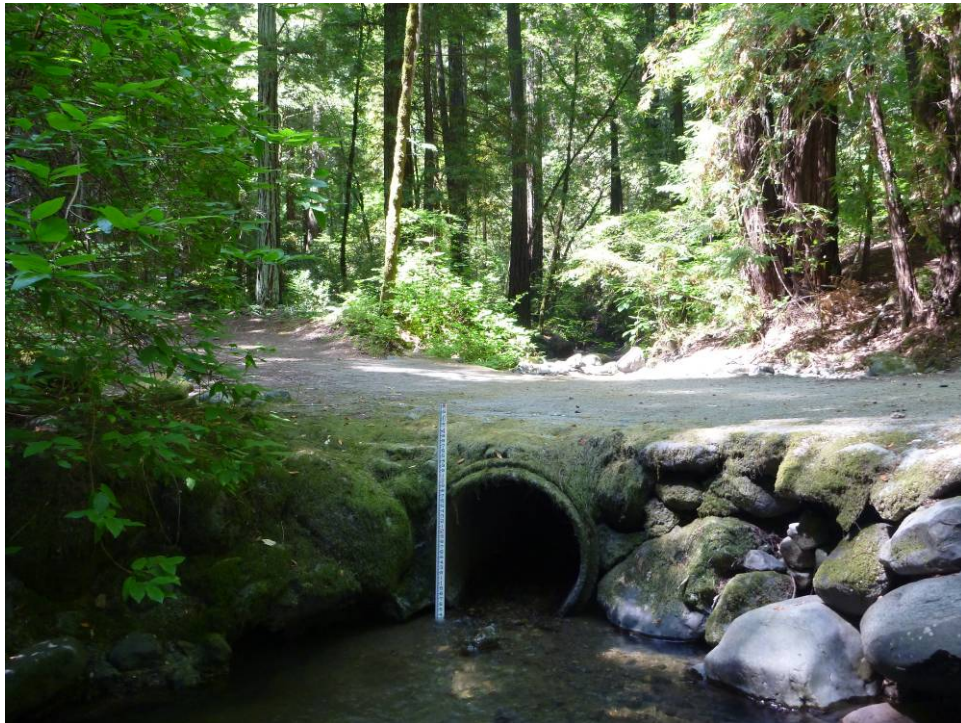
4.2h. Culvert crossing under dirt road within Bothe-Napa Valley State Park. 8/11/11

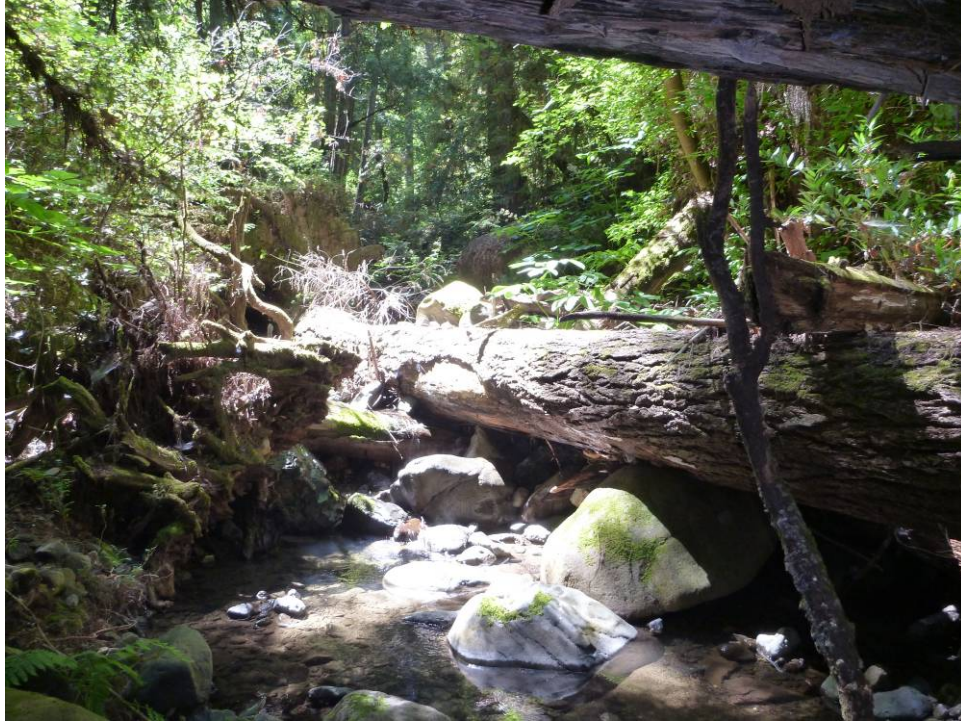
4.2i. Downed tree over stream channel. 8/11/11

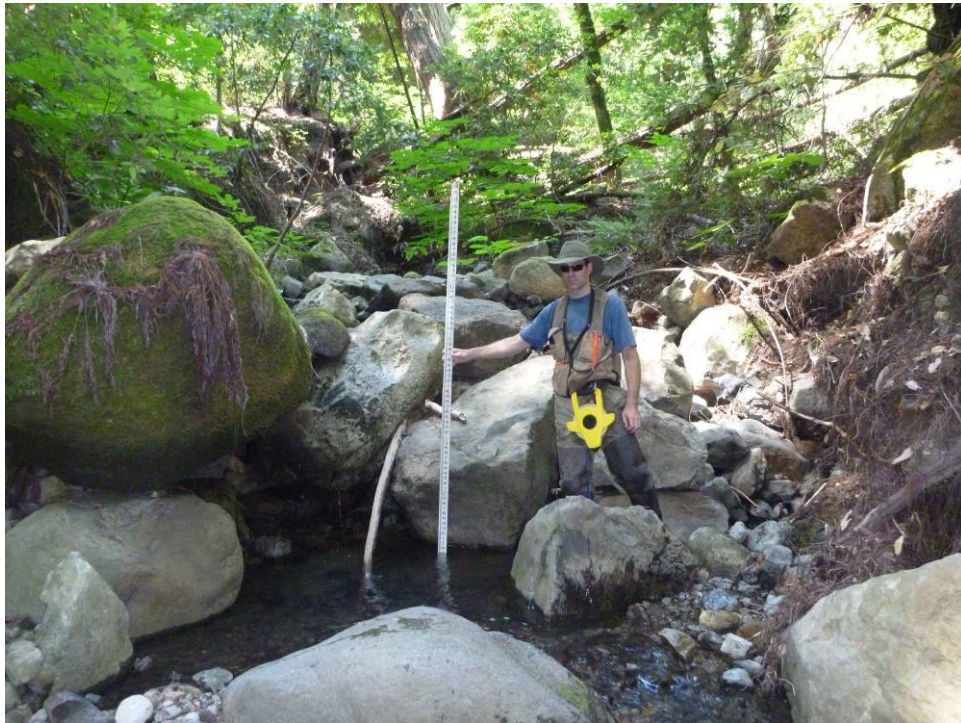
4.2l. Boulder cascade in upper reach. 8/12/11

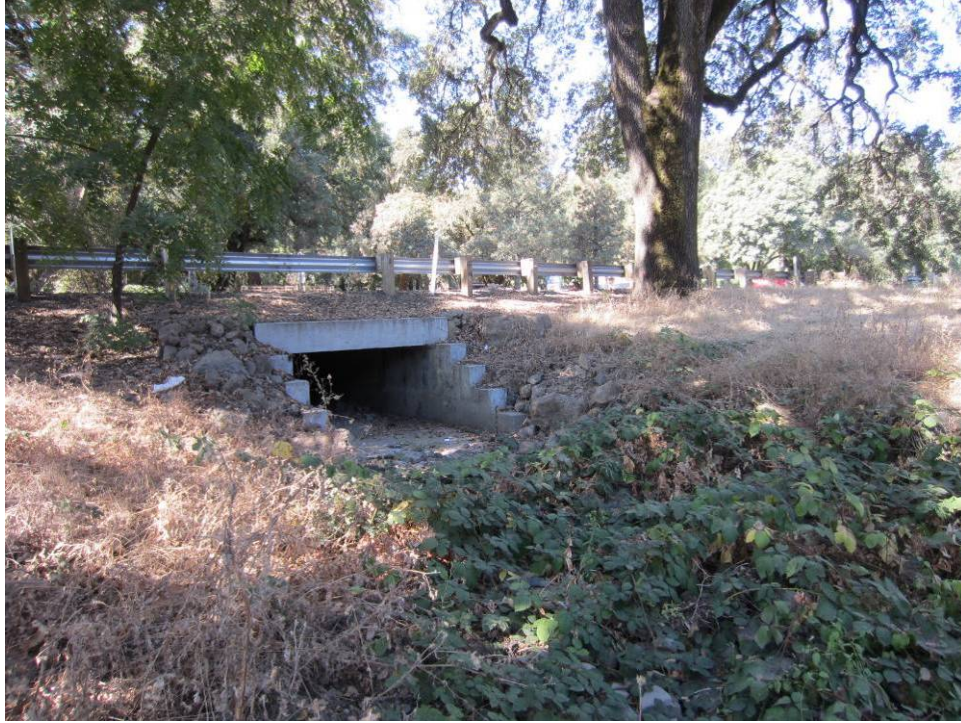
4.3c. Culvert crossing under Highway 29. 9/29/11

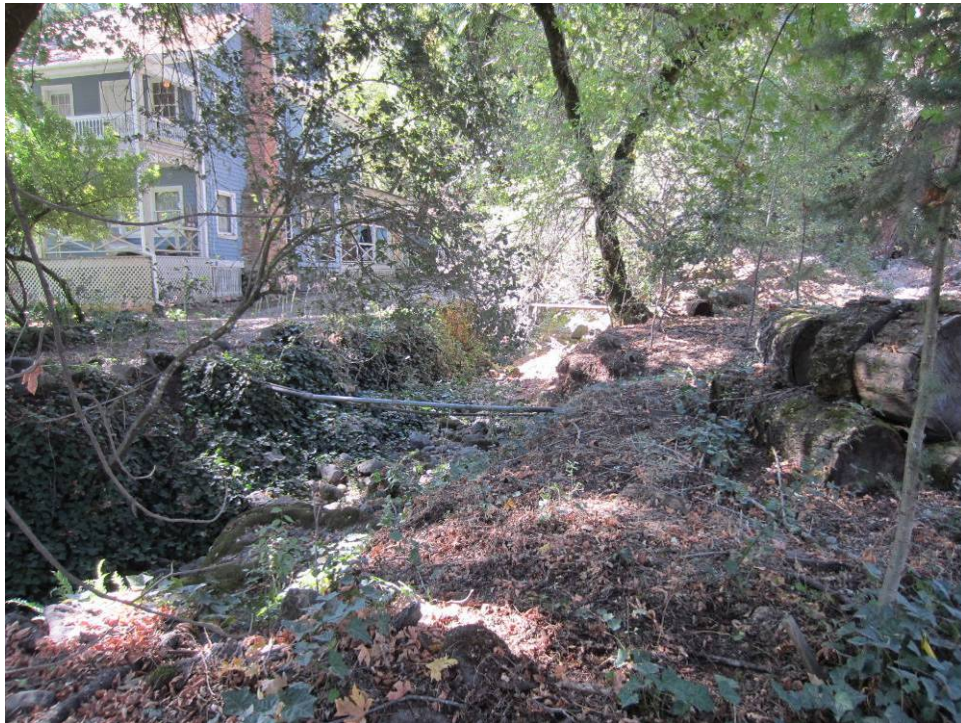
4.3d. In-stream habitat immediately upstream of Highway 29. 9/29/11

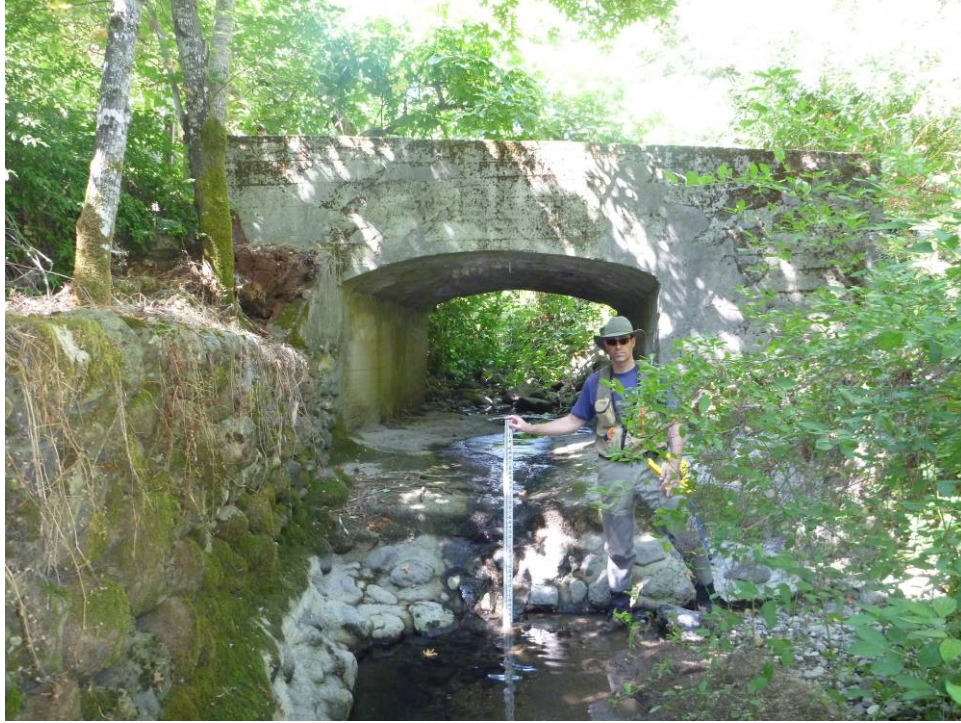
4.4c. Pool habitat downstream of artificial, low-flow barrier. 8/16/11

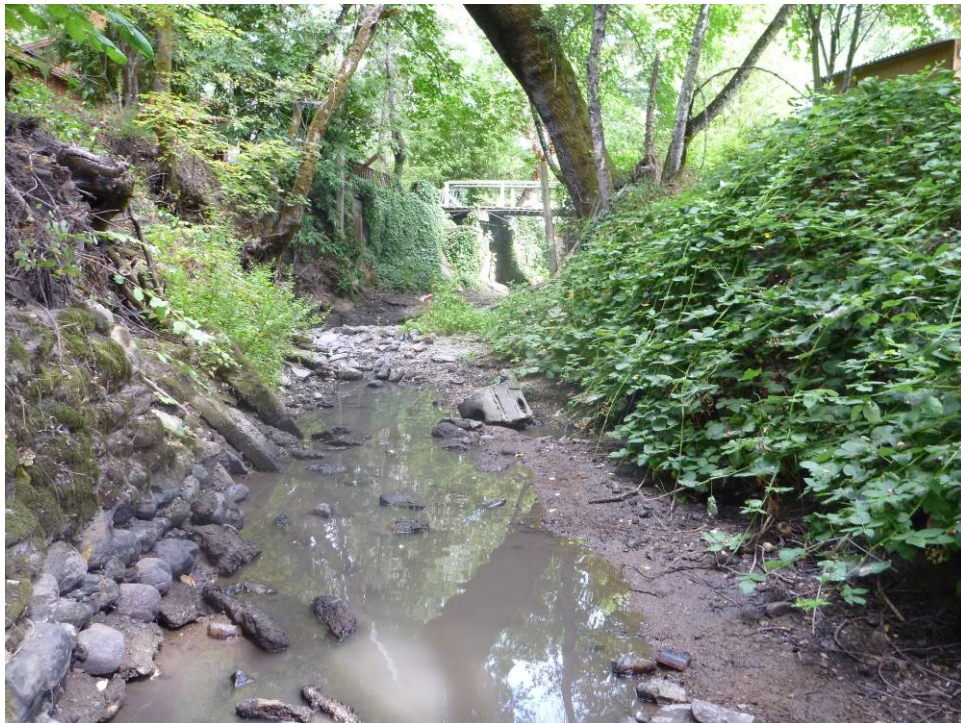
4.5b. Stagnant, isolated pool in lower Blossom Creek. 8/22/11

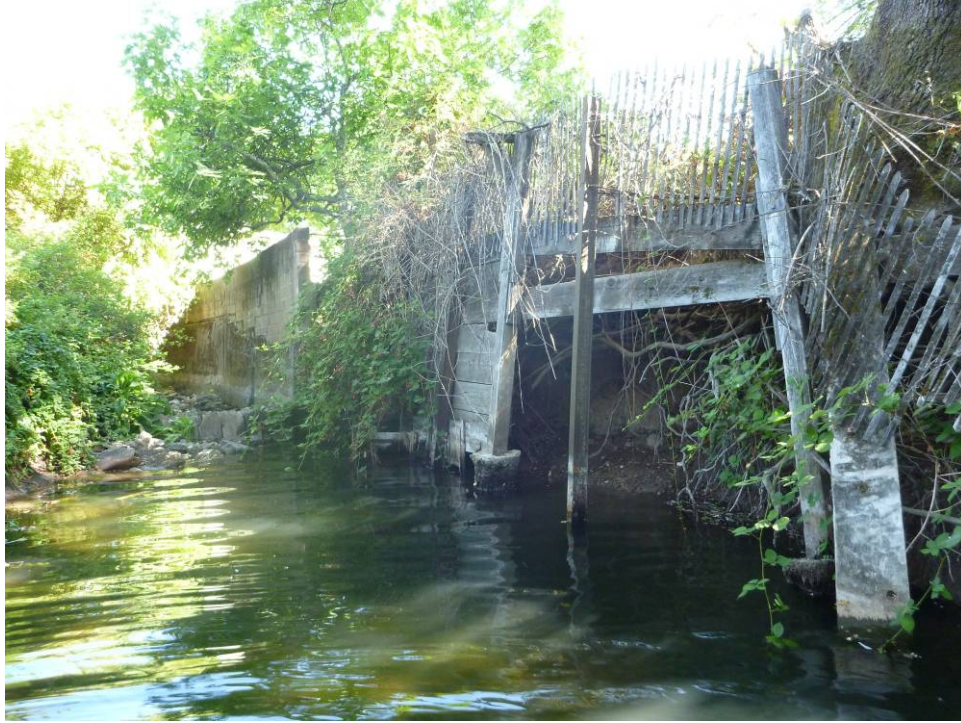
4.5c. Stagnant, isolated pool in lower Blossom Creek. 8/22/11

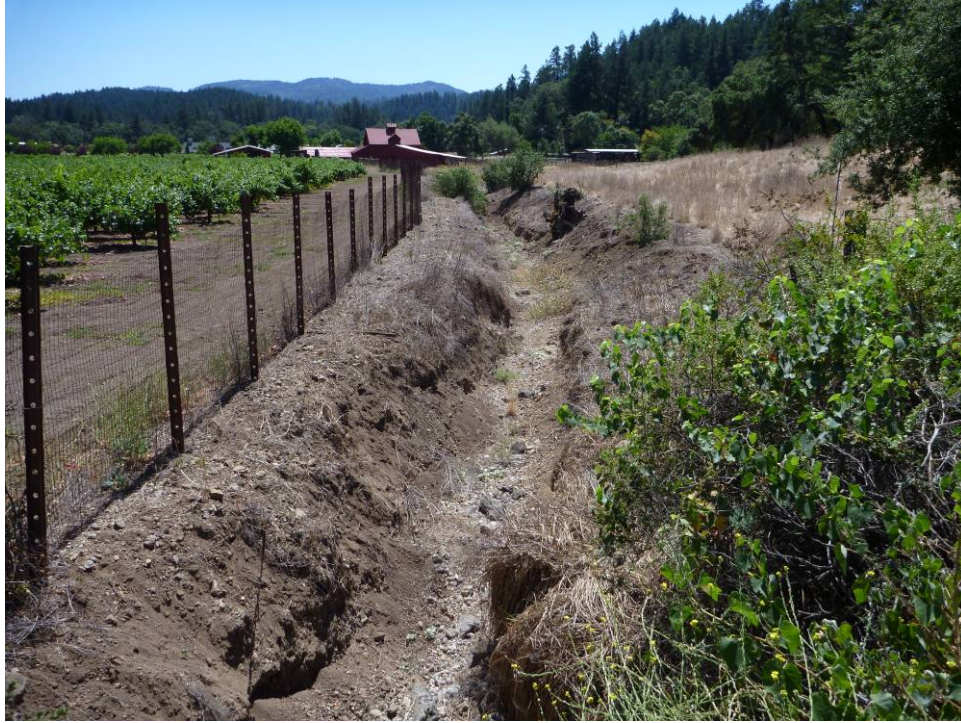
4.5e. Representative dry stream bed in upper Blossom Creek. 8/22/11

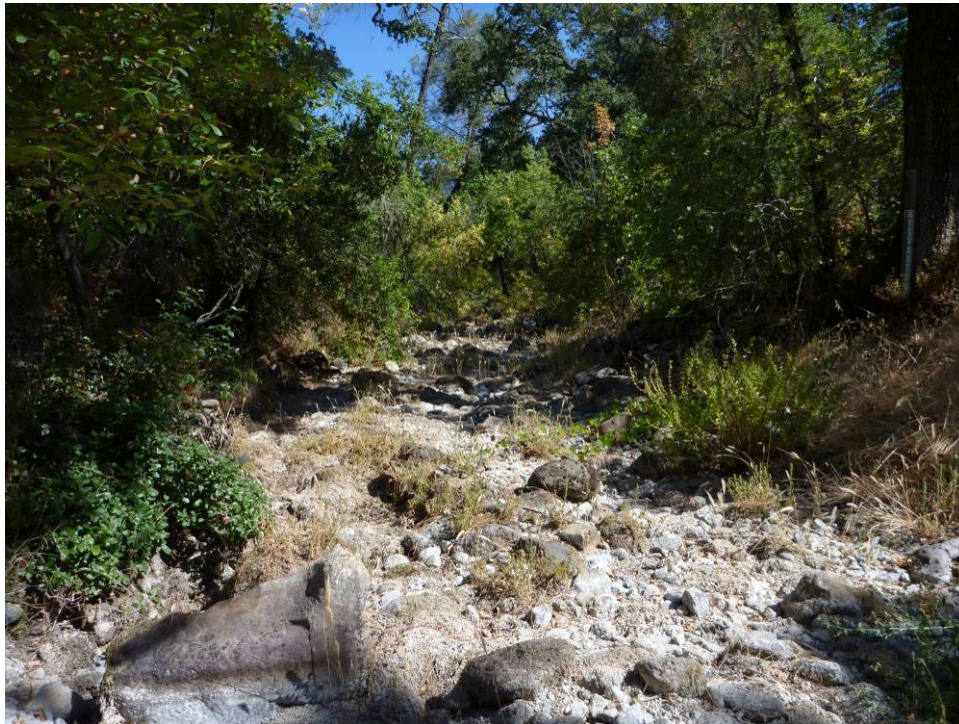
4.6c. Dry stream bed conditions in the middle reach of Garnett Creek. 8/29/11

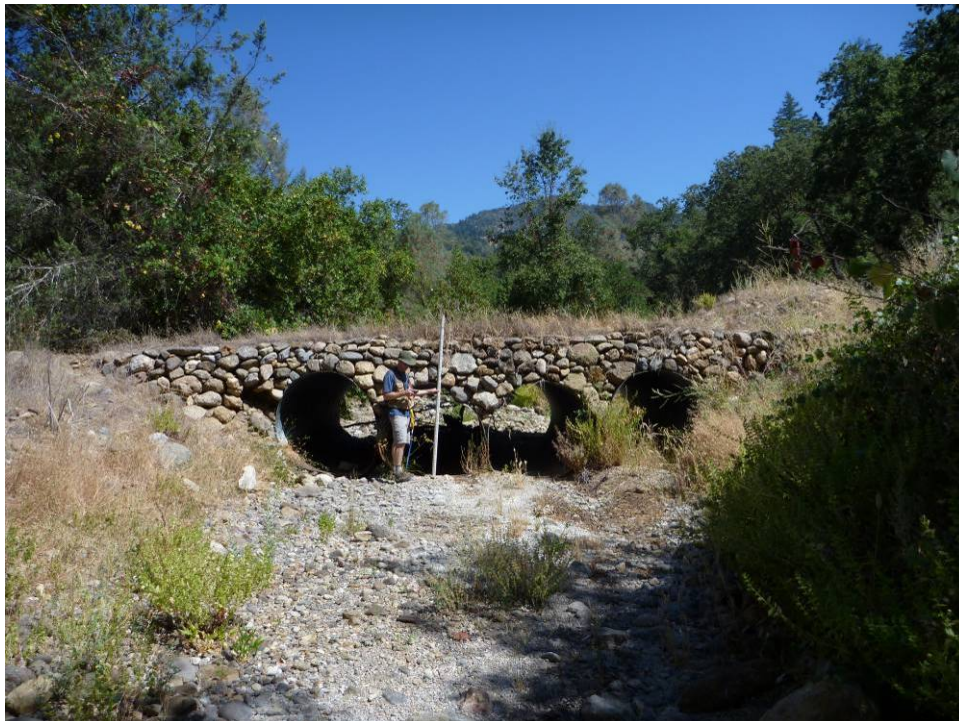
4.6d. Four barrel culvert crossing on Garnett Creek. 8/29/11

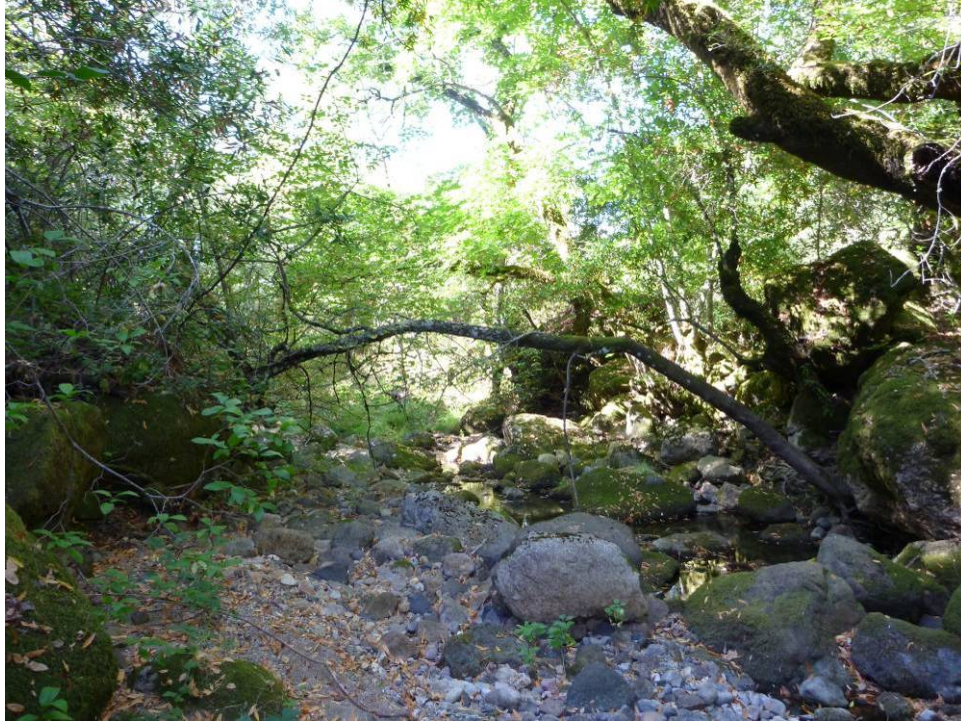
4.6g. Dry stream bed conditions in the upper reach of Garnett Creek. 9/1/11

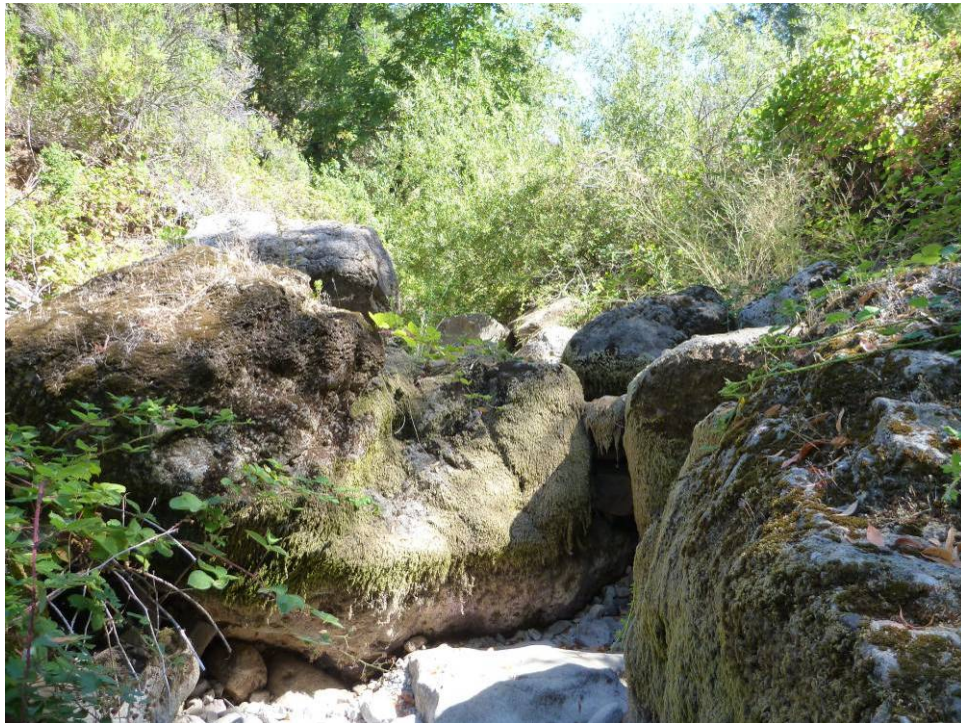
4.6h. Steep boulder cascade at upper limits of survey. 9/1/11

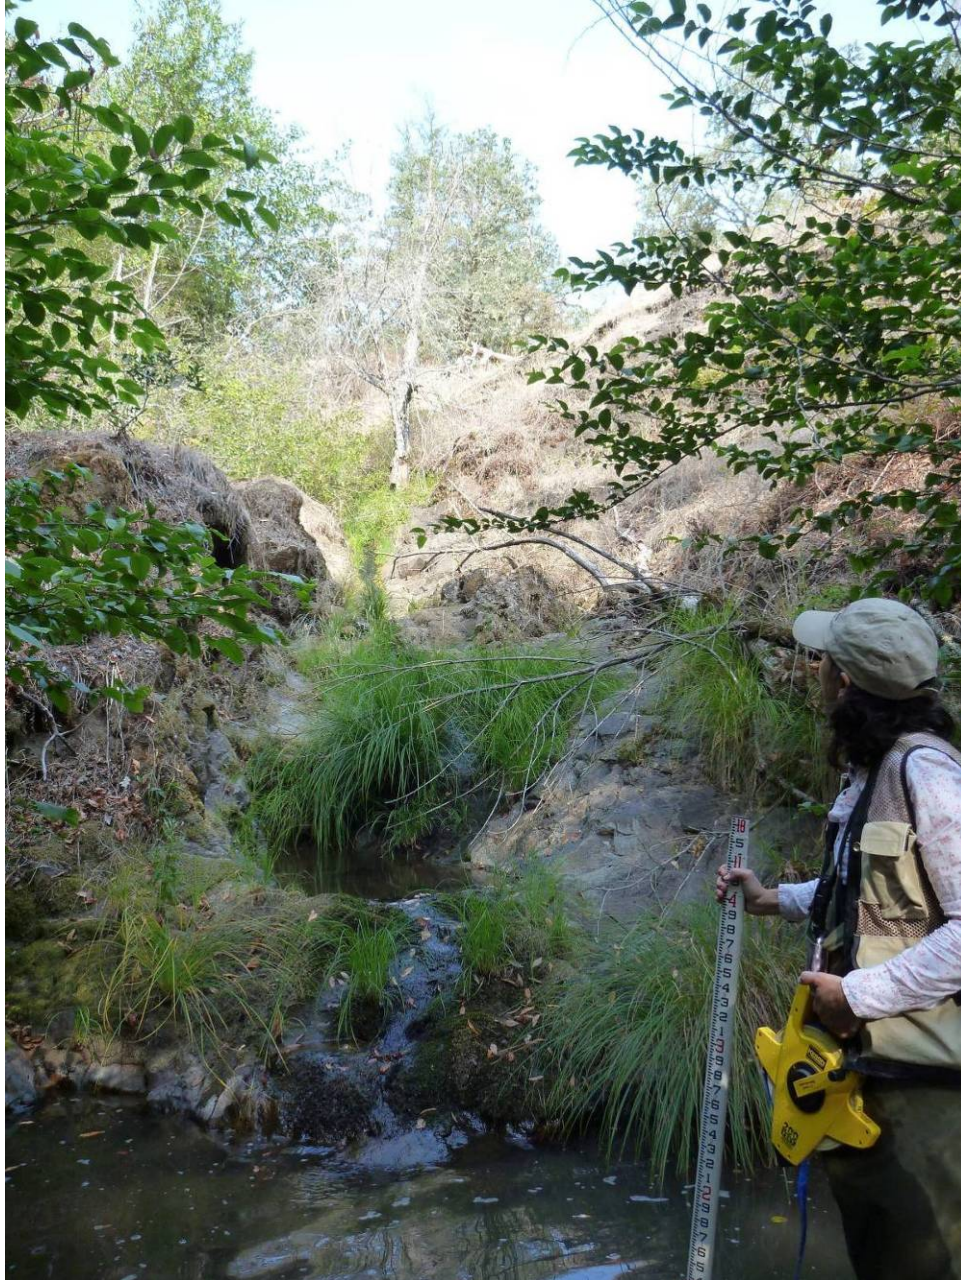
4.60. Limits of anadromy on Jericho Creek. 9/12/11

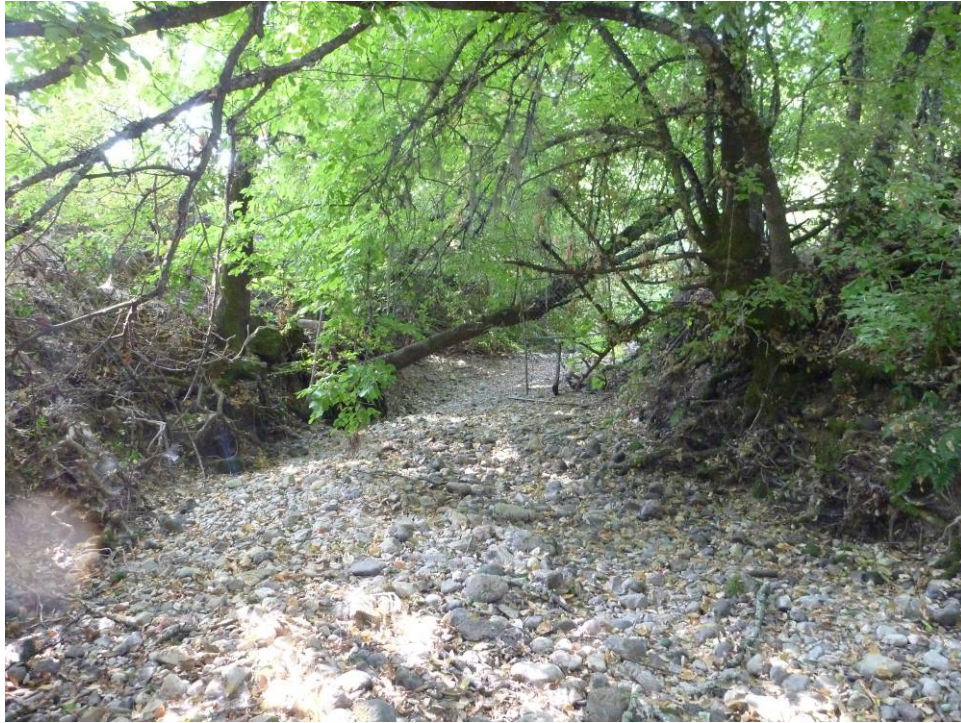
4.7a. Dry stream bed conditions near the confluence with the Napa River. 9/12/11

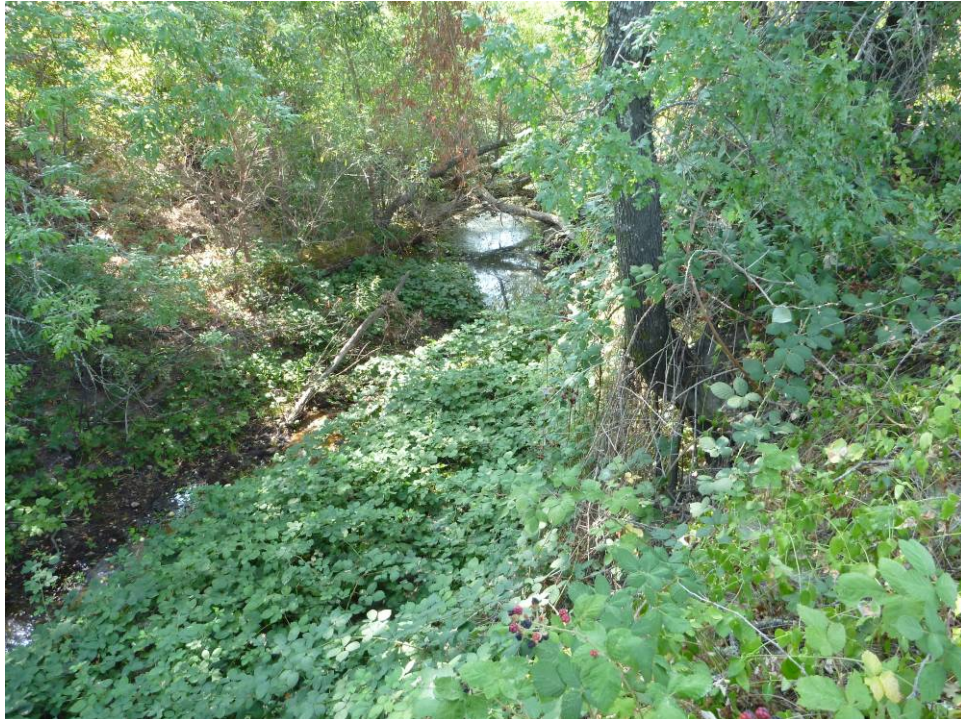
4.7b. Isolated pools in the lower reach of Simmons Canyon Creek. 9/12/11

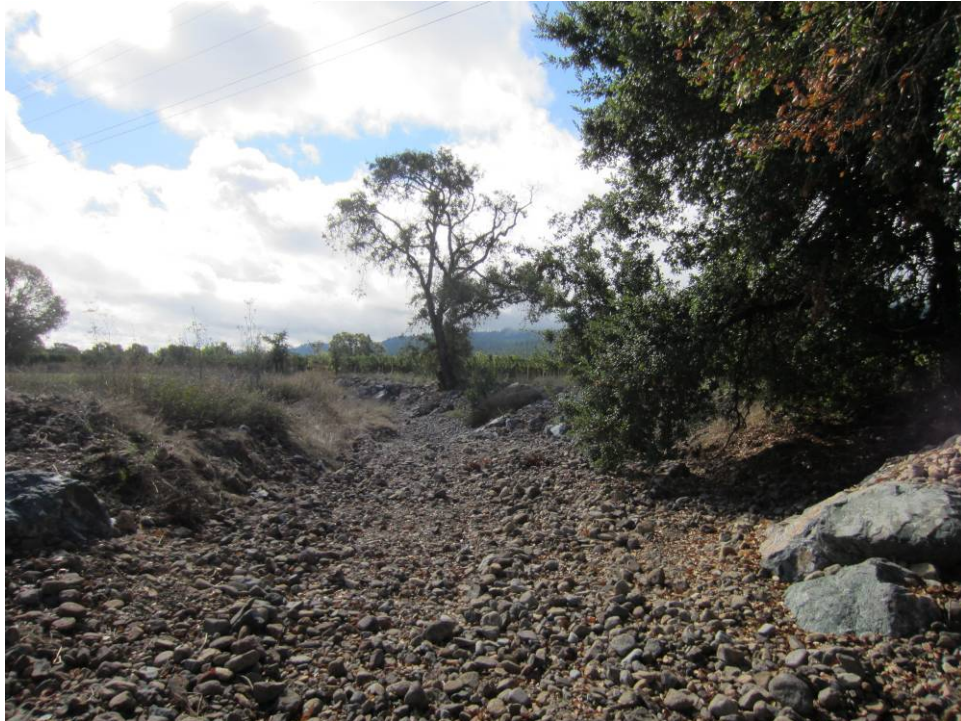
4.8d. Dry stream bed conditions downstream of Silverado Trail. 10/11/11

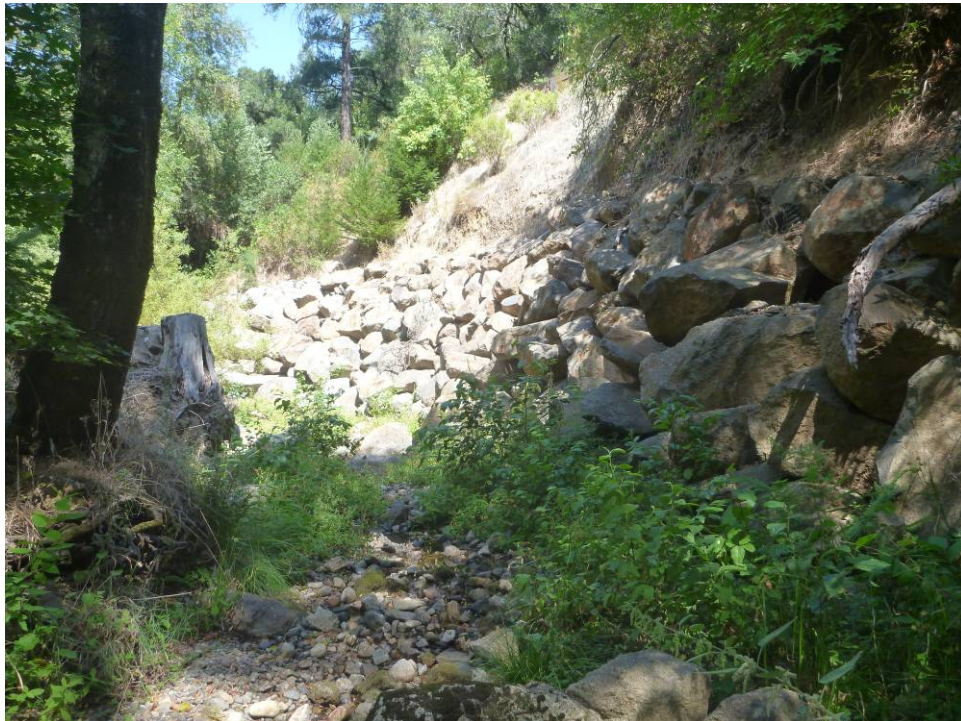
4.8j. Dry stream bed conditions in Dutch Henry Creek. 9/13/11

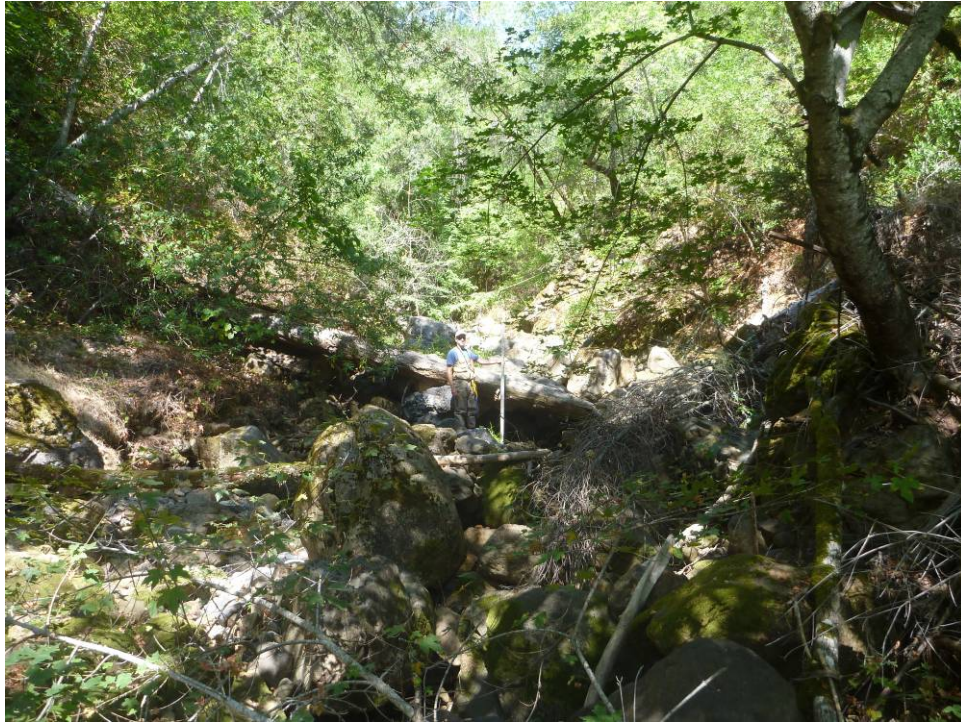
4.8k. Steep boulder cascade in Dutch Henry Creek. 9/13/11
