# CENTRAL NAPA RIVER WATERSHED PROJECT

*SALMONID HABITAT FORM AND FUNCTION*

**FINAL REPORT**

**Napa County Resource Conservation District**

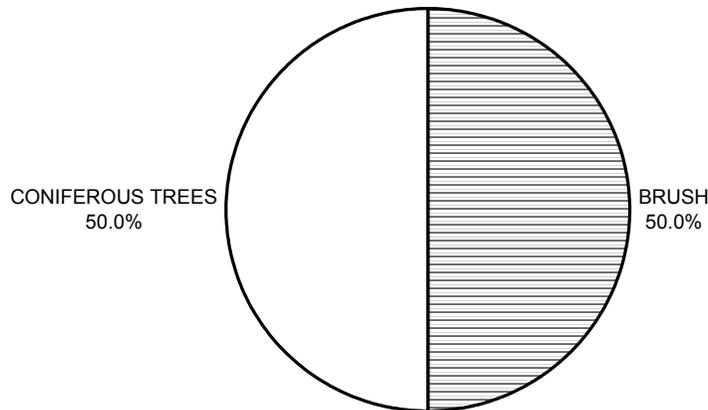
GRAPH 11

**BALE SLOUGH 2004  
DOMINANT BANK VEGETATION IN SURVEY REACH**

For the stream reach surveyed, the mean percent right bank vegetated was 31%, and the mean percent left bank vegetated was 58%. The dominant elements composing the structure of the stream banks consisted of 29% cobble/gravel, and 57% sand/silt/clay (Graph 10). Brush and coniferous trees were the dominant vegetation types observed in 50% of the units surveyed. Additionally, none of the units surveyed had hardwood trees as the dominant vegetation type (Graph 11)

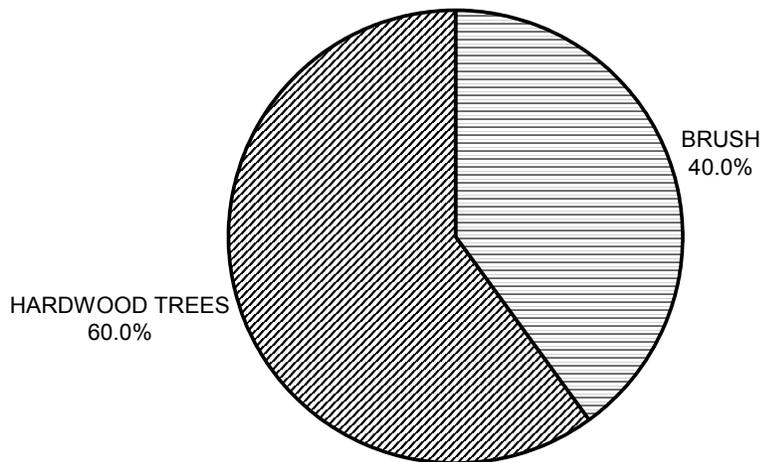
GRAPH 11

### CAÑON CREEK 2004 DOMINANT BANK VEGETATION IN SURVEY REACH

For the stream reach surveyed, the mean percent right bank vegetated was 45%, and the mean percent left bank vegetated was 28%. The dominant elements composing the structure of the stream banks consisted of 10% boulders, 10% cobble/gravel, and 80% sand/silt/clay (Graph 10). Deciduous trees and brush were the dominant bank vegetation types observed in 60%, and 40% of the units surveyed, respectively. None of the units surveyed had coniferous trees as the dominant vegetation type (Graph 11).

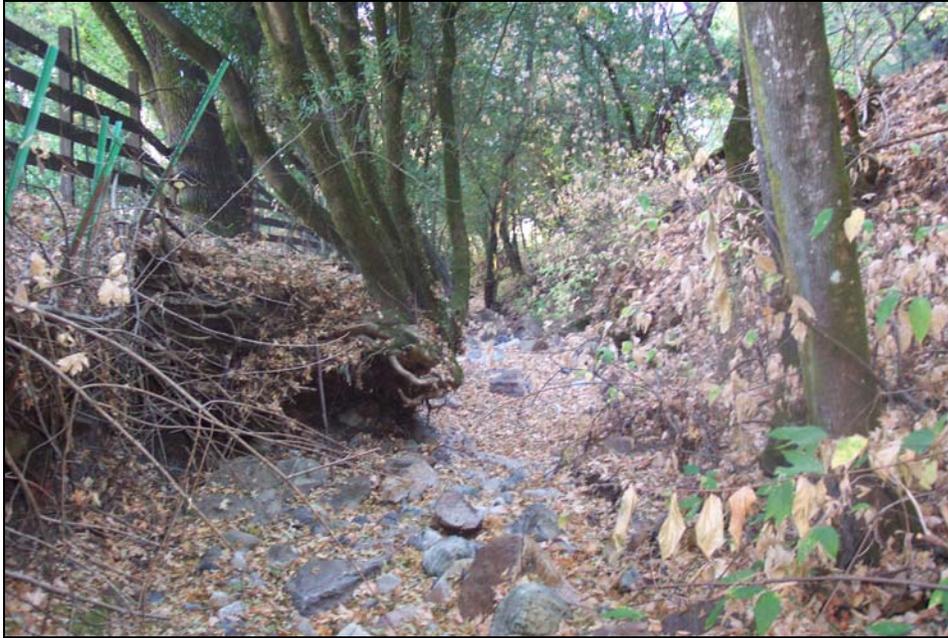
**Figure 3.5-2.** Bale Slough monitoring site completely dry, October 7, 2004.

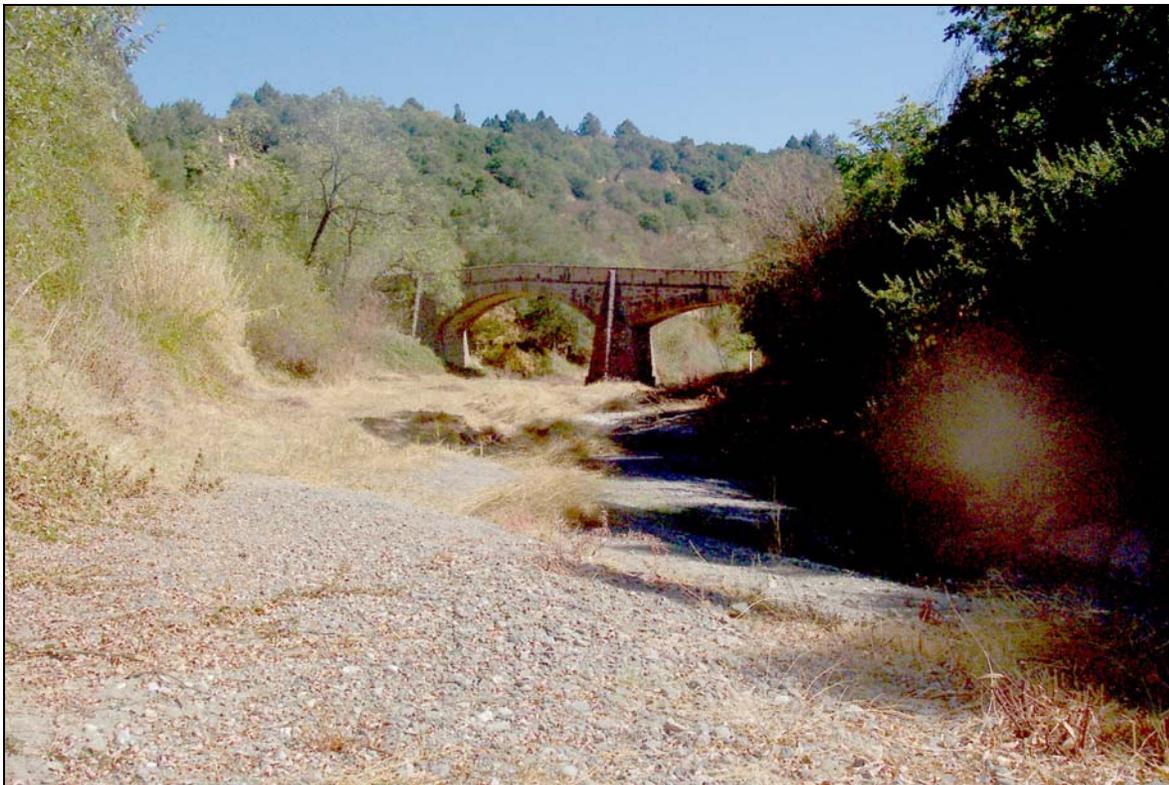
**Figure 3.5-6a.** Napa River completely dry at Pope Street in St. Helena, October 2004.

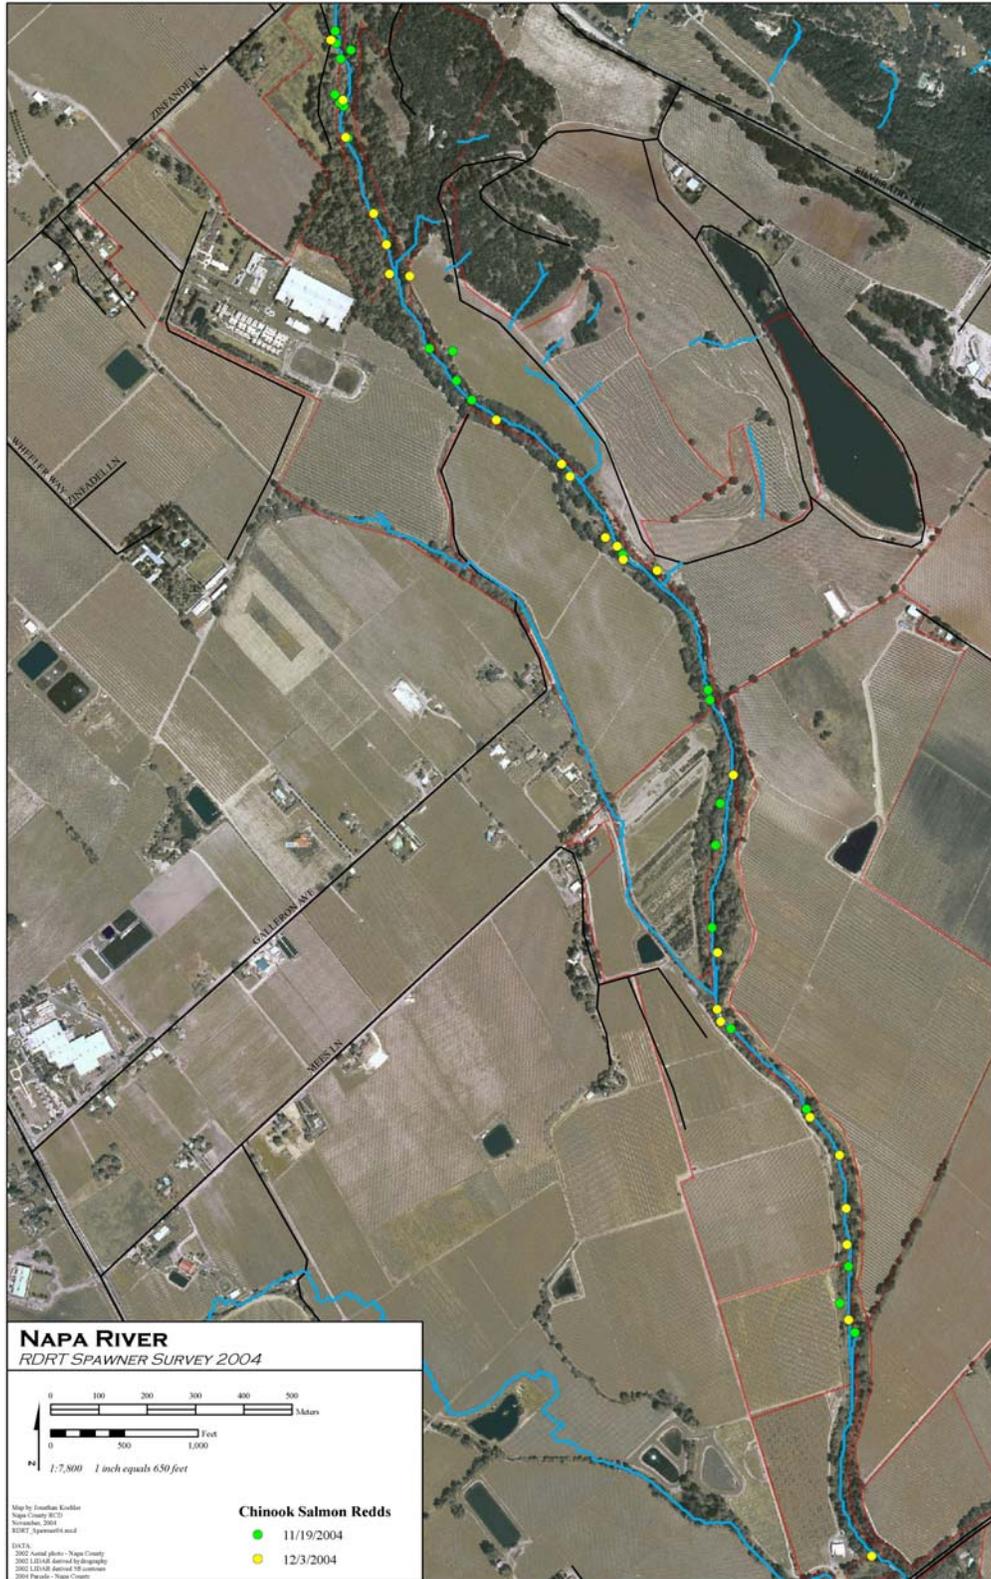
**Figure 3.7-2.** Chinook salmon spawning redd sites in fall 2004 along the upper survey reach of the Napa River between the Rutherford Crossroad and Zinfandel Lane. Redd density was highest just below the Zinfandel Lane Bridge, which formed a complete barrier to upstream migration during low flow periods.
