**Final Technical Report**

**Sediment Source Assessment,  
A Component of the  
Watershed Management Plan for the  
Sulphur Creek Watershed, Napa County, California**

**Pacific Watershed Associates  
Arcata, California  
(707) 839-5130  
May 16, 2003**

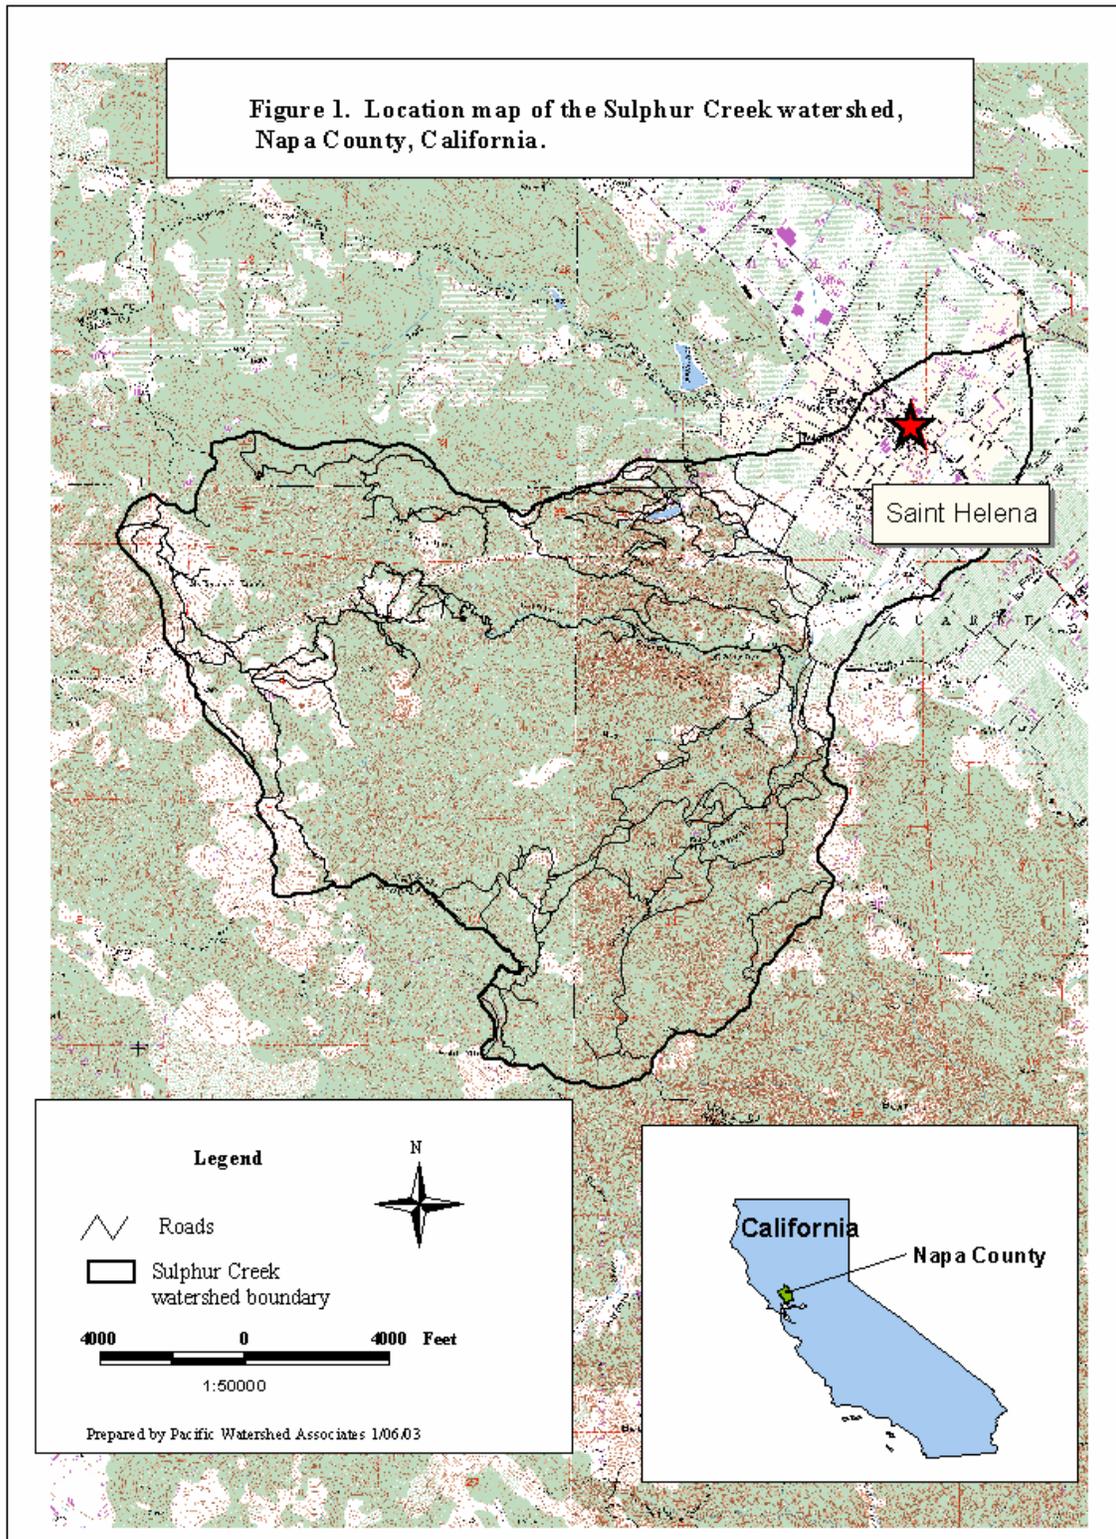
Sulphur Creek is an approximately 9.5 mi<sup>2</sup> tributary to the Napa River located in Napa County on the eastern side of the Mayacaama Mountains (Figure 1). As mapped on the USGS Kenwood, Calistoga, Saint Helena and Rutherford 7.5' minute topographic quadrangle maps, Sulphur Creek contains approximately 24 miles of blue-line streams and tributaries. The watershed contains the 2.9 mi<sup>2</sup> Heath Creek sub-basin and the 5.6 mi<sup>2</sup> Sulphur Canyon that drains through the town of Saint Helena. Elevations in the watershed range from approximately

200 feet at the confluence with the Napa River to approximately 2,730 feet above mean sea level at Bald Mountain.

The hillslope/tributary sediment source assessment consisted of three main work items: 1) an analysis of historic air photos of hillslopes and stream channel systems, 2) a field assessment of upland sediment sources to identify road-related and other non road-related management-related sediment sources that are currently delivering or have the potential to deliver sediment to streams, and 3) preparation of a prioritized plan-of-action for upland erosion prevention and erosion control. The Sulphur Creek watershed assessment area includes the upland portions of the basin extending upstream from the confluence of Sulphur Canyon and Heath Creek, and the small un-named sub-basin north of Sulphur Canyon, where they emerge from the mountain front (Figure 1).

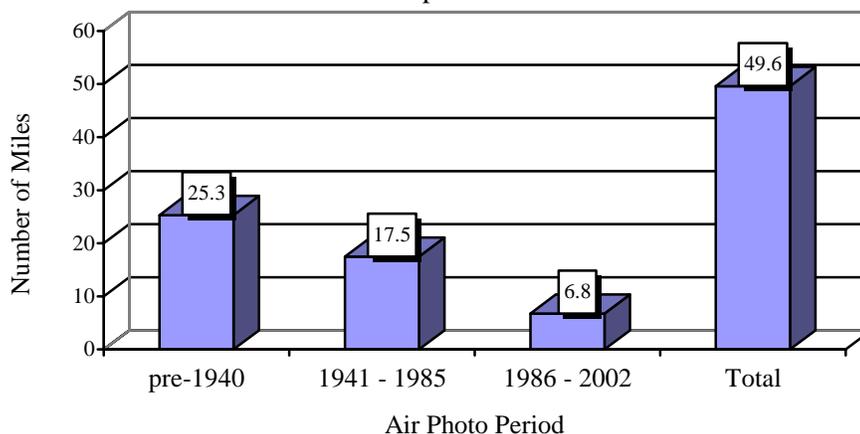
Figure 2. Road construction history, Sulphur Creek watershed, Napa Co.

Between 1940 and 1985, 17.5 miles of road were constructed primarily in Heath Canyon, the lower portion of Sulphur Canyon and the small sub-watershed located north of Sulphur Canyon. Finally, between 1985 and 2002, an additional 6.8 miles of road were constructed, primarily in the upper portions of the Sulphur Creek watershed and in the small northern sub-basin (Map 1).

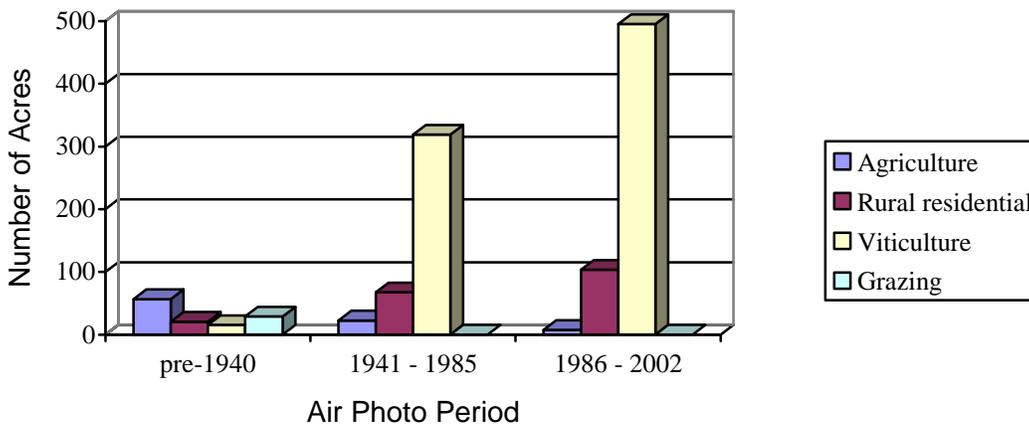
Figure 3. Land use history, Sulphur Creek watershed, Napa Co.

Grazing activities were recorded as of 1940 in the small subwatershed located to the north of Sulphur Canyon. No grazing activities were noted on the later 1985 or 2002 air photo sets (Figure 3 and Maps 2-4). The increase in vineyard and rural residential development suggest the conversion of general agricultural and grazing areas to vineyards and rural residential uses.

The majority of land use activity in the watershed assessment area was concentrated in the unnamed tributary located to the north of Sulphur Canyon. As of 2002, this small watershed contains approximately 48% of the viticulture activities, 66% of the rural residential development and 56% of the general agricultural activities. The remainder of land use activity is

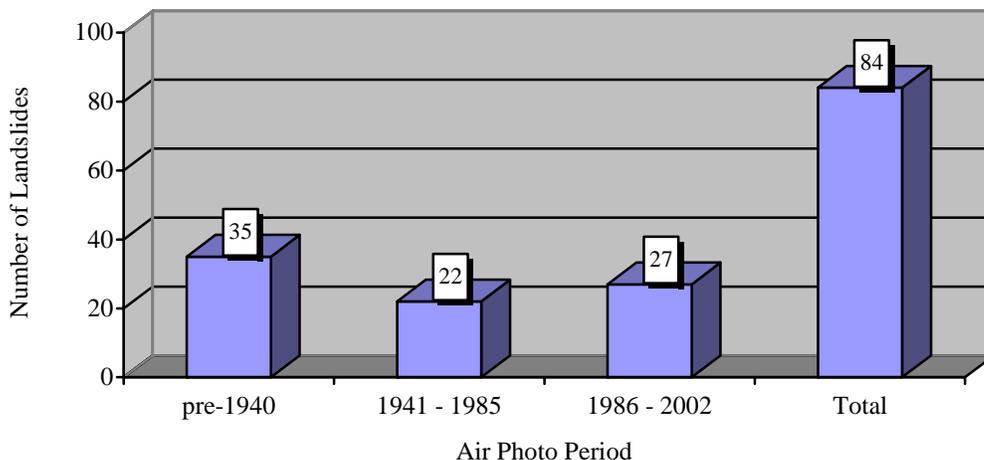
Figure 4. Frequency of air photo identified landslides, Sulphur Creek watershed, Napa Co.

Of the 84 landslides identified in the air photo analysis, fifteen (15) landslides had no apparent sediment delivery to Sulphur Creek and its tributaries. The remaining sixty-nine (69) landslides delivered an estimated total of 419,600 yds<sup>3</sup> of sediment (Table 2). As of the 1942 air photos, approximately 302,100 yds<sup>3</sup> of sediment was delivered to Sulphur Creek and its tributaries from landsliding. Between 1942 and 1985, approximately 83,500 yds<sup>3</sup> of sediment was delivered to streams and nearly 34,000 yds<sup>3</sup> of sediment was delivered between 1985 and 2002 (Table 2). In general, landslides in the Sulphur Creek watershed consisted of large debris landslides, deep

seated landslides, composite landslides and debris flows with an average length of 160 feet and an average of 5,000 yds<sup>3</sup> of sediment delivered to the stream system.

Approximately 50% (206,500 yds<sup>3</sup>) of the total sediment delivered from air photo identified landslides in Sulphur Creek originates from one large composite landslide located near the ridge of the south-facing slope above Sulphur Canyon. This landslide occurred as of the 1940 air photo set and portions of the landslide have re-activated by the time of the 1985 and 2002 air photo years. Sediment generated from this landslide pushed the stream against the opposite bank and resulted in a large debris landslide on the opposite hillside delivering nearly 50,000 yds<sup>3</sup> to the stream.

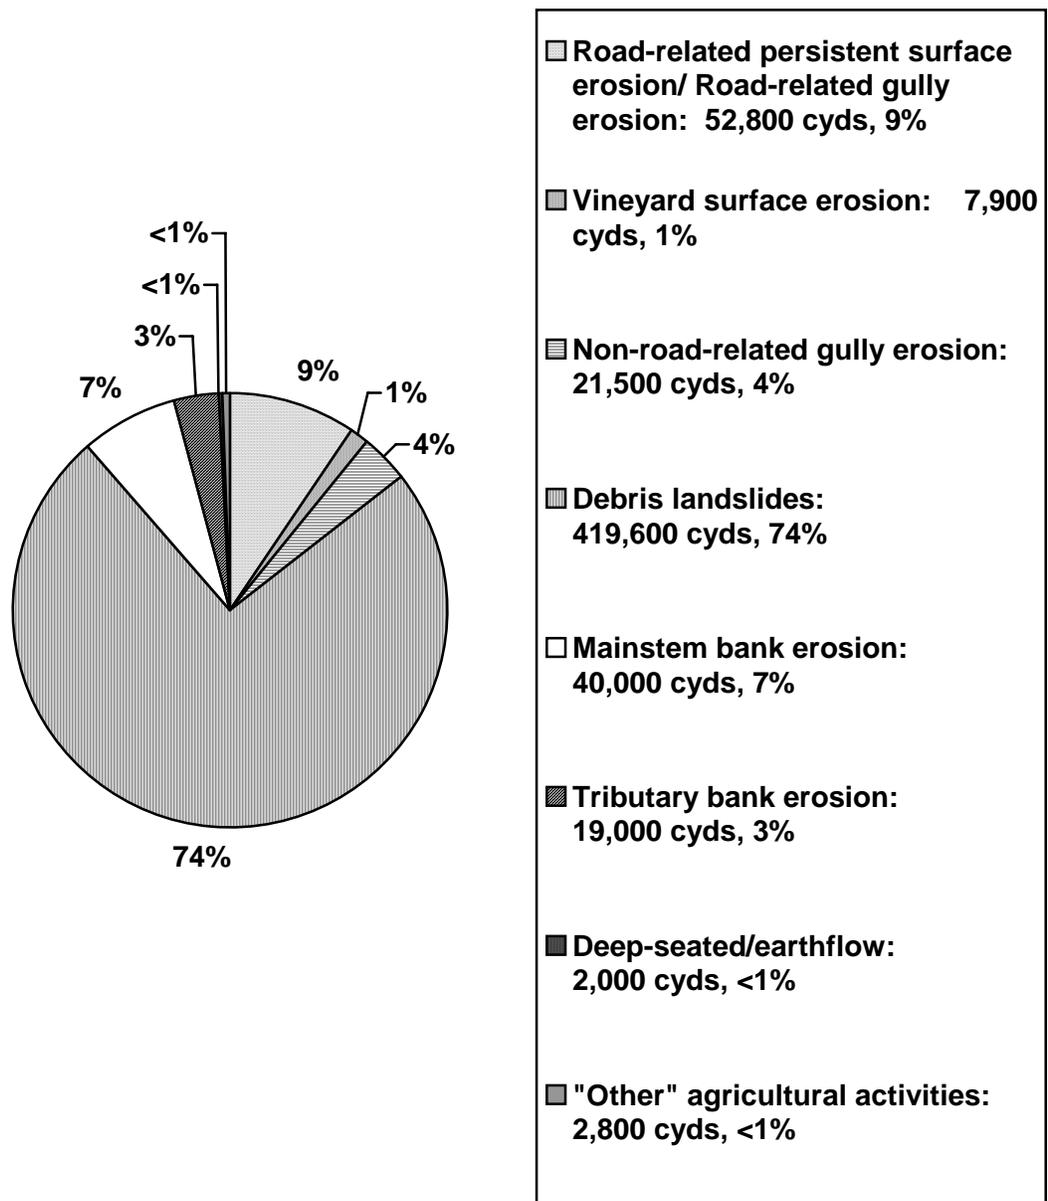
Figure 8. Sediment sources and sediment delivery in the Sulphur Creek watershed.

Approximately 52,800 yds<sup>3</sup> of past erosion and sediment delivery from road-related chronic surface erosion and gullies was estimated over the last 50 years. This represents 9% of the total estimated past sediment delivery from sediment sources in the Sulphur Creek watershed (Figure 8).
