NAPA RIVER FISH BARRIER PLAN

August 2011

***NAPA COUNTY RESOURCE CONSERVATION DISTRICT
1303 JEFFERSON STREET, SUITE 500B
NAPA, CALIFORNIA 94559***

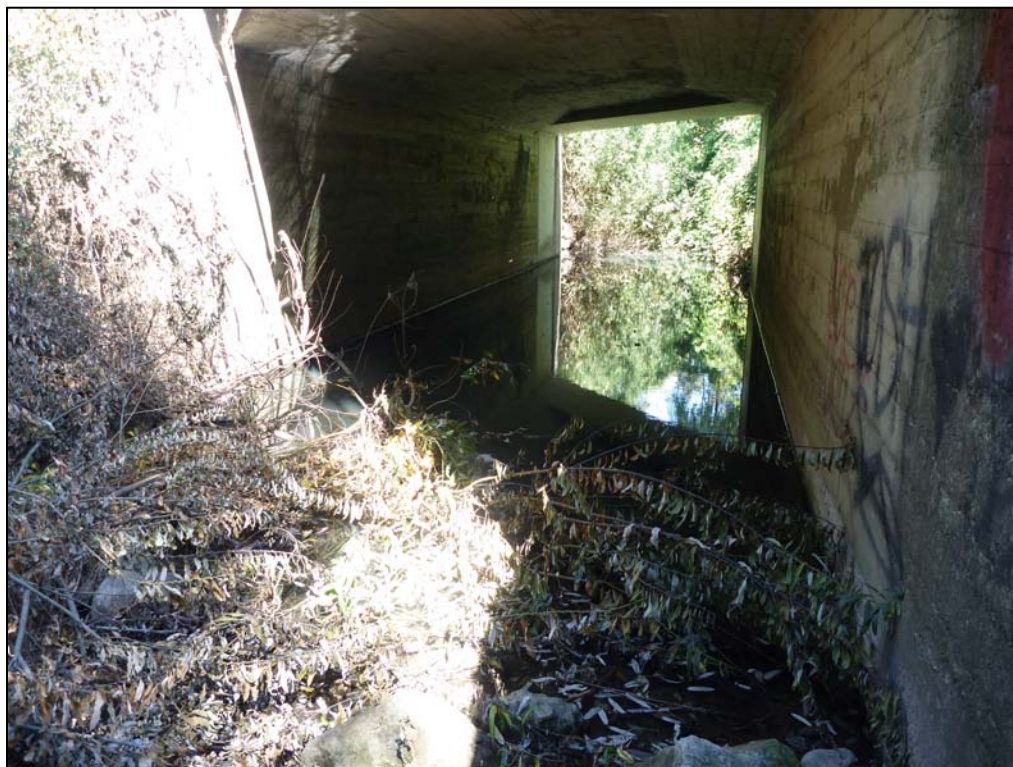
Bell Creek Culvert at Silverado Trail – This site consists of a 6” concrete weir at the downstream edge of a natural-bottomed box culvert over the Silverado Trail (Figure 7). RCD field crews originally identified the weir as a potential passage barrier in 2004 during a summertime habitat survey. However, as part of this project, RCD observed passage conditions at the site over a range of typical winter and spring flows, and it was determined to be only a minor low-flow obstacle. No further assessment was deemed necessary.

Figure 7. Bell Creek culvert at the Silverado Trail (facing upstream)

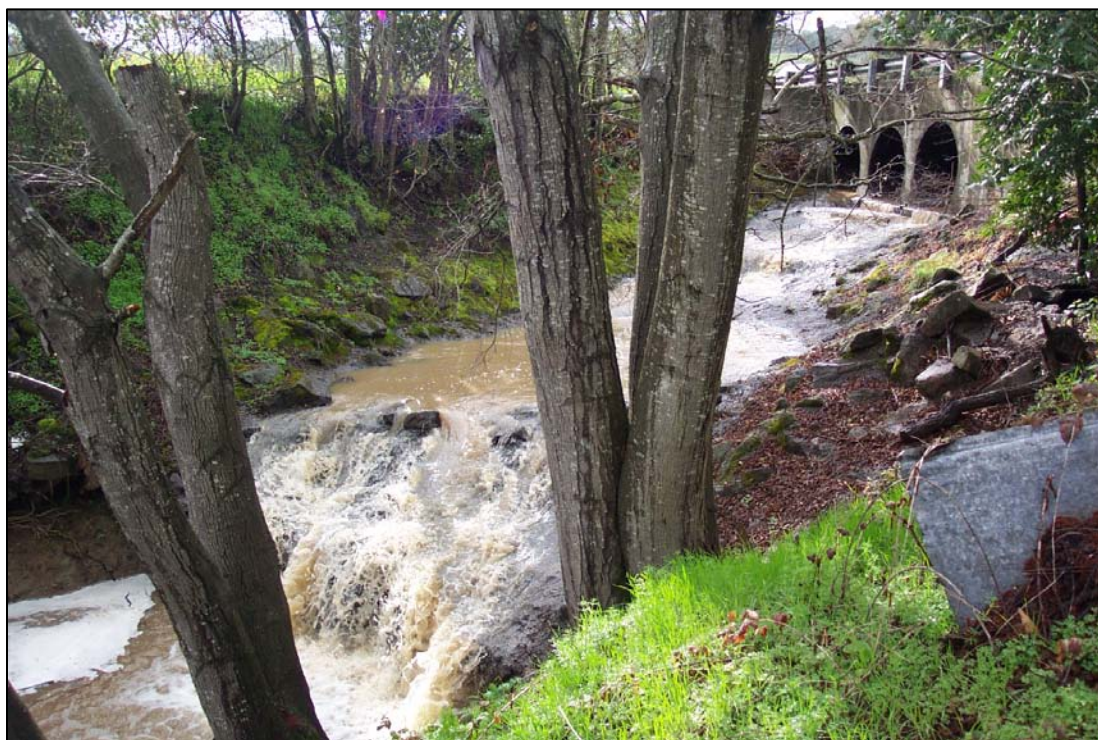
Huichica Creek Culvert at Highway 12/121 – This site consists of a triple-barrel culvert with an approximately 50-foot long concrete apron at the Highway 12/121 crossing (Figure 8). RCD contacted Caltrans at the beginning of this project to determine the status of the crossing and to discuss if there were any pending plans for replacement or retrofit of the site. Caltrans staff stated that the crossing is slated for replacement with a free-span bridge within the next five years (Blizard, pers. comm.). However, the specific design of this crossing repair has not yet been finalized, and implementation funding has not been secured. RCD determined that, given the existing momentum for this site along with Caltrans’ commitment to replace the structure, an assessment under this project was not warranted.

Figure 8. Huichica Creek culvert at Highway 12/121.

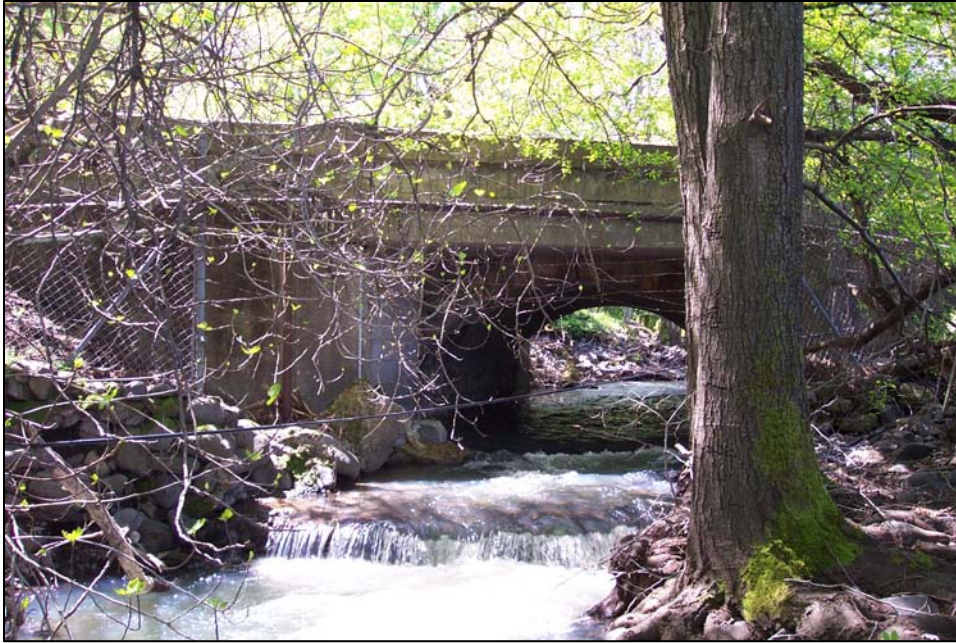
Ritchey Creek Culvert at Highway 29 – This site consists of a concrete box culvert at the Highway 29 crossing near Bothe State Park (Figure 9). During the course of this project, another watershed group, the *California Land Stewardship Institute*, received funding to assess the culvert. The resulting report was completed by Phillip Williams and Associates in December 2008. RCD is continuing to collaborate with California State Parks, Caltrans, and other stakeholders to implement a fix for this site.

Figure 9. Ritchey Creek culvert at Highway 29

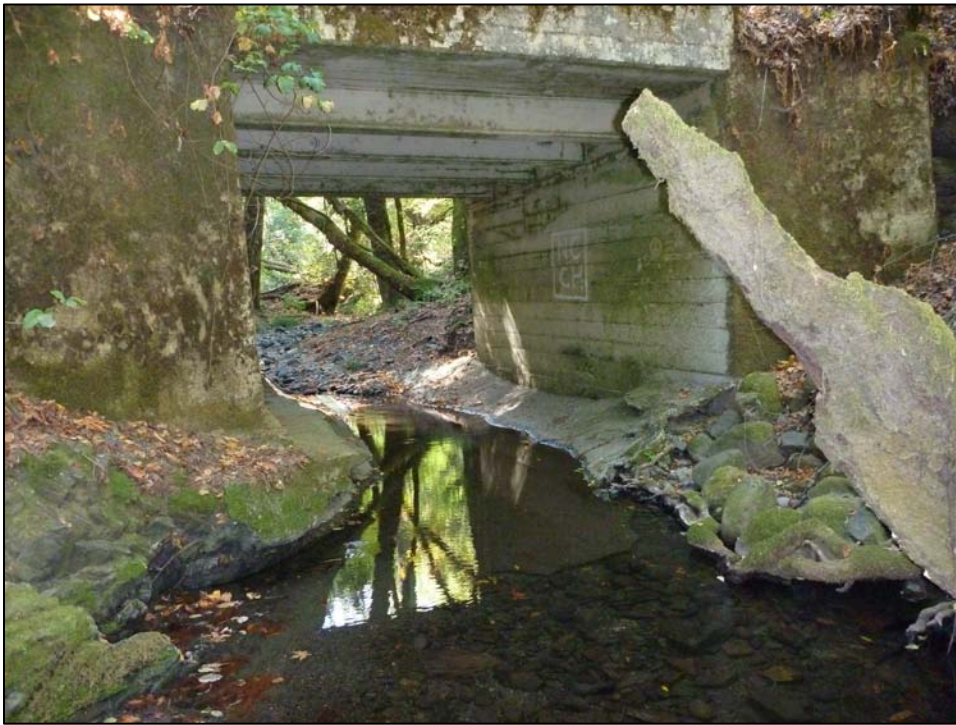
Sulphur Creek Culvert at Sulphur Springs Road - This site consists of concrete box culvert (Figure 10). It was originally identified in 2002 during a summertime habitat survey as a potential barrier. However, as part of this project, RCD observed passage conditions at the site over a range of typical winter and spring flows, and the site was determined to not be a significant obstacle. No further assessment was deemed necessary.

Figure 10. Sulphur Creek culvert at Sulphur Springs Road

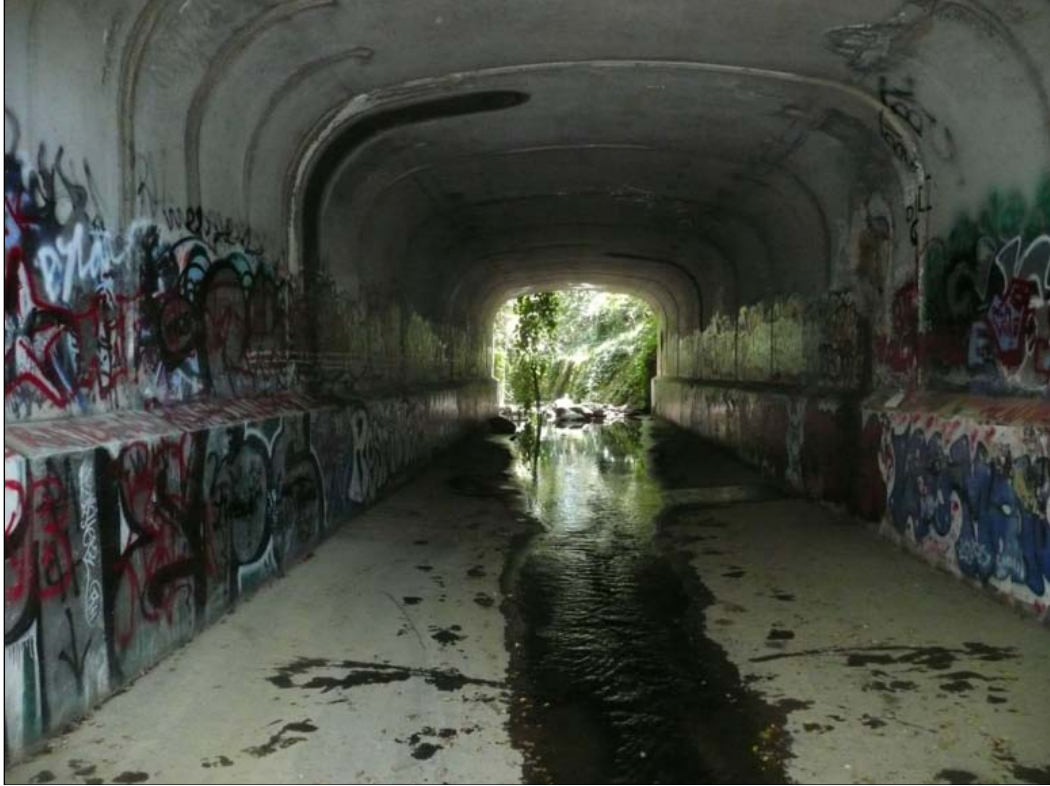
Figure 3. Looking downstream through the Robinson Lane culvert.

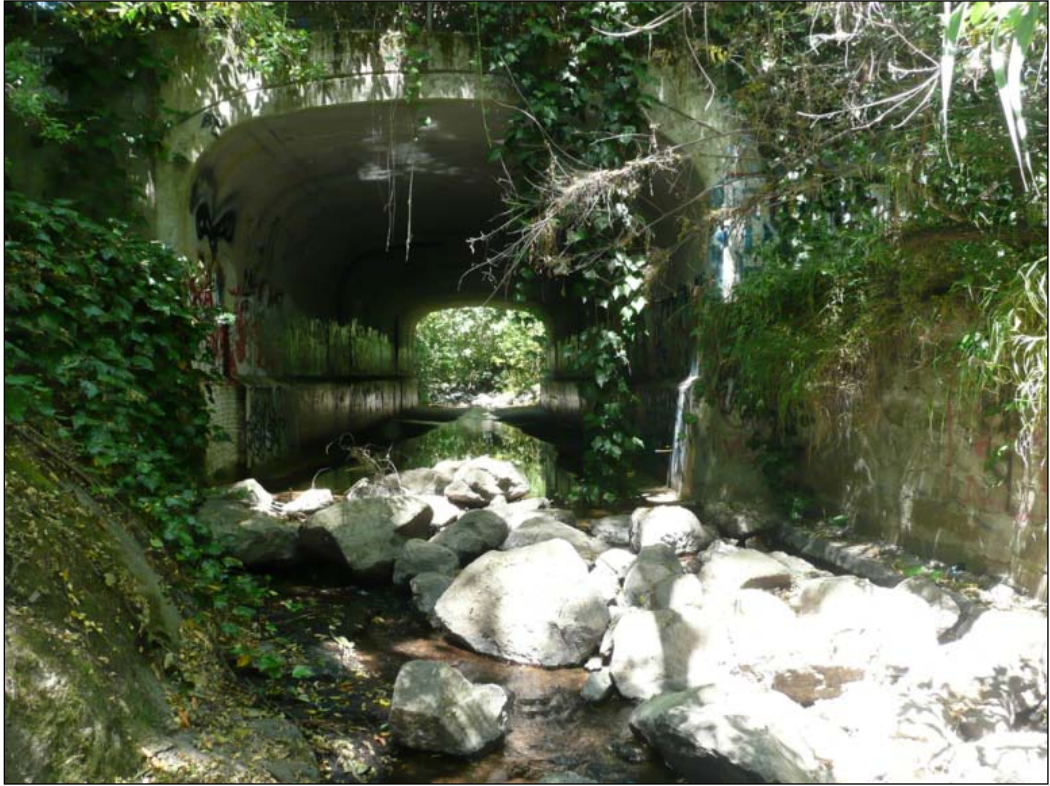
Figure 4. View of downstream face of culvert looking upstream.

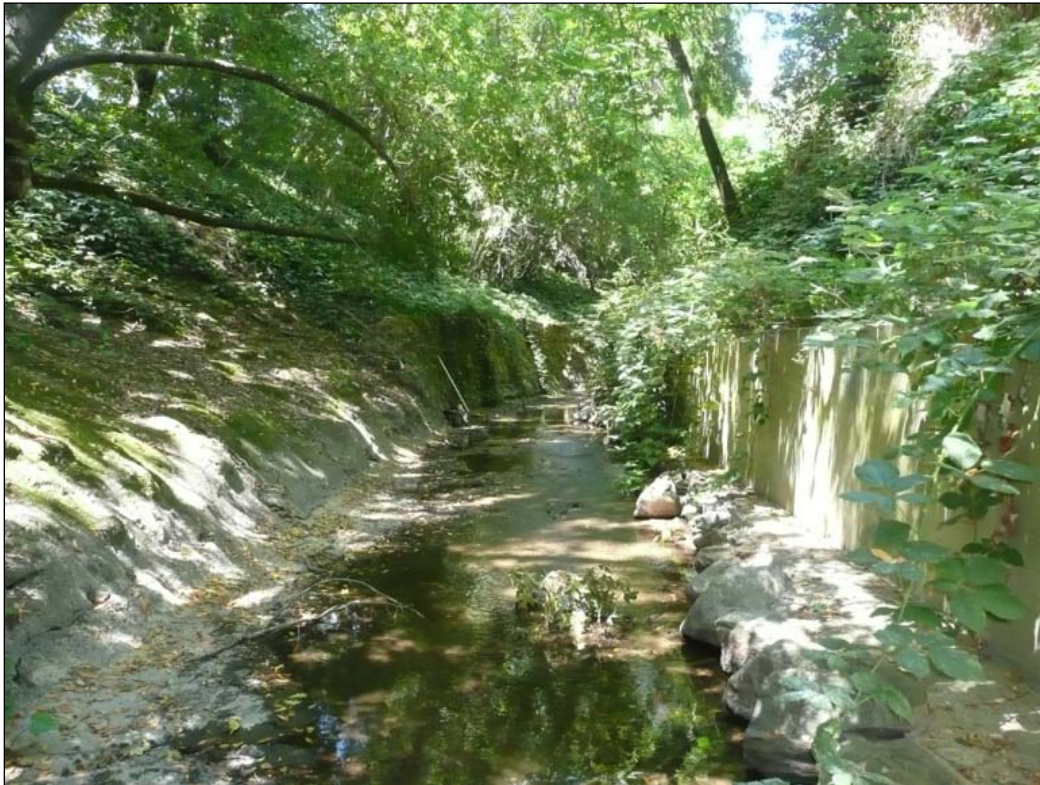
Figure 5. View looking upstream toward culvert from downstream end of concrete apron.

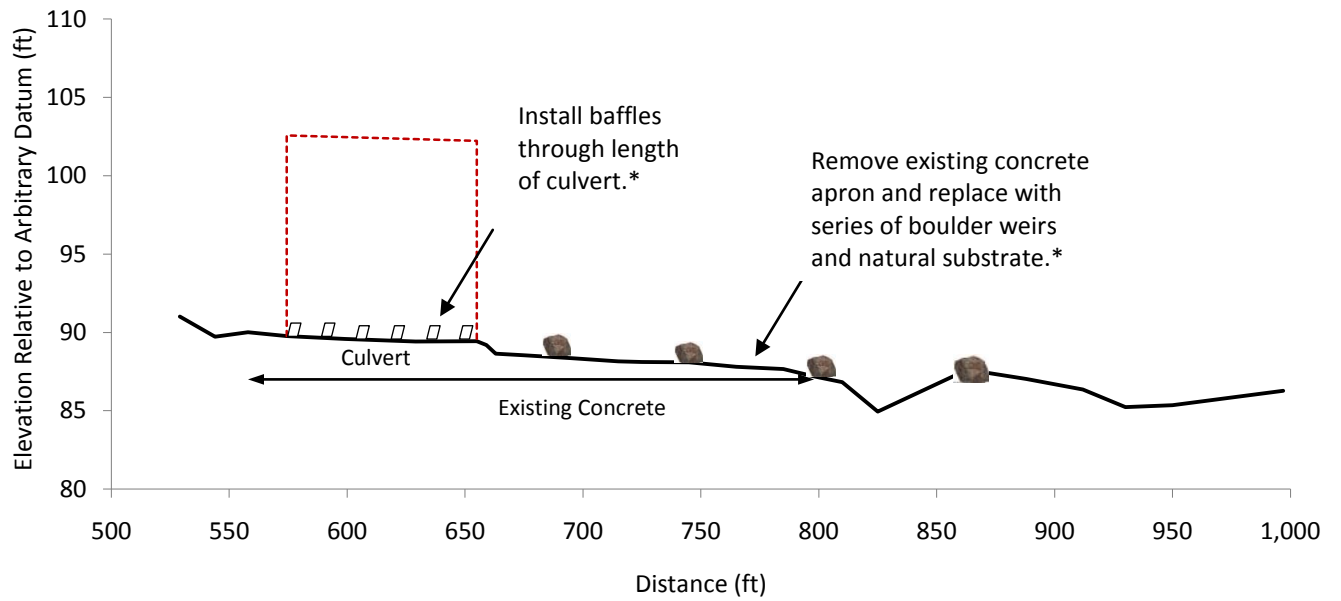
CONCEPTUAL DESIGN

*Exact location, size, and number of features to be determined by a qualified engineer to achieve velocity and depth targets for salmonid passage.

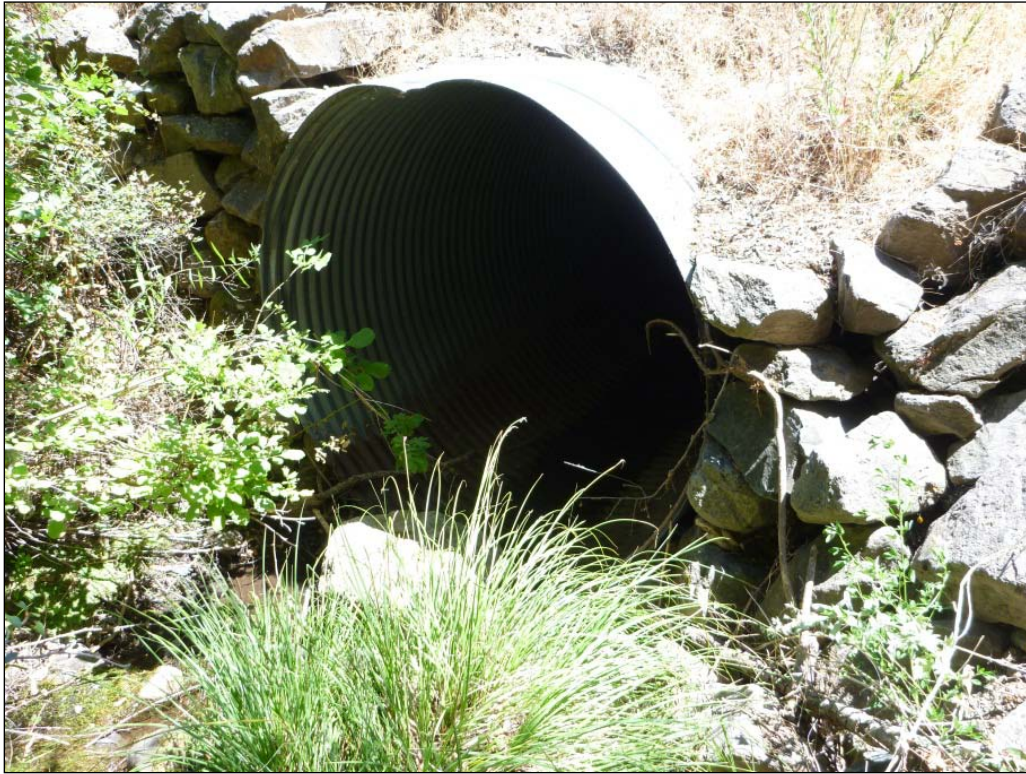
The Dry Creek Road culvert at Campbell Creek is a 6-foot diameter 100-foot long circular thin-wall corrugated steel pipe culvert with a projecting barrel inlet (Figure 2). The culvert is located at the outlet of the watershed, with the downstream end of the culvert emptying directly into Dry Creek. Under low-flow conditions, there is an approximate 3-foot drop from the outlet of the culvert to the tailwater surface (Figure 3).

Figure 2. View of the inlet of the Dry Creek Road culvert.

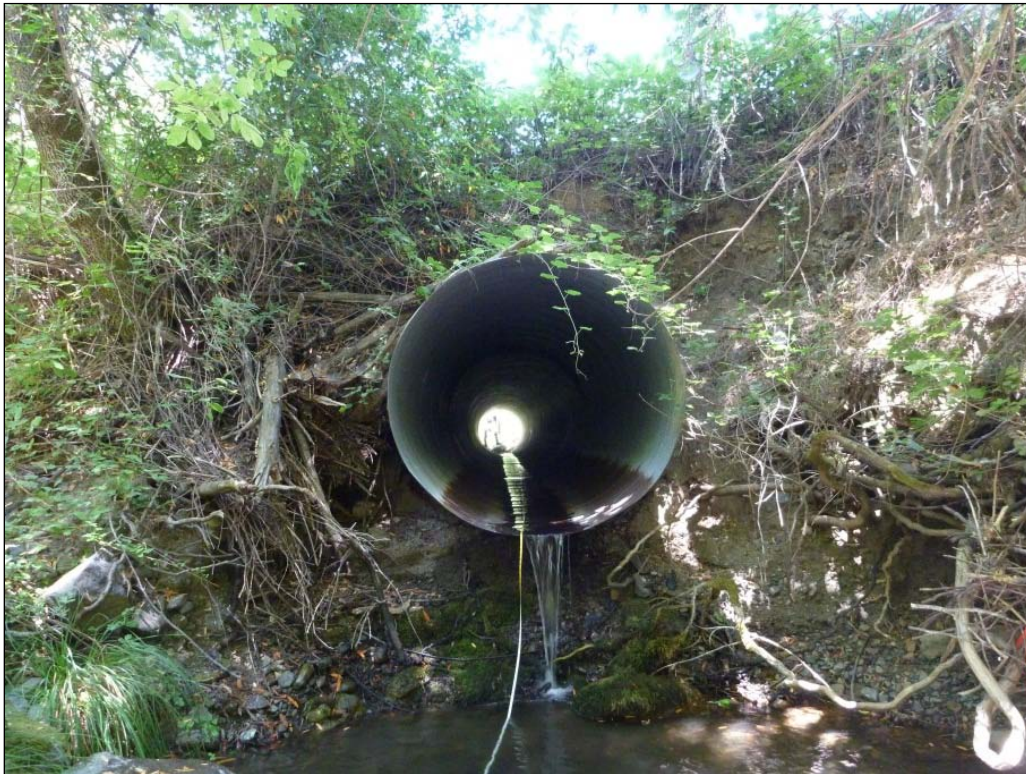
Figure 3. View looking upstream through the Dry Creek Road culvert.

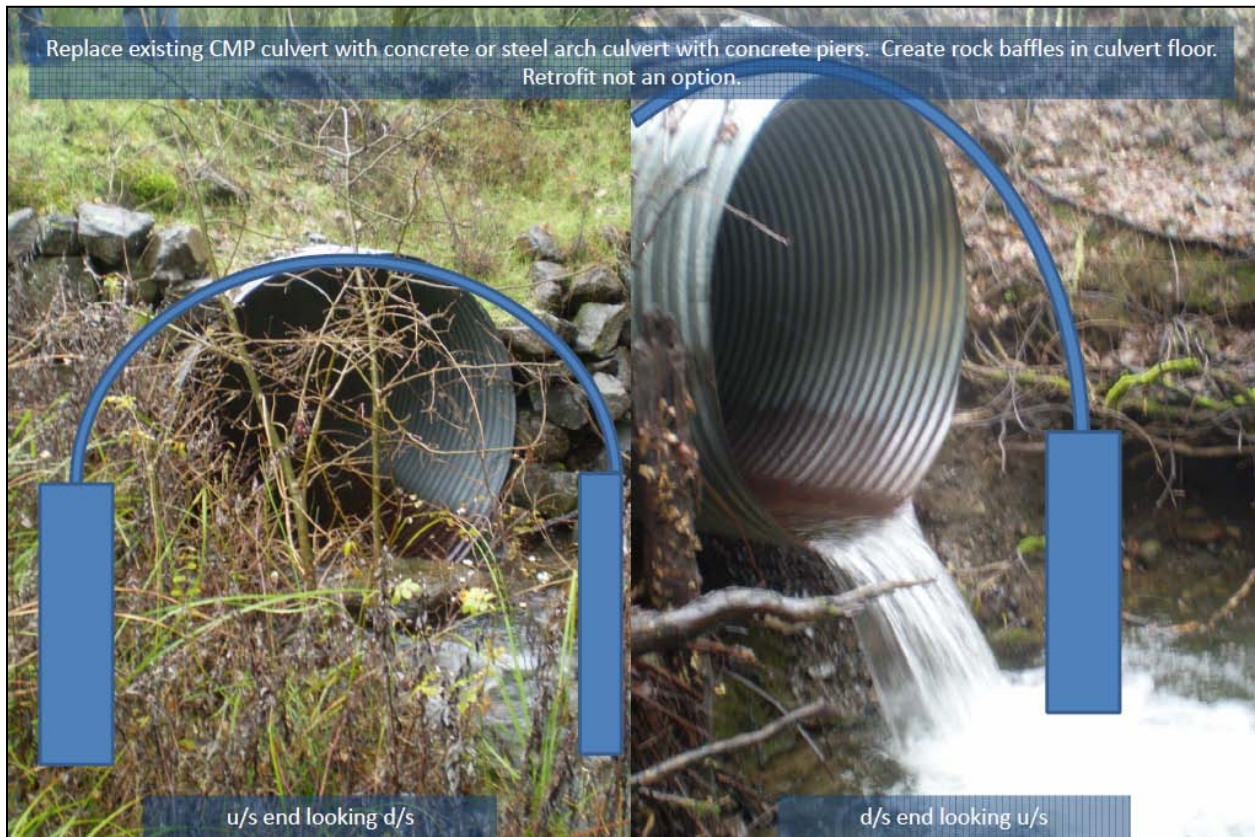
Option 2:

frequent flooding of the stream crossing due to the undersized culvert carries several risks including motorist safety, stream channel erosion, and costs associated with the potential failure and emergency stabilization and replacement of the culvert. If Option 2 is selected, the replacement culvert should be embedded or have rock baffles in the floor to reduce velocities and increase depth in the culvert.

RCD recommends Option 2. Although 0.67 miles of additional habitat is a relatively small contribution to the overall watershed, it is habitat of the highest quality in the area. In addition,

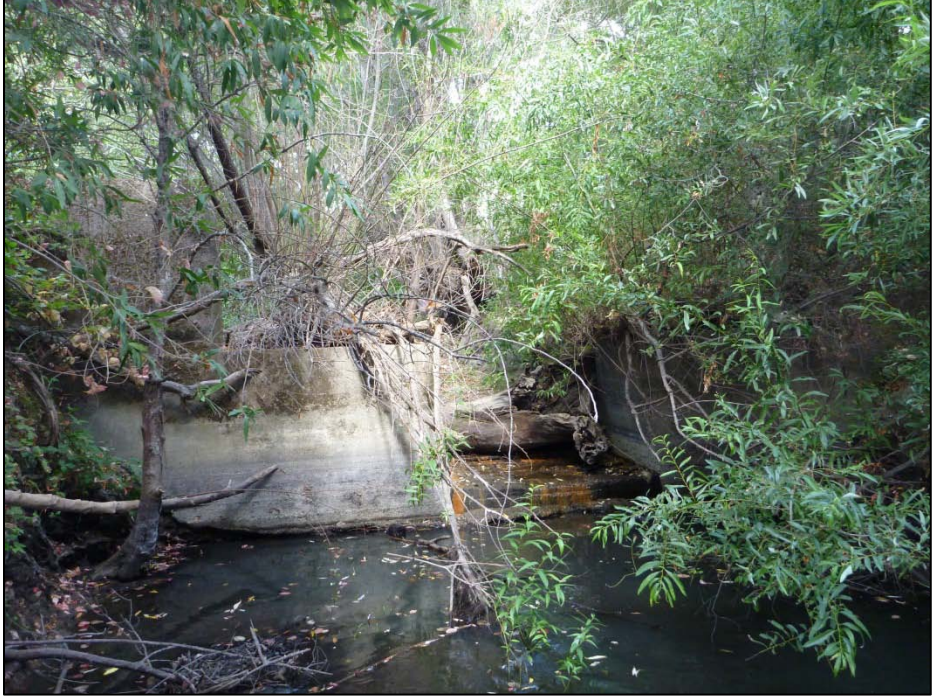
The defunct in-stream flashboard dam is a concrete dam with an 8-foot wide lower water channel up to a height of 5.2 feet above the streambed elevation (Figures 3 and 4). Above 5.2 feet, the water channel widens to 23.8 feet and this width extends to the crest of the dam at 12.2 feet above the streambed (Figure 5). It appears that flashboards could be installed in both of these openings to impound water up to the crest of the dam. When the stream is flowing, the sill of the lower water channel is backwatered by the downstream pool. Since it no longer operates, the dam itself is not a low-flow barrier; however, the dam constricts the flow which can create a velocity barrier under high-flow conditions, and the constriction can easily become jammed with large wood, as it is currently (Figure 4), creating a significant low-flow barrier.

Figure 3. Looking upstream at the defunct flashboard dam under summer zero-flow conditions.

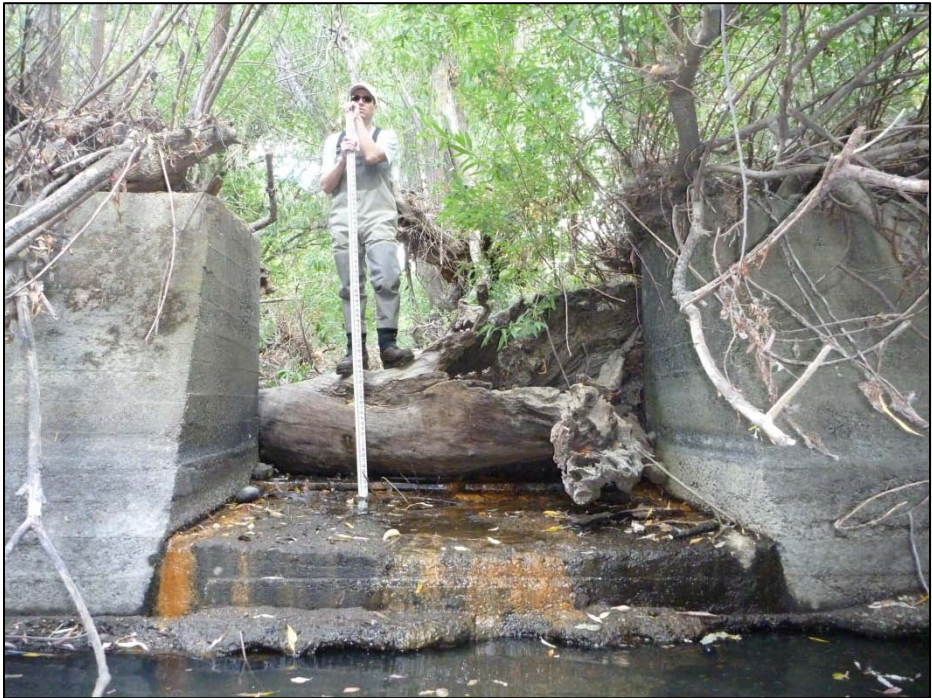
Figure 4. Looking upstream at the lower water channel and jammed log under summer zero-flow conditions.

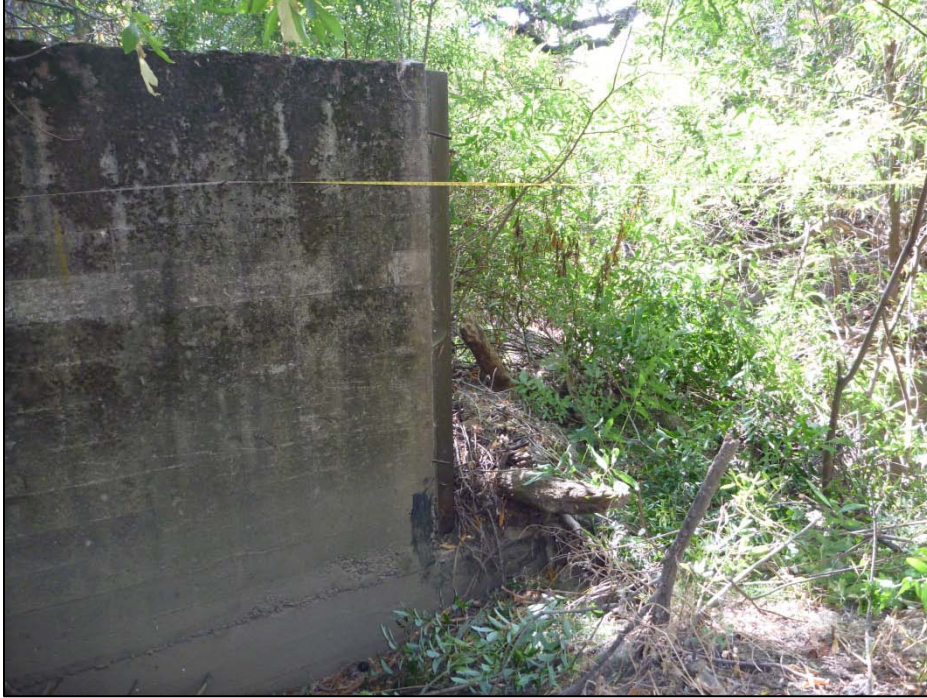
Figure 5. Looking obliquely downstream at upstream side of dam on left bank. Upper water channel and dam crest are shown.

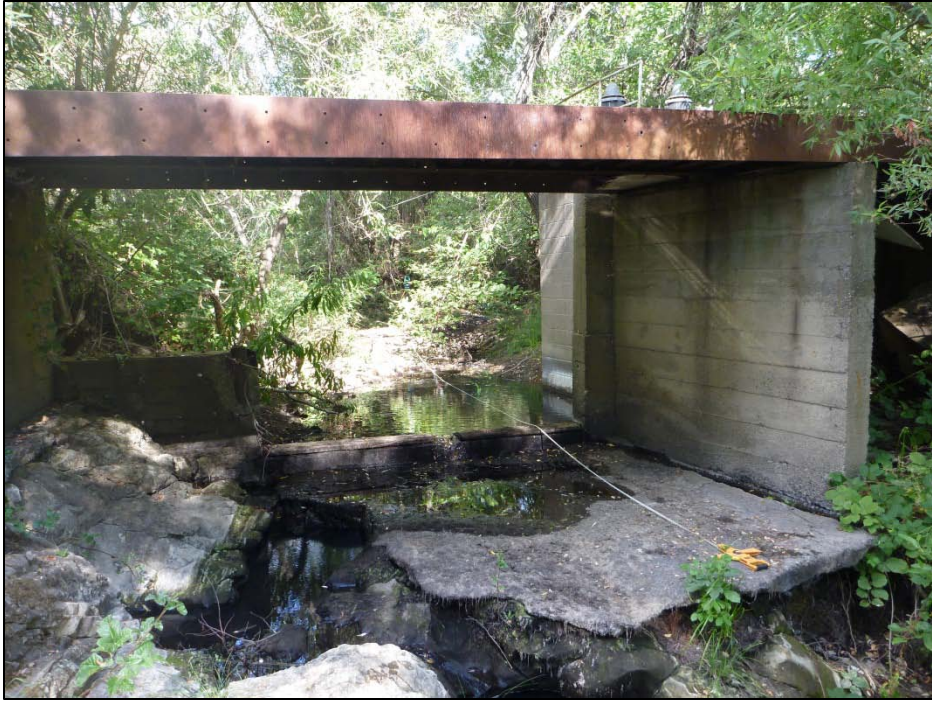
Figure 3. Looking upstream at the pumping station under summer low-flow conditions. Weir, apron, and bridge are shown.

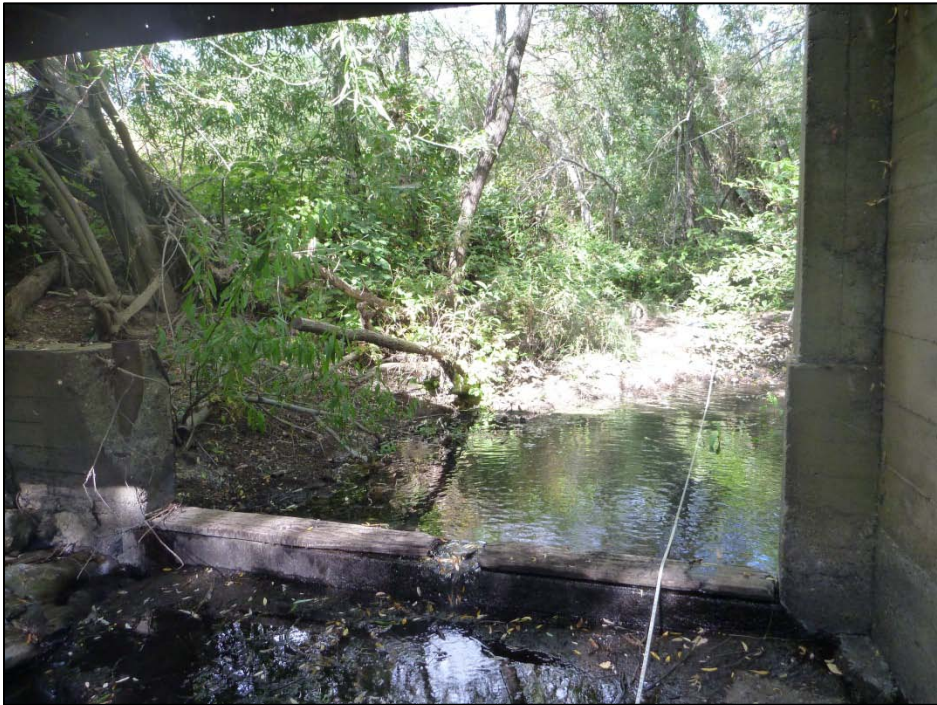
Figure 4. Looking upstream at the weir under summer low flow conditions.

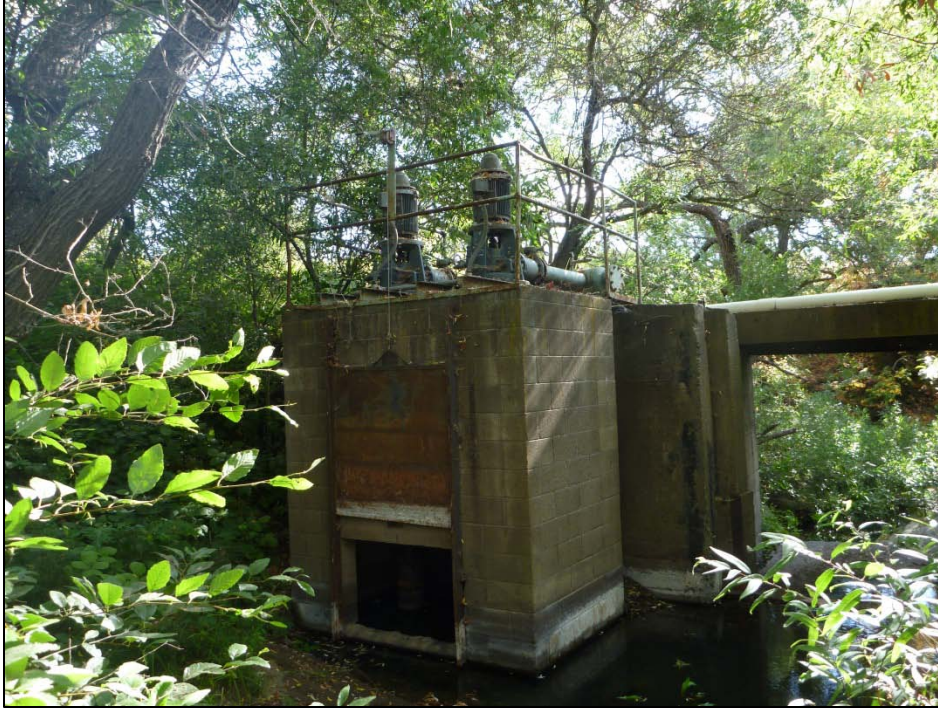
Figure 5. Looking downstream at the pump house and left bank bridge abutment.

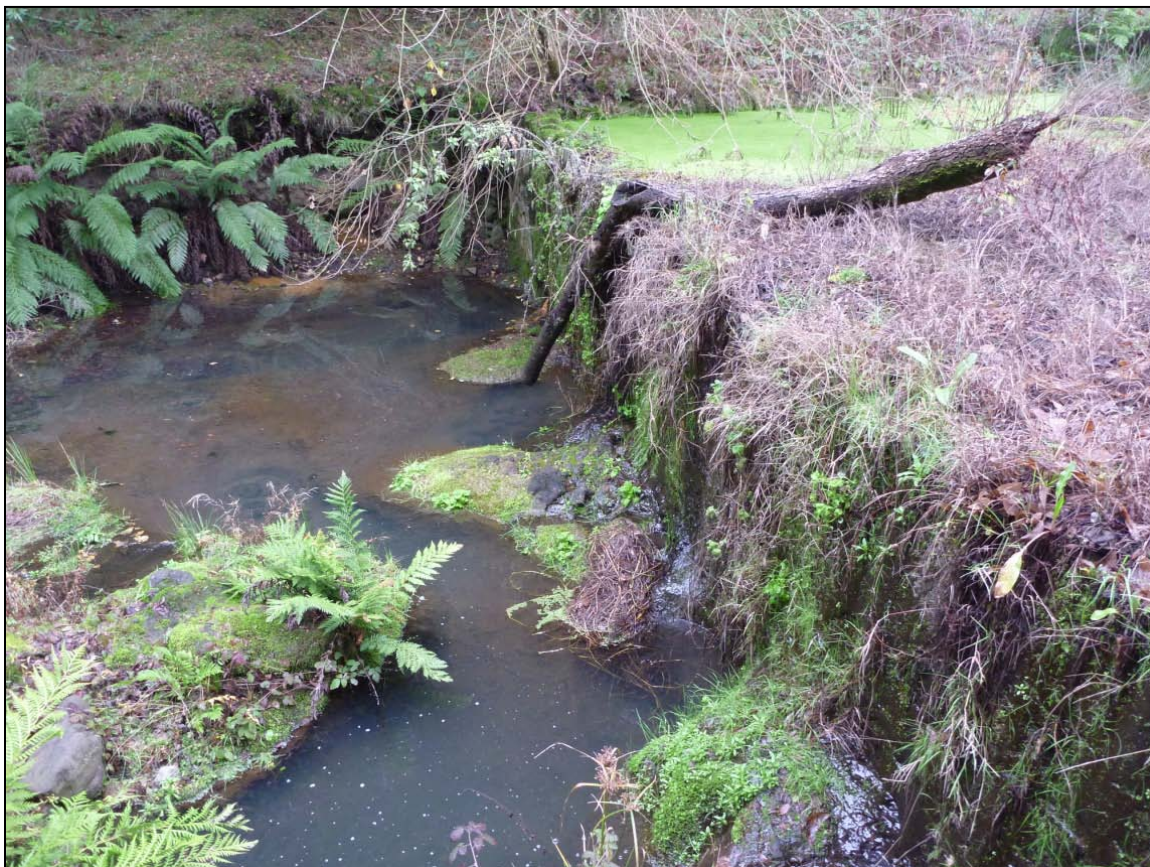
Figure 2. View of the dam from the left bank under low flow conditions.

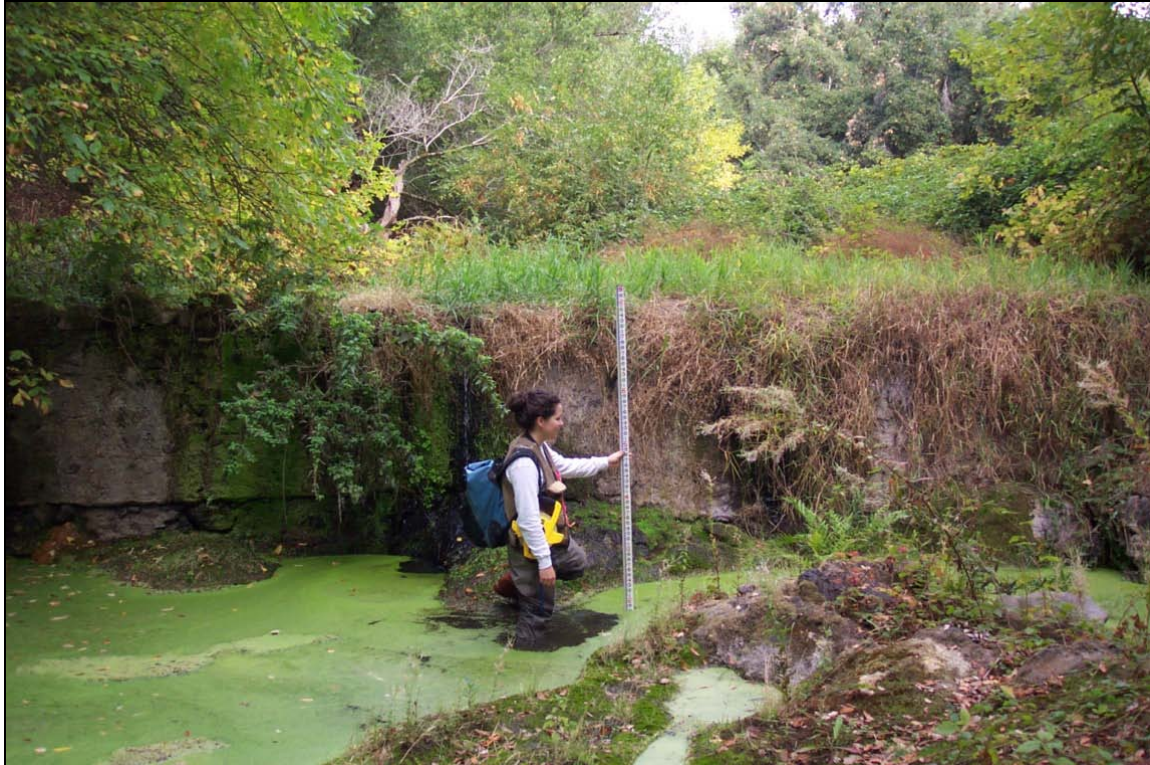
Figure 3. Looking upstream at the dam face under zero-flow conditions.

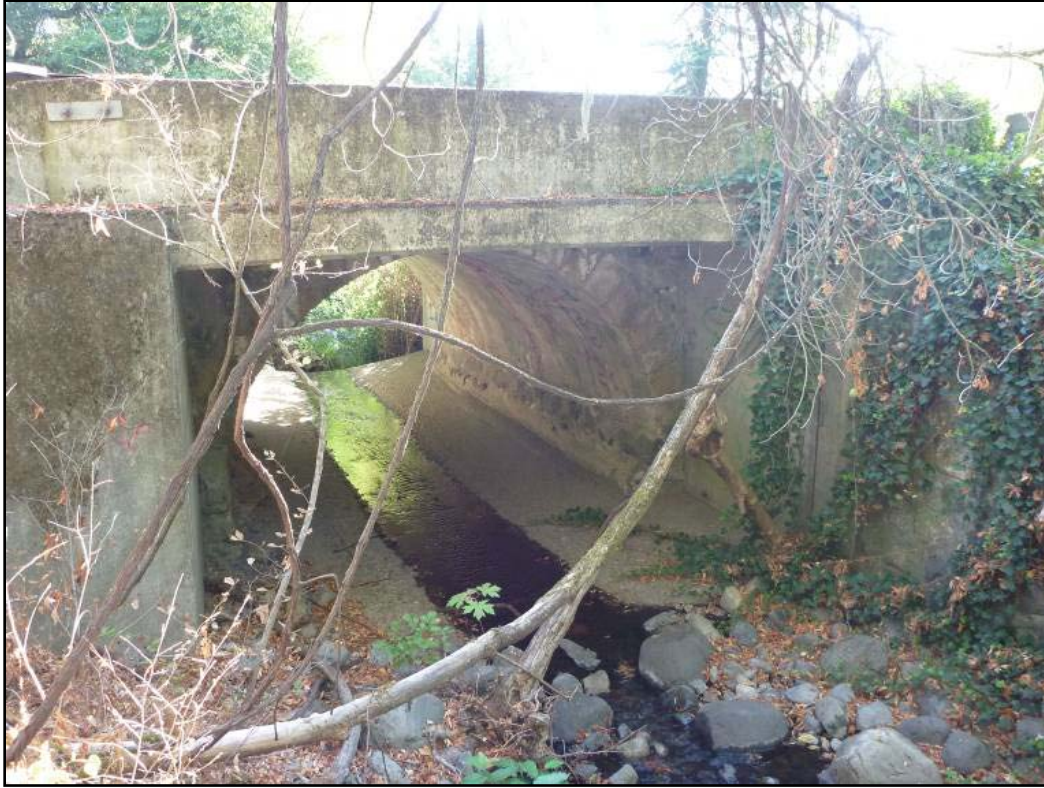
Figure 2. View of upstream culvert face looking downstream.

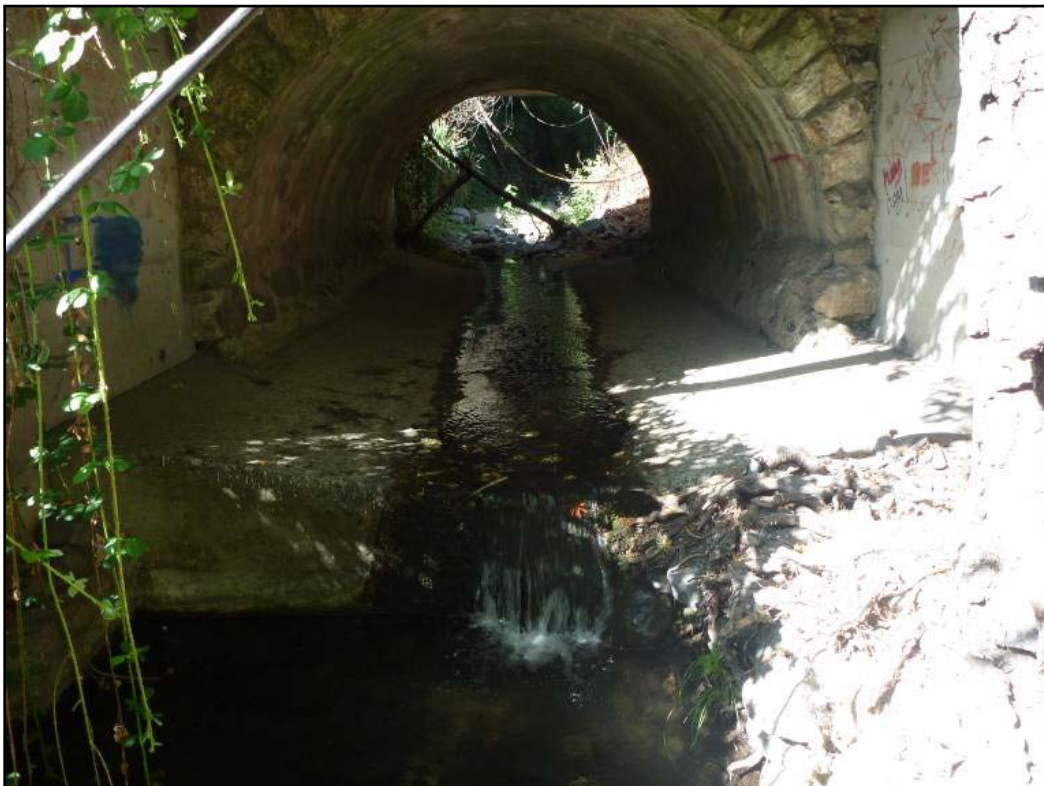
Figure 3. View of downstream end of culvert looking upstream.

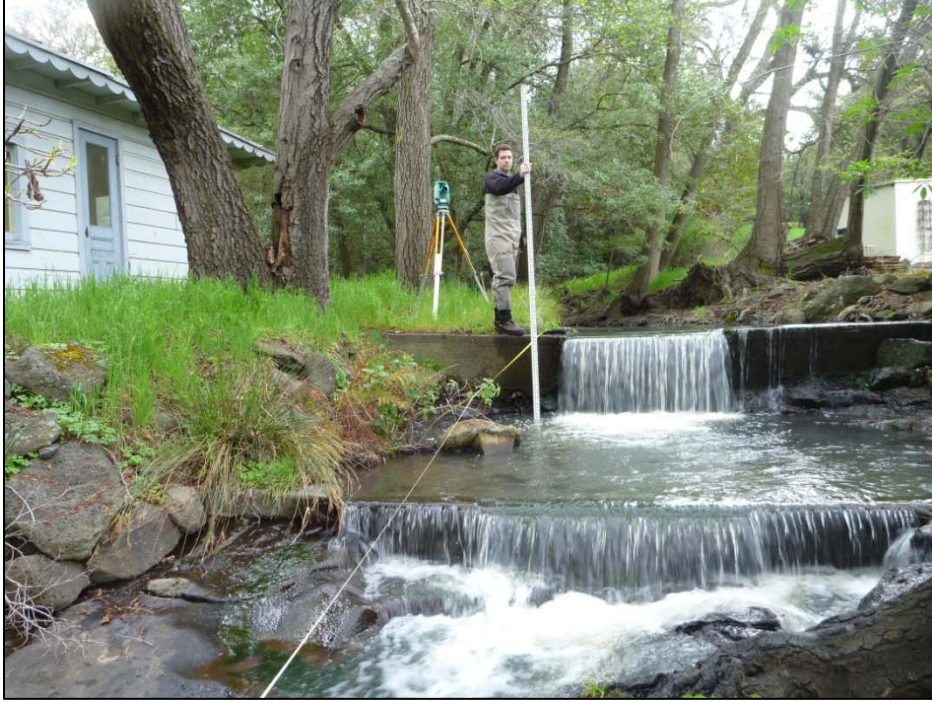
Figure 2. View of the two weirs at site MUR-2 during typical late winter flow conditions (March 10, 2010).

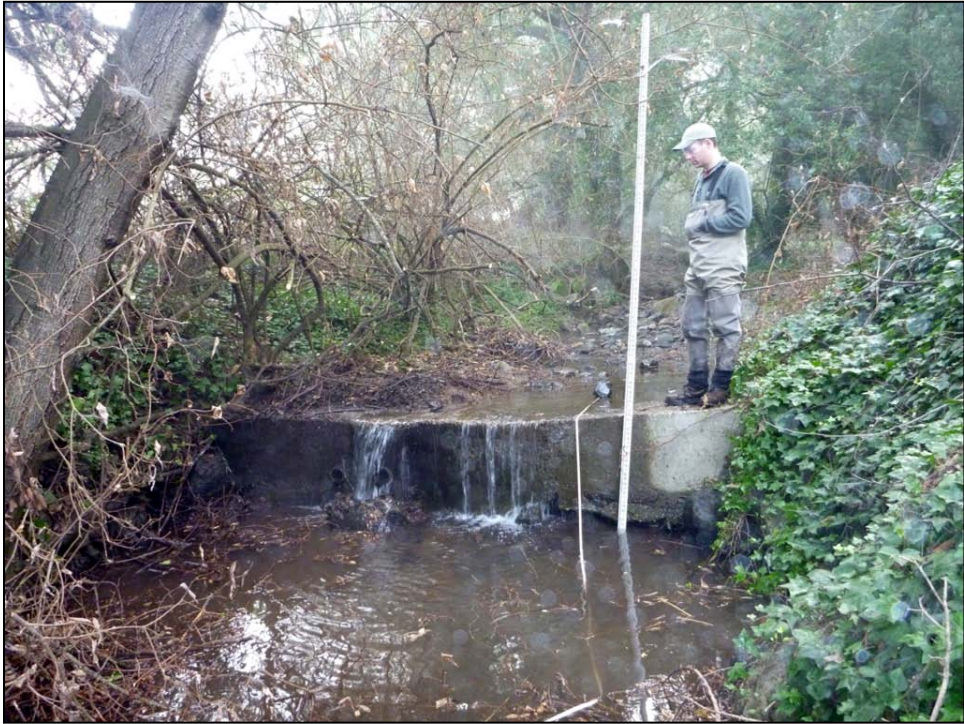
Figure 3. Looking upstream at the weir at site MUR-3 under typical winter low flow conditions.

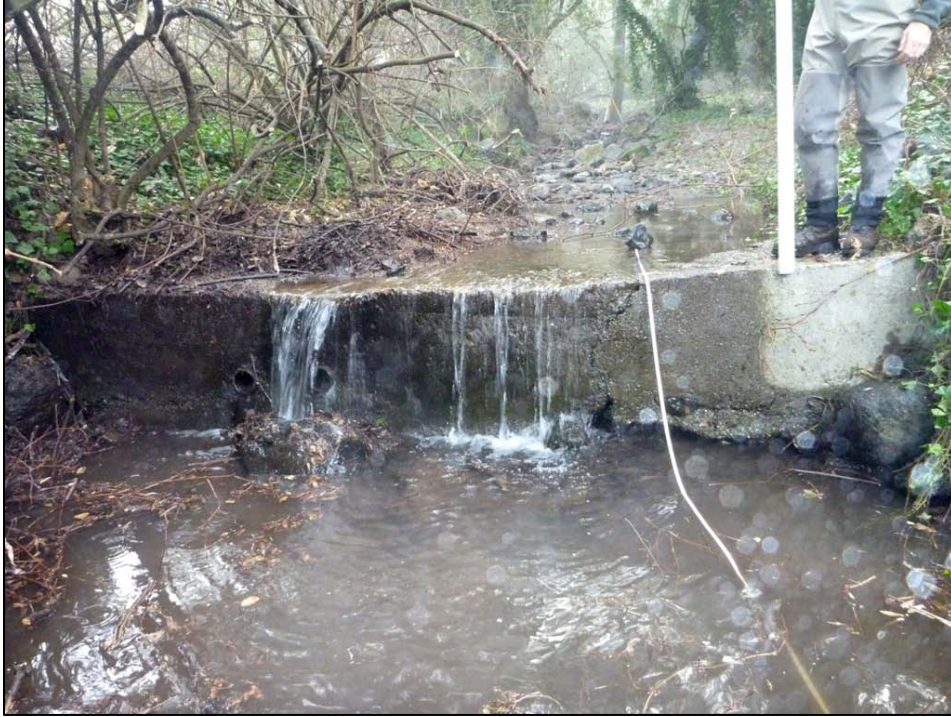
Figure 4. Closer view of the concrete weir at site MUR-3.

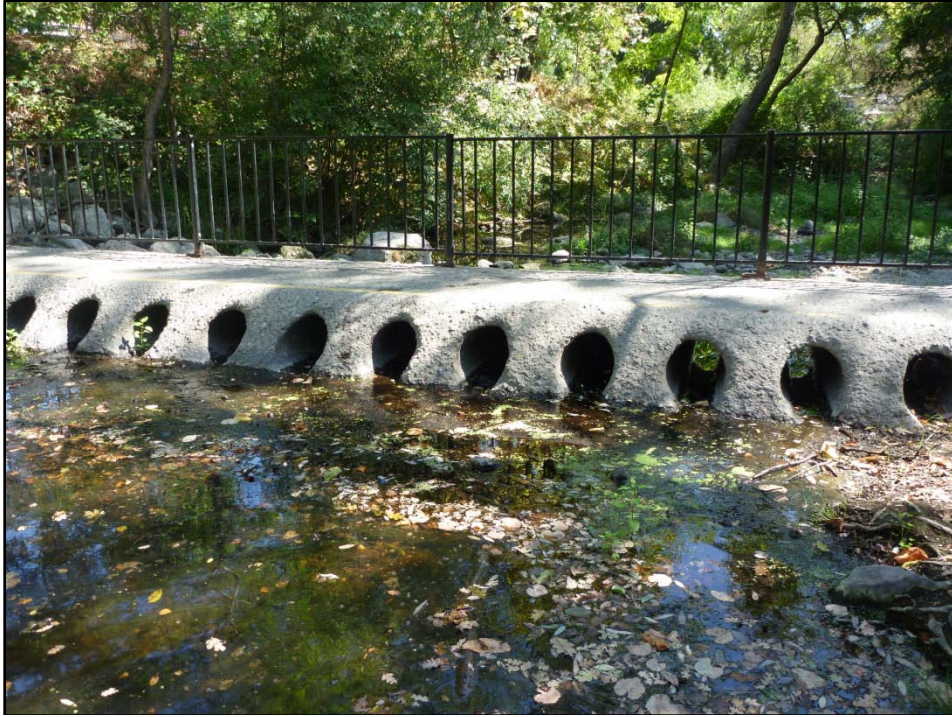
Figure 4. Closer look at upstream side of foot path under near zero-flow conditions.

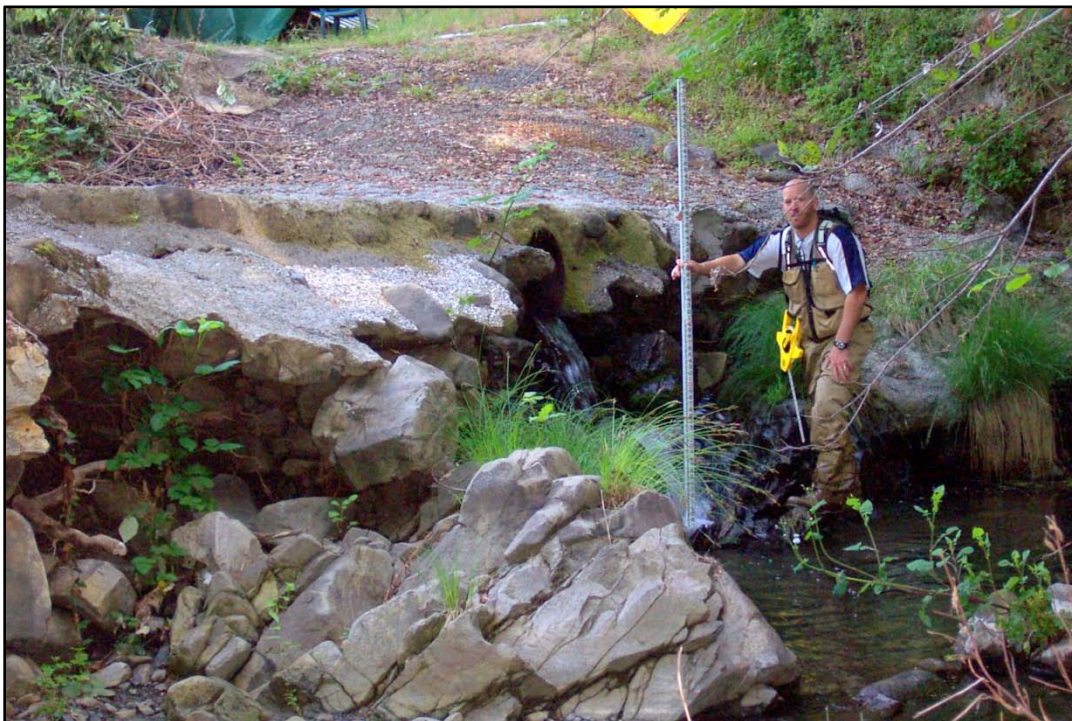
Figure 3. View of downstream face of Pickle Canyon Creek concrete ford under low flow.

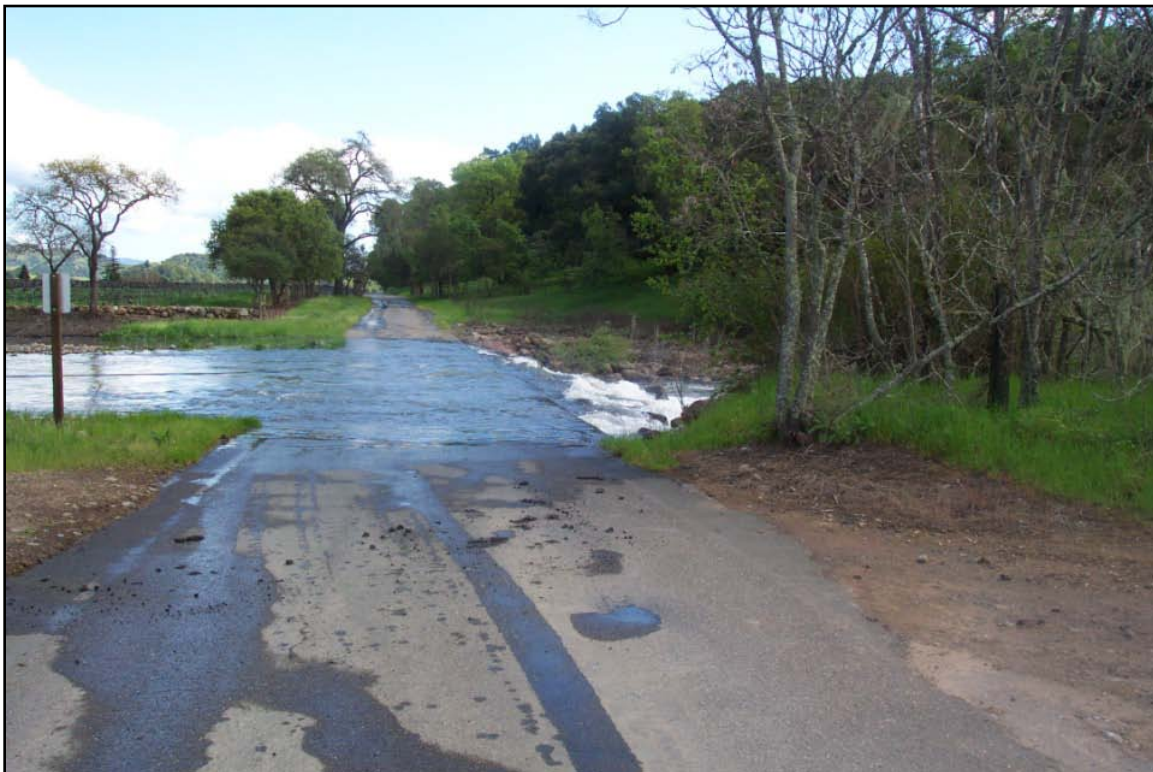
Figure 3. Looking south down State Lane, across Rector Creek under spring flow (April 2006).
