NAPA RIVER FISH BARRIER PLAN

August 2011

***NAPA COUNTY RESOURCE CONSERVATION DISTRICT
1303 JEFFERSON STREET, SUITE 500B
NAPA, CALIFORNIA 94559***

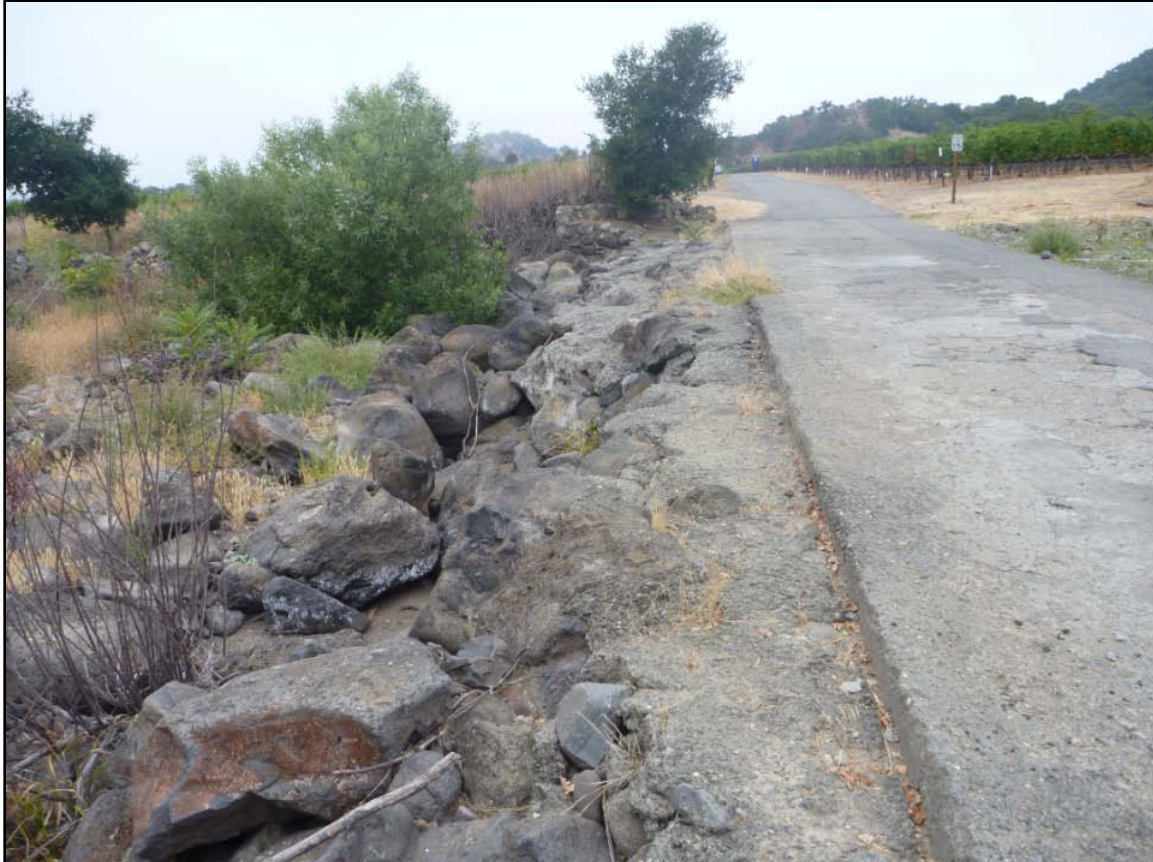
Figure 4. View of downstream side of crossing looking north along State Lane (August 2010).

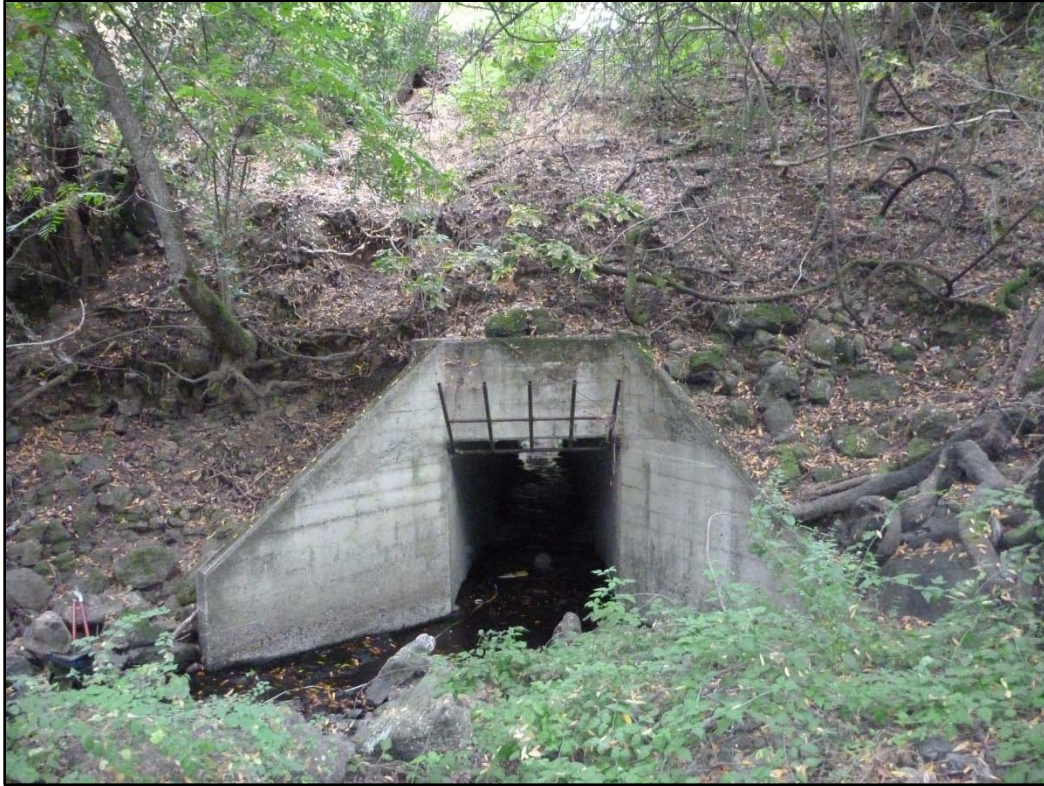
Figure 2. View of culvert inlet looking downstream.

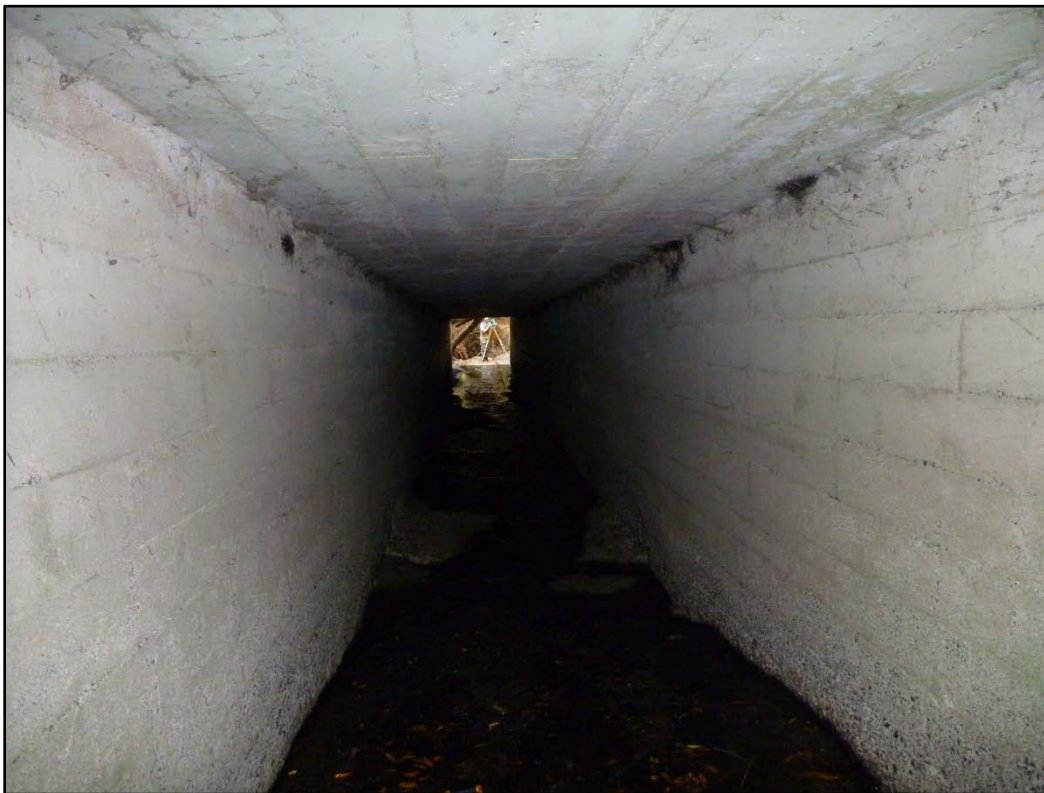
Figure 3. Looking downstream through the culvert.

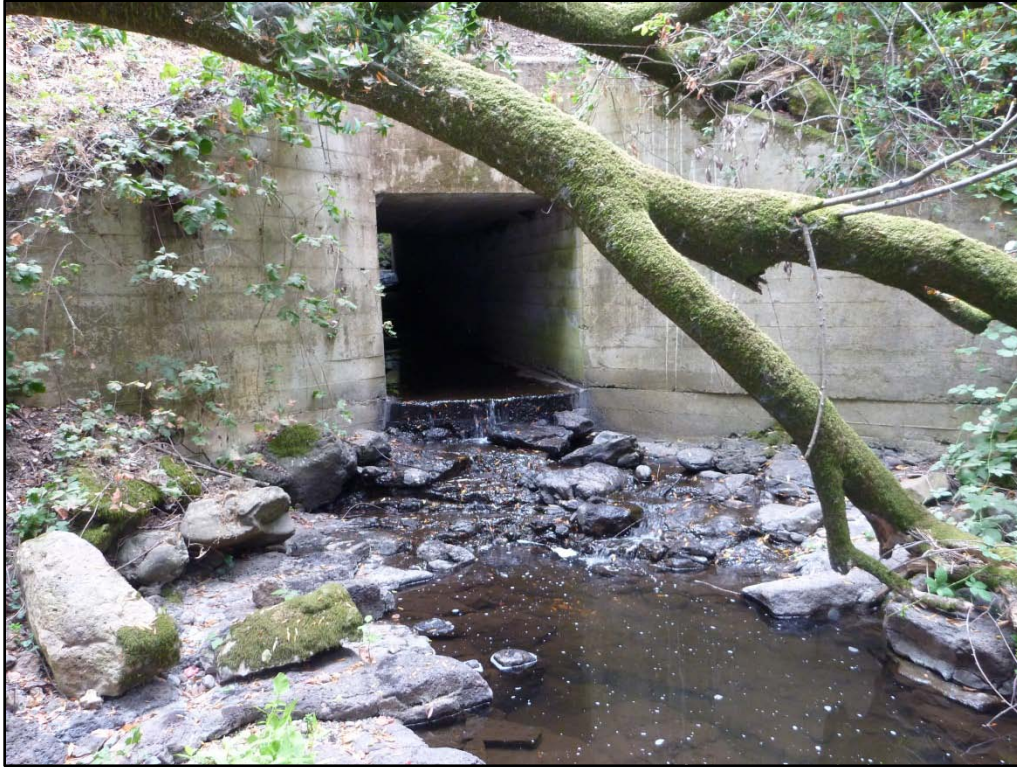
Figure 4. View of culvert outlet looking upstream.

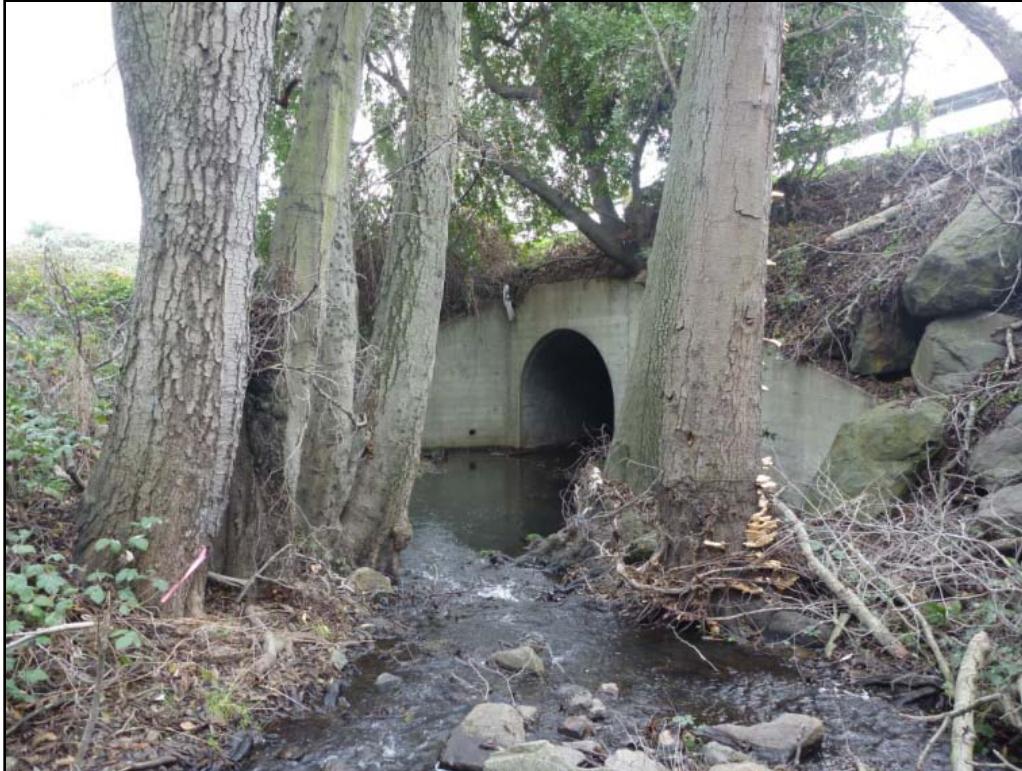
Figure 2. View of upstream culvert inlet and wing-walls looking downstream.

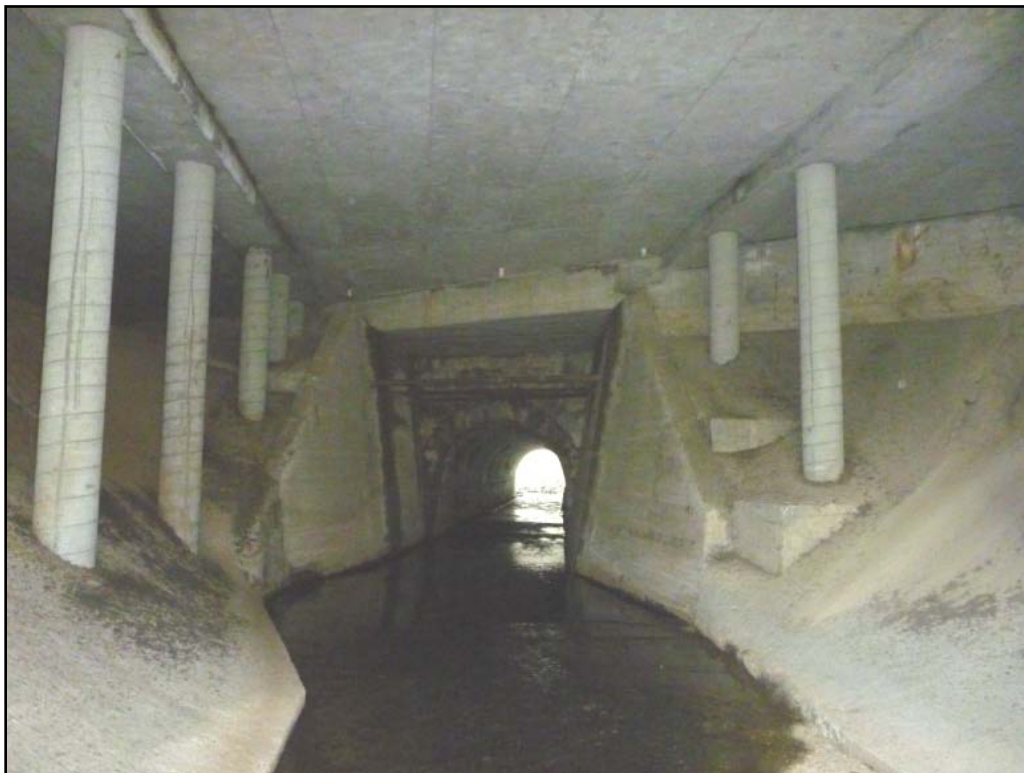
Figure 3. View of box culvert extension and trapezoidal channel looking upstream.

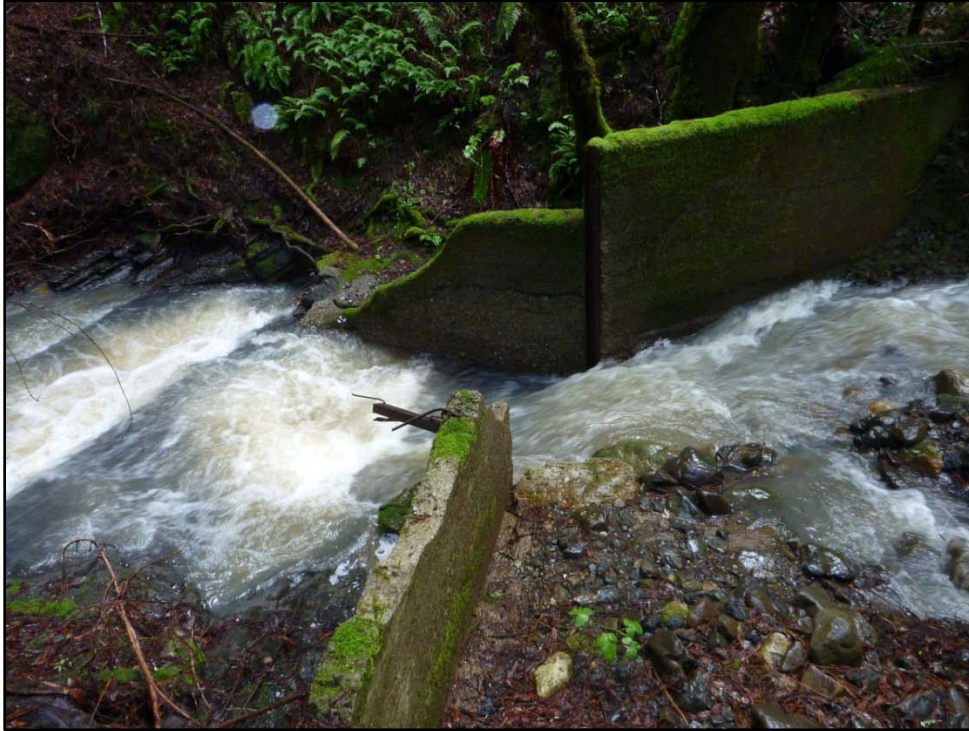
Figure 3. Defunct flashboard dam during a winter storm.

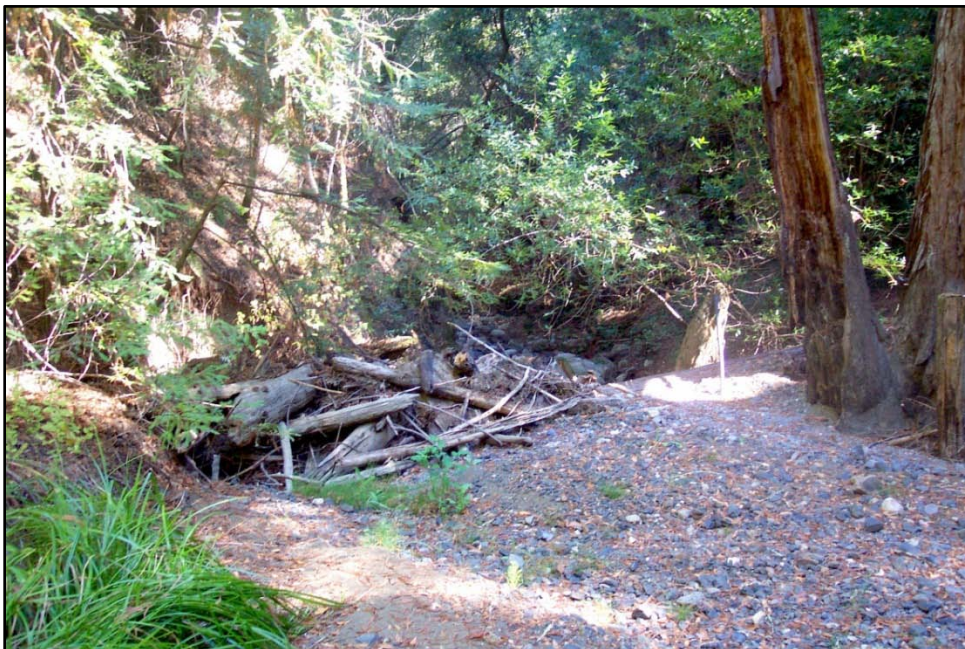
The former earthen ford on Wing Canyon Creek was the crossing of a currently unused and unmaintained dirt road. The ford appears to have been built across a natural accumulation of sediment behind a debris jam and was held in place by a fallen redwood tree and a few boulders that created an approximate 6-foot falls.

Figure 3. Looking downstream from the earthen ford under summer flow conditions prior to clearing of the debris jam.
