March 1, 2021
CAInc File No. 20-643.1

Subject: **Draft Geotechnical Memorandum**
NCRCD-Sulphur Creek Fish Passage (Project #30144)
Napa County, California

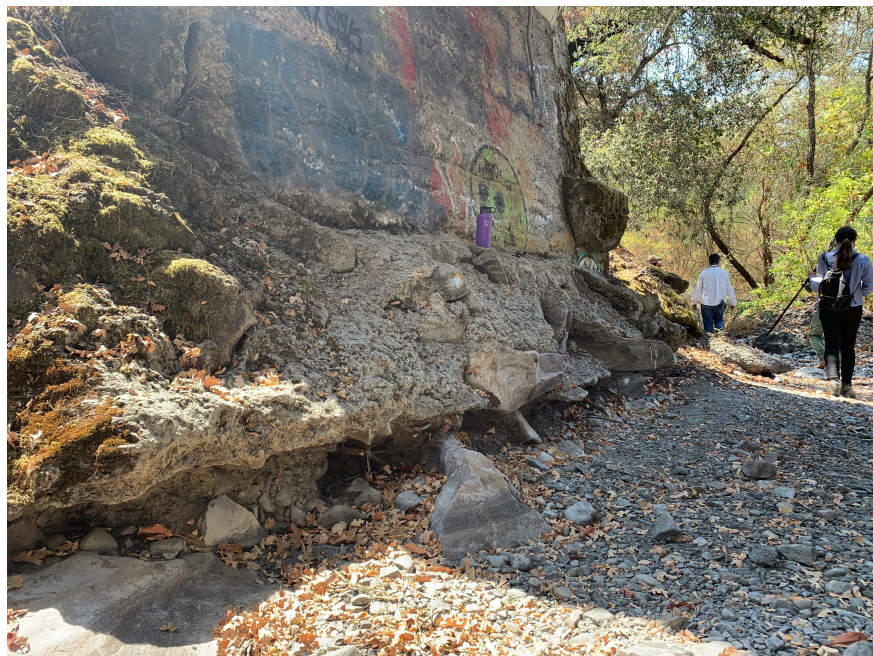
Photo 1 – Southern abutment (looking southwest)

Sulphur Creek constricts to about 15 ft wide as it flows easterly under the bridge, likely increasing flow velocities and downstream bank erosion. The bridge, built in the early 1900s, is about a 28 ft long and 12 ft wide single lane, single span reinforced concrete structure. At the northern abutment, a concrete wall approximately 21 ft long runs along the western bank. At the eastern bank of the northern abutment and on both sides of the southern abutment, heavy rock has been placed to protect the banks from scour. The bridge is scour critical with the spread foundations exposed within the channel. At both abutments, repairs have been attempted to protect against scour effects. At the southern abutment, the repair has also been undermined by scour (see Photo 1).

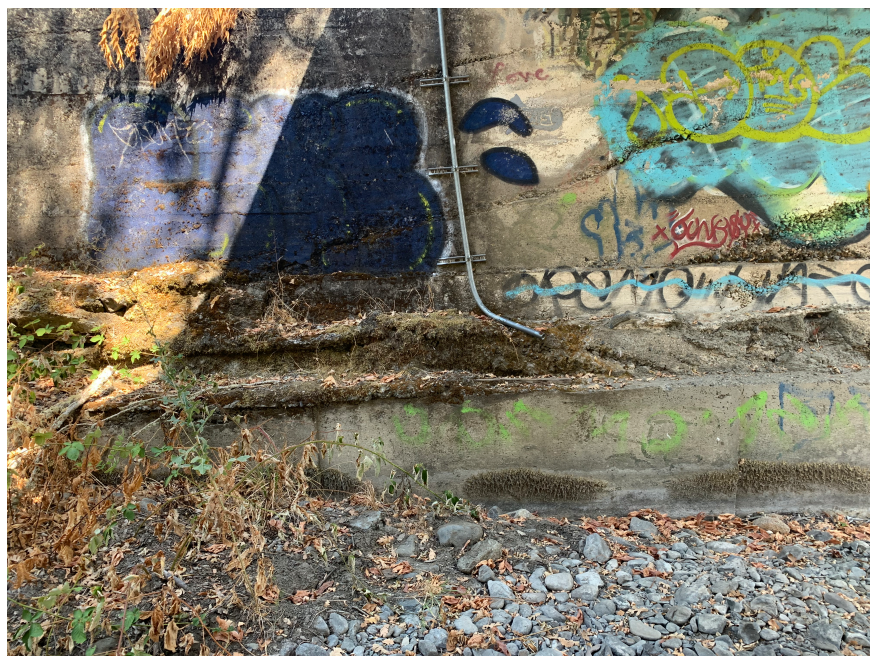
Photo 2 – Northern abutment (looking north)

At the northern abutment, multiple concrete pours are visible along the footing (see Photo 2). The newest concrete pour has not yet been fully scoured. During our September 2020 site visit, CAInc

excavated bedload materials at the northern footing and estimated the footing bottom at elev. 303.6 ft¹.

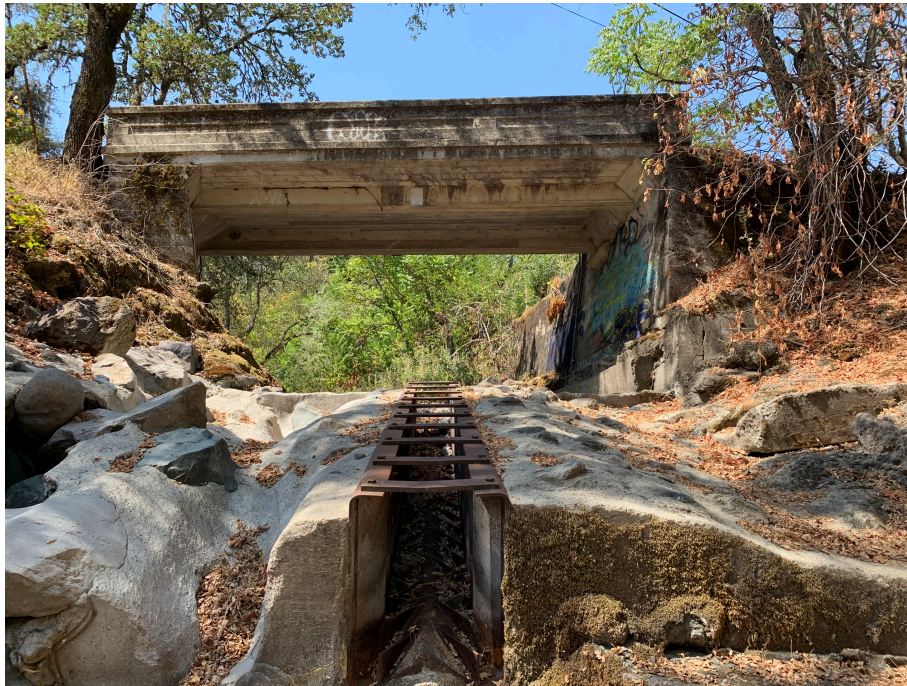
Photo 3a – Fish ladder (looking west)

The channel widens at the fish ladder located just downstream (about 10 ft) from the bridge. A metal ladder is located in the middle of the channel with concrete spanning to both banks (see Photos 3a/b). A wired rock weir is located about 20 ft downstream from the fish ladder, creating a pool in between the structures. The fish ladder concrete encasement shows evidence of some scour but appears to be limiting the scour immediately downstream of the bridge.

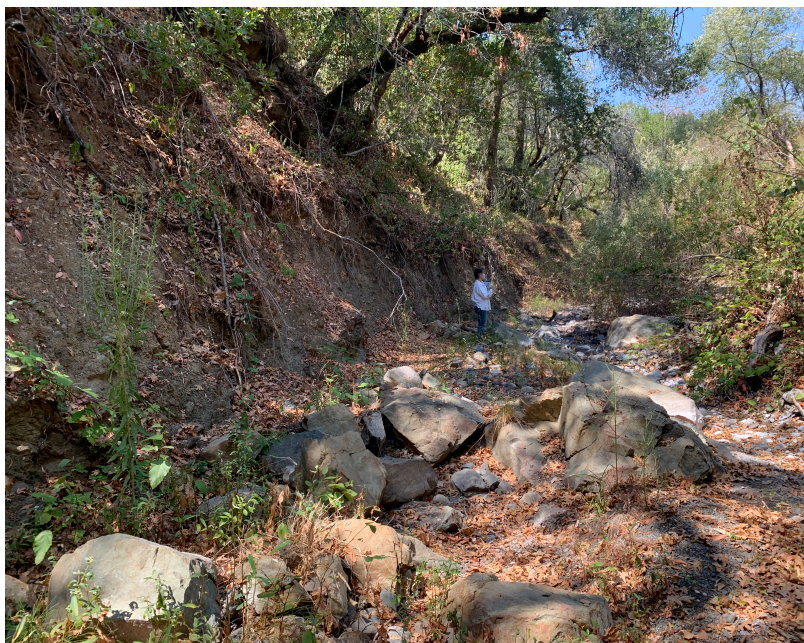
Photo 4 – Over-steepened southern bank and channel bedload (looking west)

About 200 ft downstream from the bridge, CAINC observed a 100±ft long rock outcrop consisting of intensely weathered, moderately soft to moderately hard shale. The weathered rock was overlain by silty to clayey sand with gravel. The northern bank was heavily vegetated while the southern bank was over-steepened due channel erosion. Large bedload material (such as boulders) were more prevalent downstream of the bridge (see Photo 4).

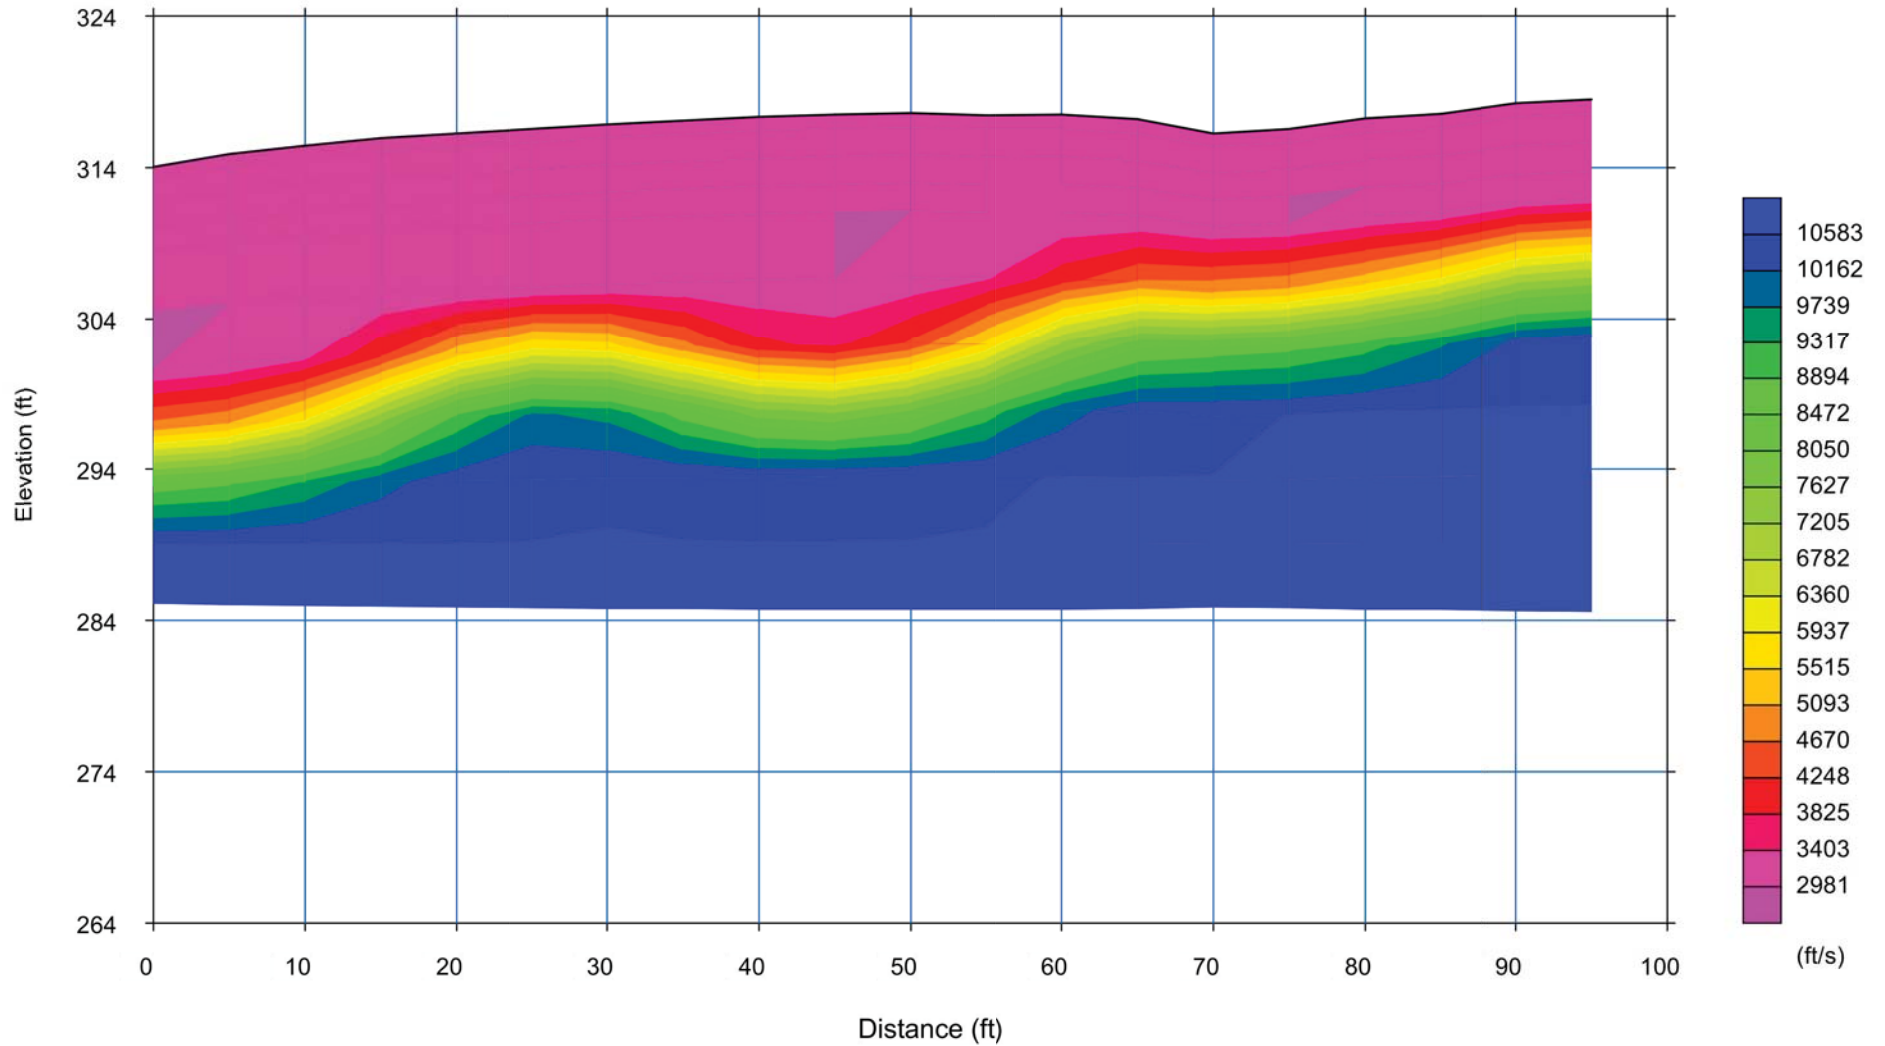
S-1

G21 at 100 ft
elev. 318.1

The data was recorded with a 24 channel ES-3000 seismometer with geophones arranged in a line running generally east to west for S-1 and southwest to northeast for S-2 and S-3. Twenty-one geophones were used for S-1, S-2, and S-3. The energy source for this testing was a 40-lb falling weight with an approximate 24-inch drop striking a steel plate at various locations along the geophone spread. The recorded data was analyzed using the Geometrics, Inc. SeisImager/SW software package. Refraction seismic profiling indicates primary wave (compression wave) velocities which are correlated to shear wave velocities. The refraction profiles and locations are shown in Figures 6A through 6C and Figure 2a, respectively.

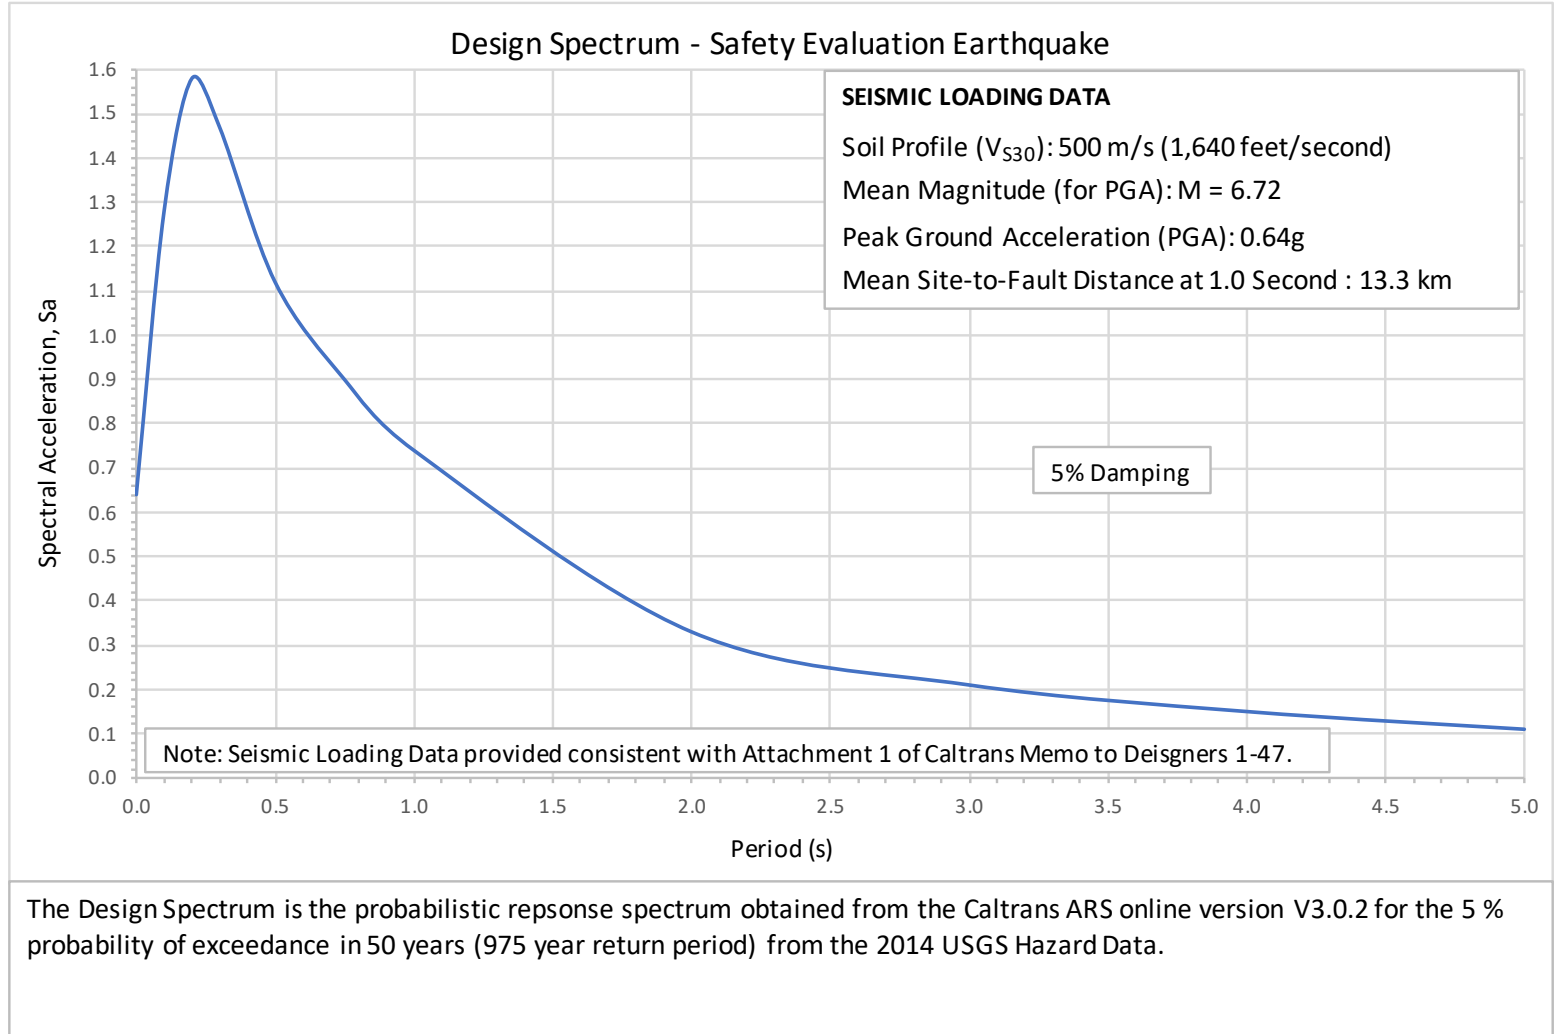
Period (s)	Spectral Acceleration, Sa (g)
0.00	0.64
0.10	1.28
0.20	1.58
0.30	1.47
0.50	1.12
0.75	0.90
1.00	0.74
2.00	0.33
3.00	0.21
4.00	0.15
5.00	0.11

The Design Spectrum is the probabilistic response spectrum obtained from the Caltrans ARS online version V3.0.2 for the 5% probability of exceedance in 50 years (975 year return period) from the 2014 USGS Hazard Data.

We include the recommended Seismic Design Data as Figure 8.
