Northern Napa River Tributary Streams Survey Report May 2012

Prepared for:
City of St. Helena
1480 Main Street
St. Helena, CA 94574

NAPA COUNTY
RCD

PRUNUSKE CHATHAM, INC.

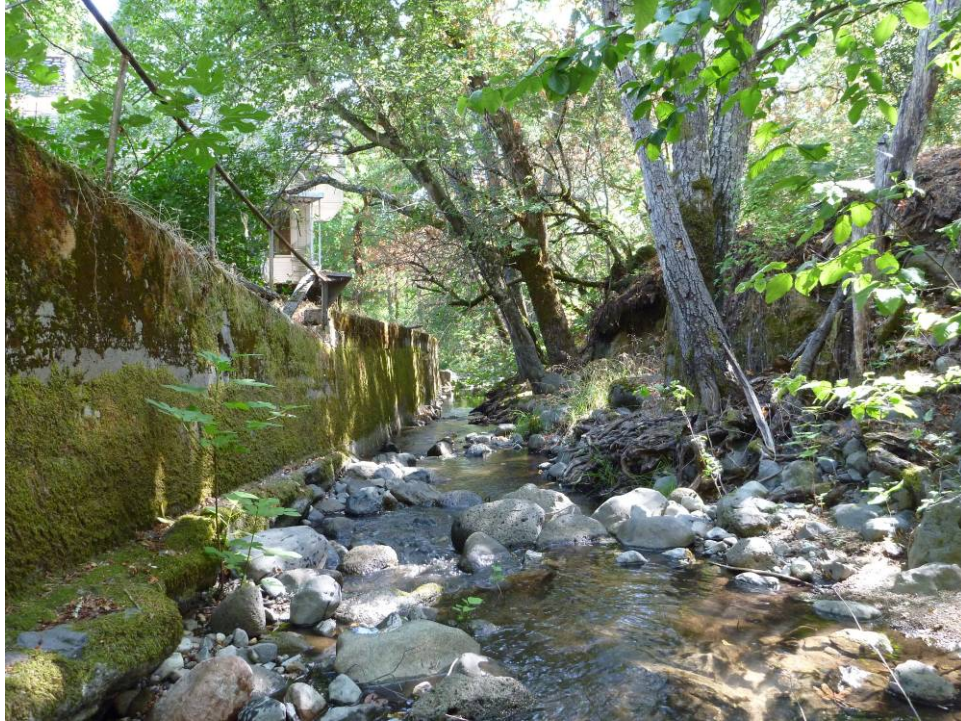
4.2c. Remnants of the diversion dam removed in 2003. 8/10/11

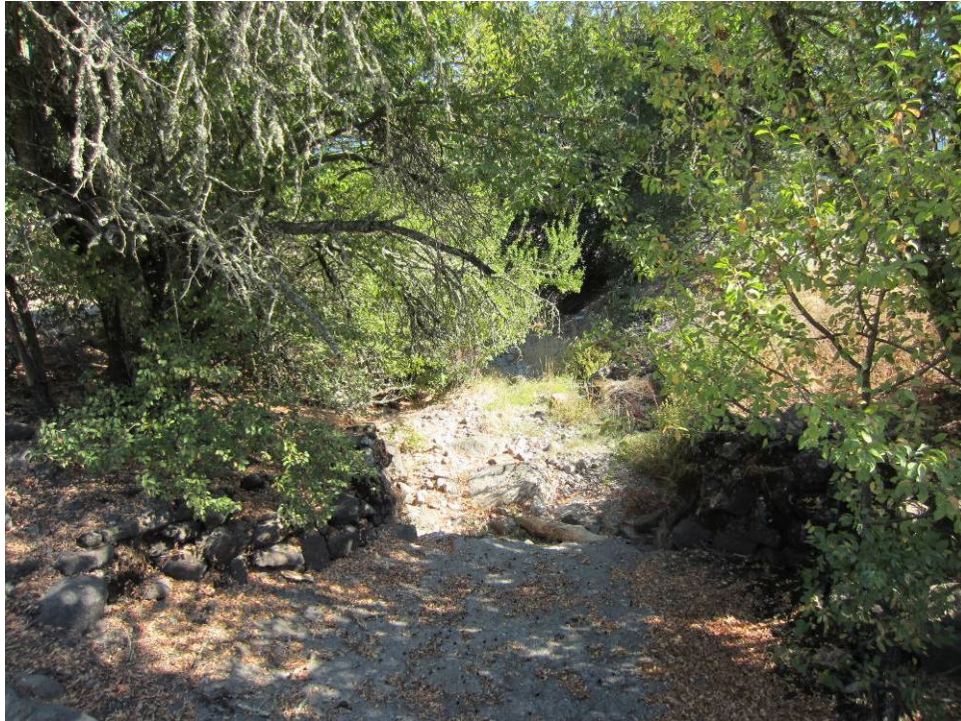
During the 2011 habitat reconnaissance survey of Nash Creek, the accessible channel was completely dry, and no aquatic species were observed.

4.3a. Nash Creek downstream of Highway 29 crossing. 9/29/11

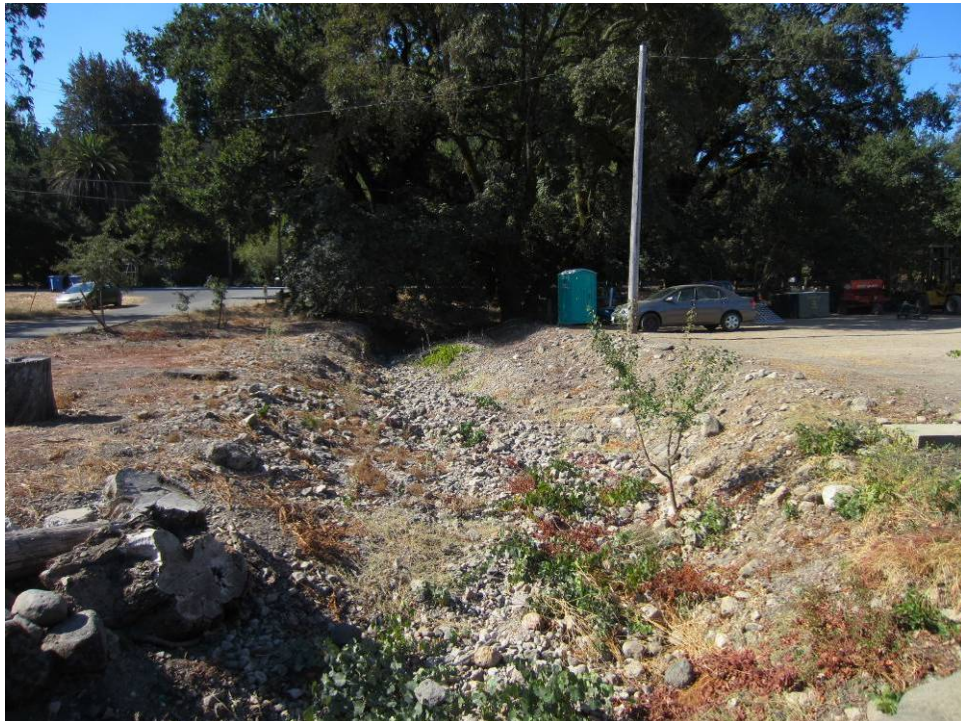
4.3b. In-stream habitat downstream of Highway 29 crossing. 9/29/11

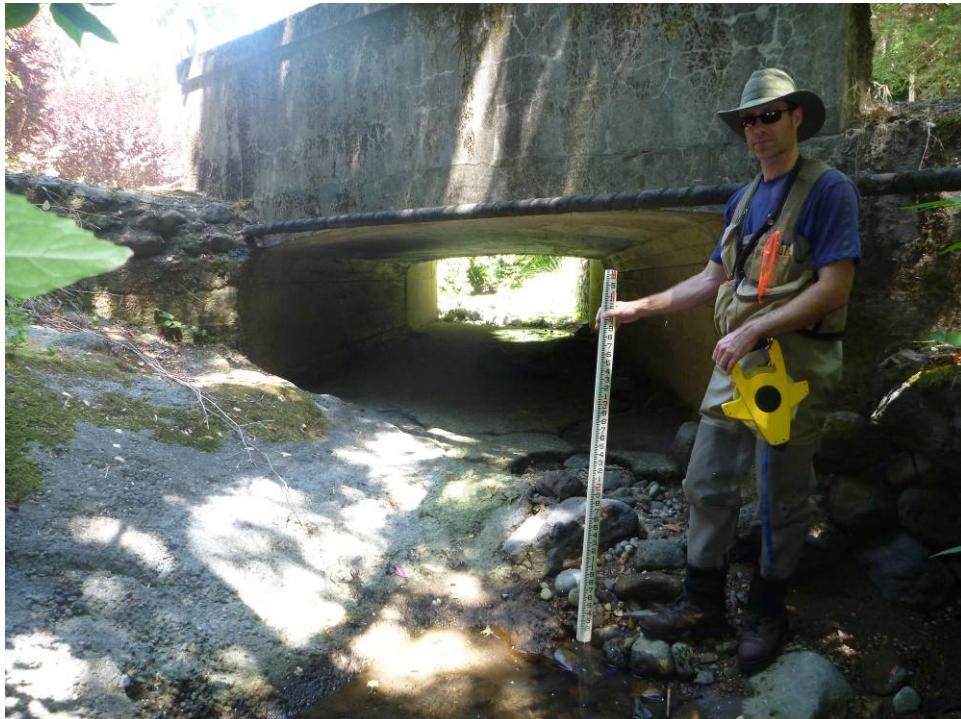
4.4f. Culvert crossing under Diamond Mountain Road. 8/16/11

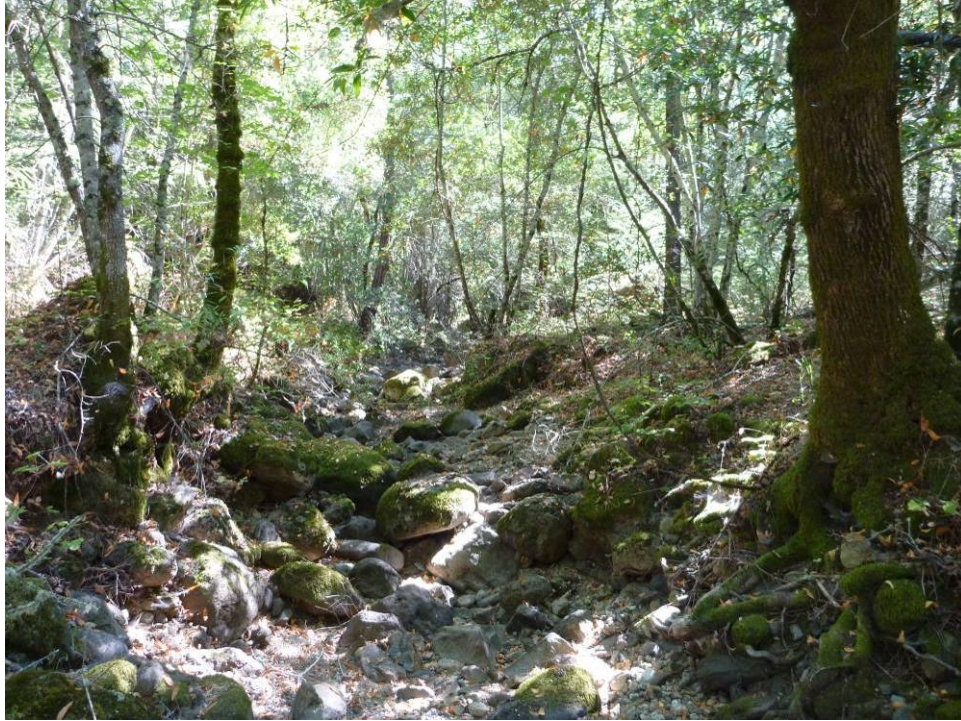
4.6i. Hoisting Works Canyon Creek with characteristic dry stream bed and steep boulder cascade. 8/29/11

Overall, mainstem Garnett Creek provides suitable habitat for steelhead and/or resident rainbow trout. No habitat for steelhead/rainbow trout was observed within Horns and Hoisting Works Canyon Creeks due to dry stream bed conditions and steep topography (Photos 4.6i, 4.6j, 4.6k, and 4.6l).

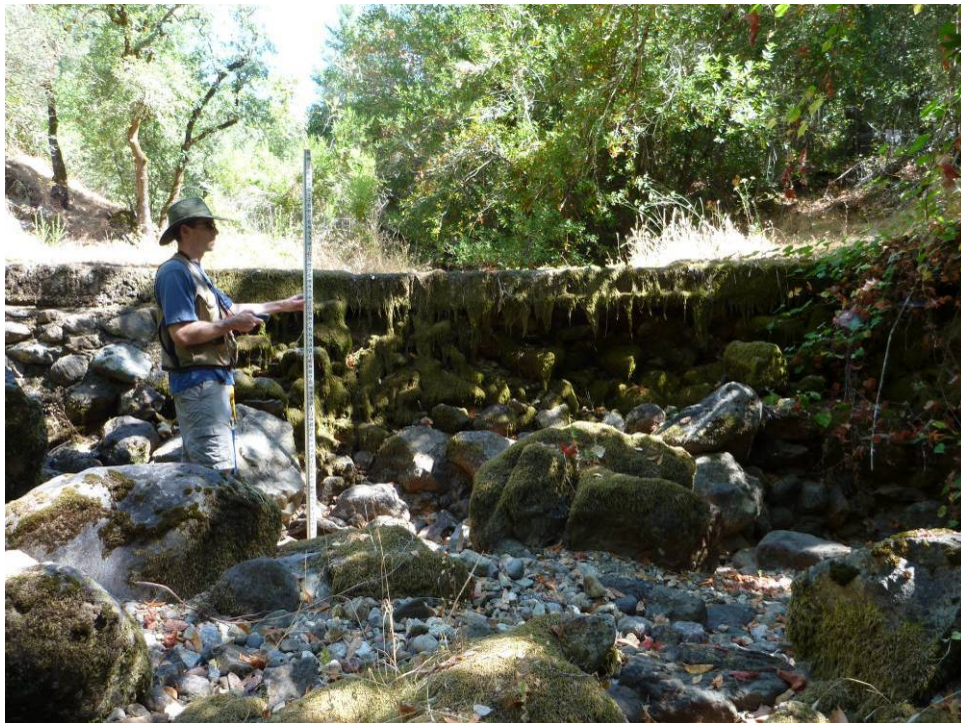
4.6j. Concrete road crossing on Hoisting Works Canyon Creek. 8/29/11

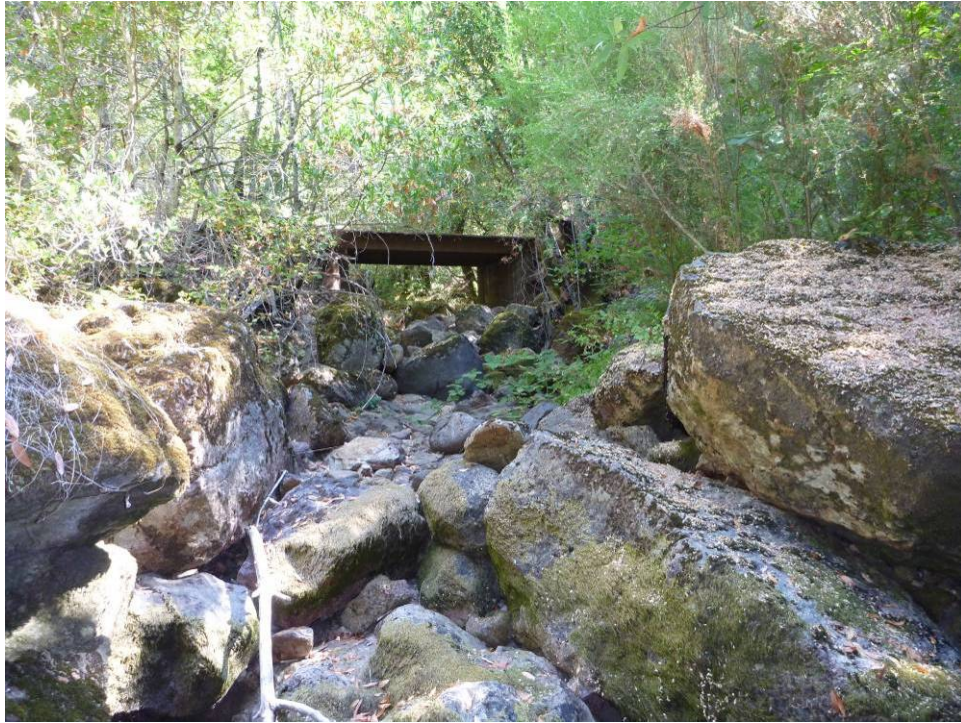
4.6k. Horns Creek with characteristic dry stream bed and steep boulder cascade. 8/31/11

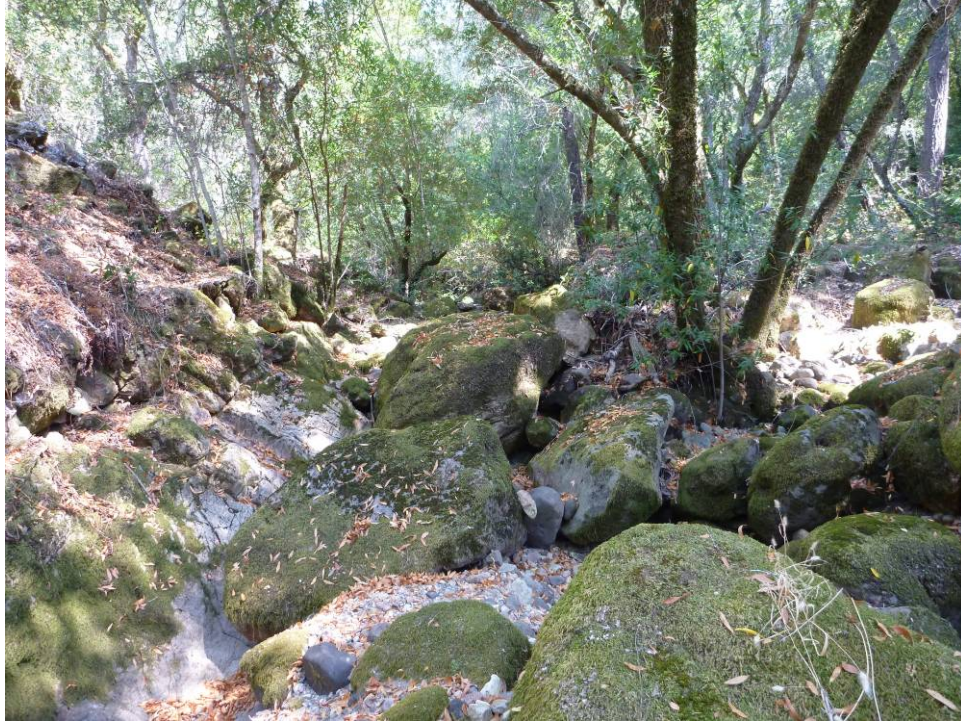
4.7c. Upper reach of Simmons Canyon Creek with characteristic dry stream bed and steep boulder cascade. 9/12/11

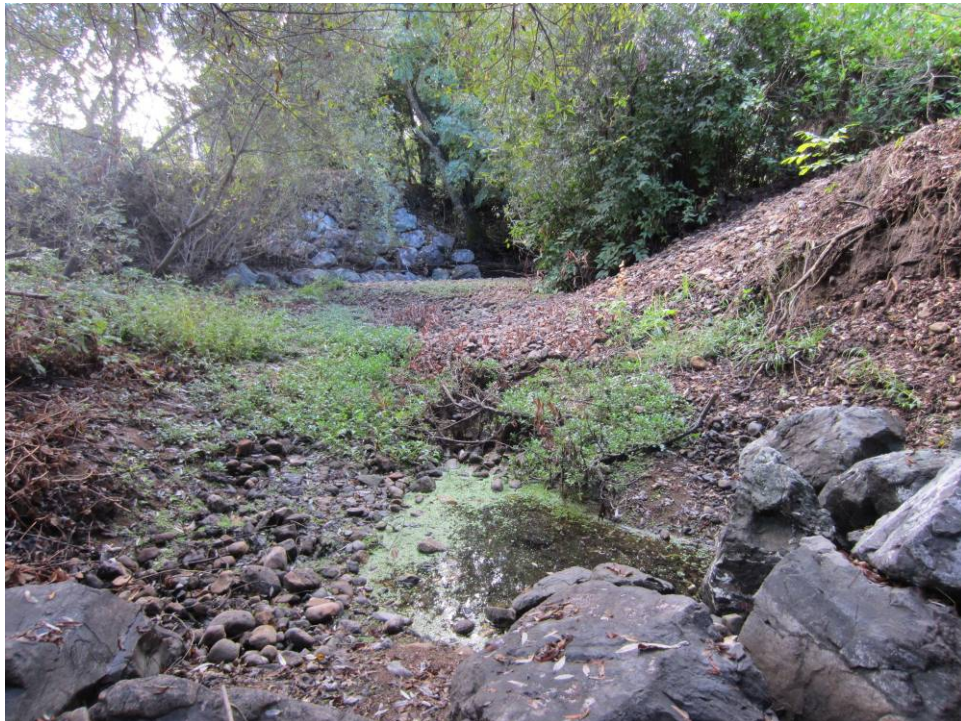
4.8b. Isolated pool in lower reach of Selby Creek. 10/11/11
