Typical Problems and Applied Treatments for a Non-fish Bearing Upgraded Stream Crossing

PWA Typical Drawing #1a

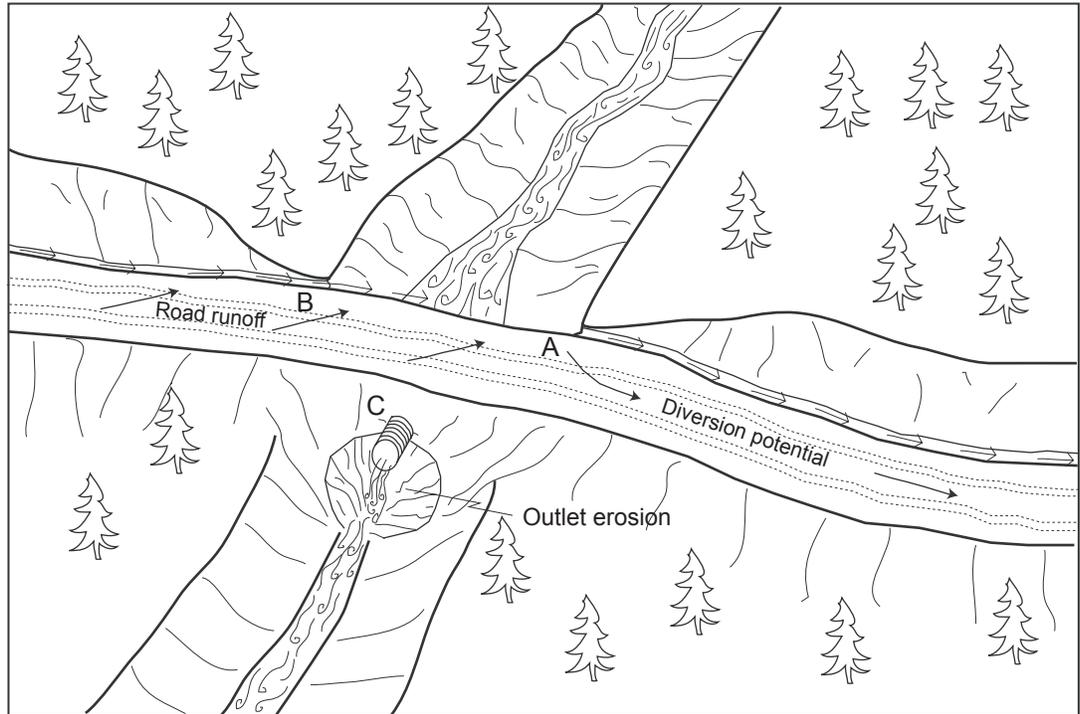
Problem condition (before)

- A - Diversion potential
- B - Road surface and ditch drain to stream
- C - Undersized culvert high in fill with outlet erosion

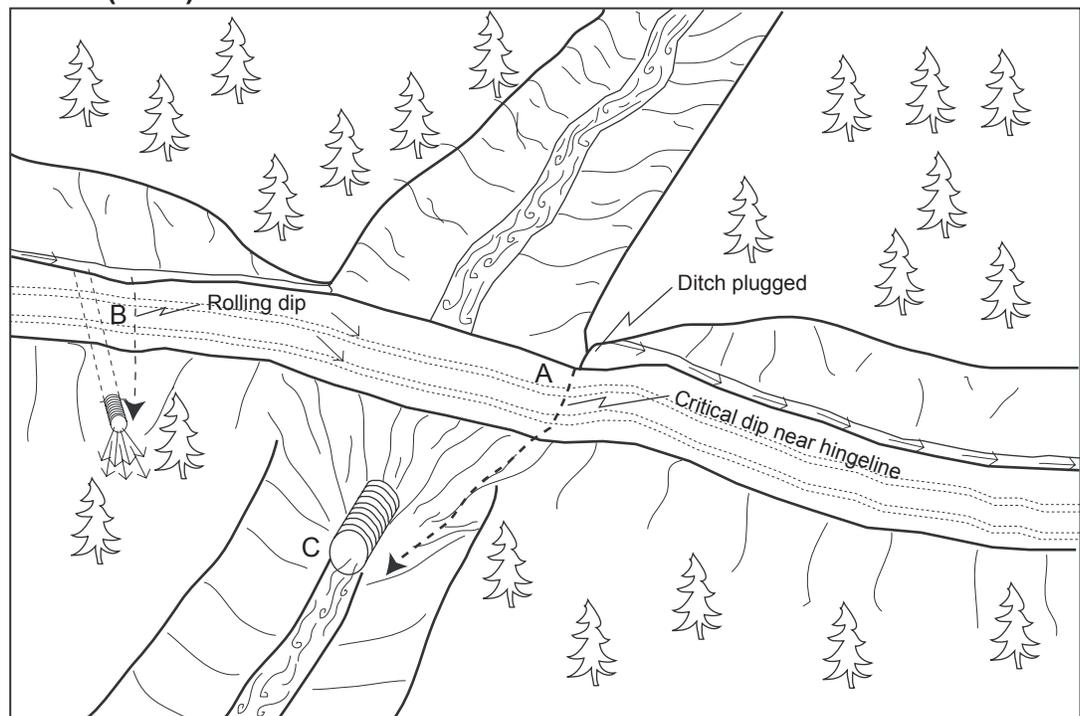
Treatment standards (after)

- A - No diversion potential with critical dip installed near hingeline
- B - Road surface and ditch disconnected from stream by rolling dip and ditch relief culvert
- C - 100-year culvert set at base of fill
