Typical Problems and Applied Treatments for a Decommissioned Stream Crossing

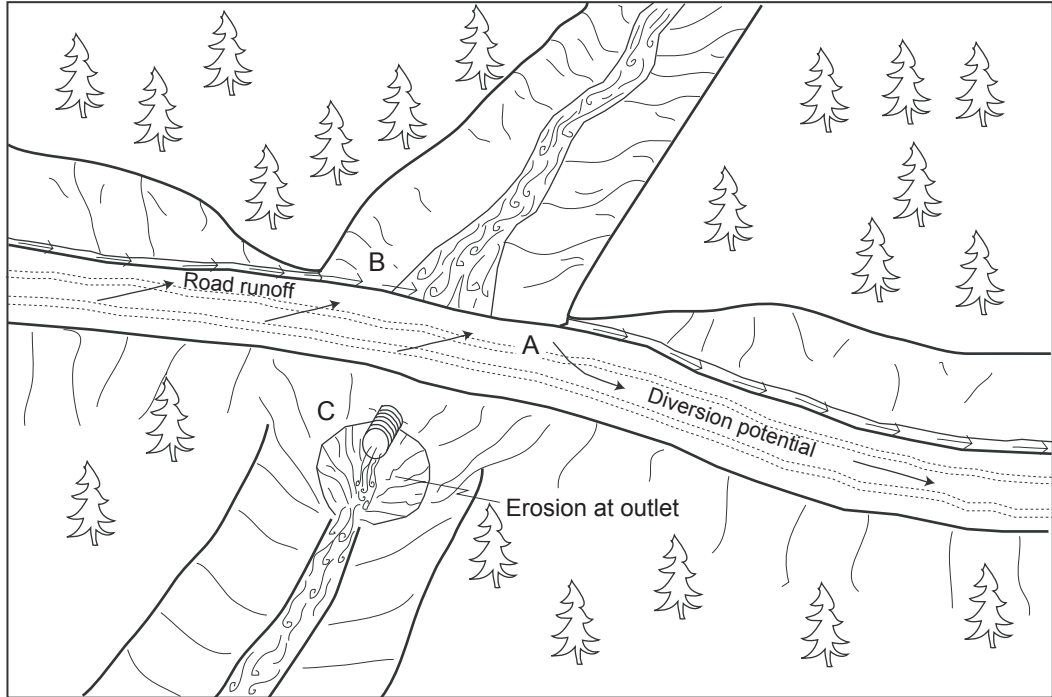
Problem condition (before)

- A - Diversion potential
- B - Road surface and ditch drain to stream
- C - Undersized culvert high in fill with outlet erosion

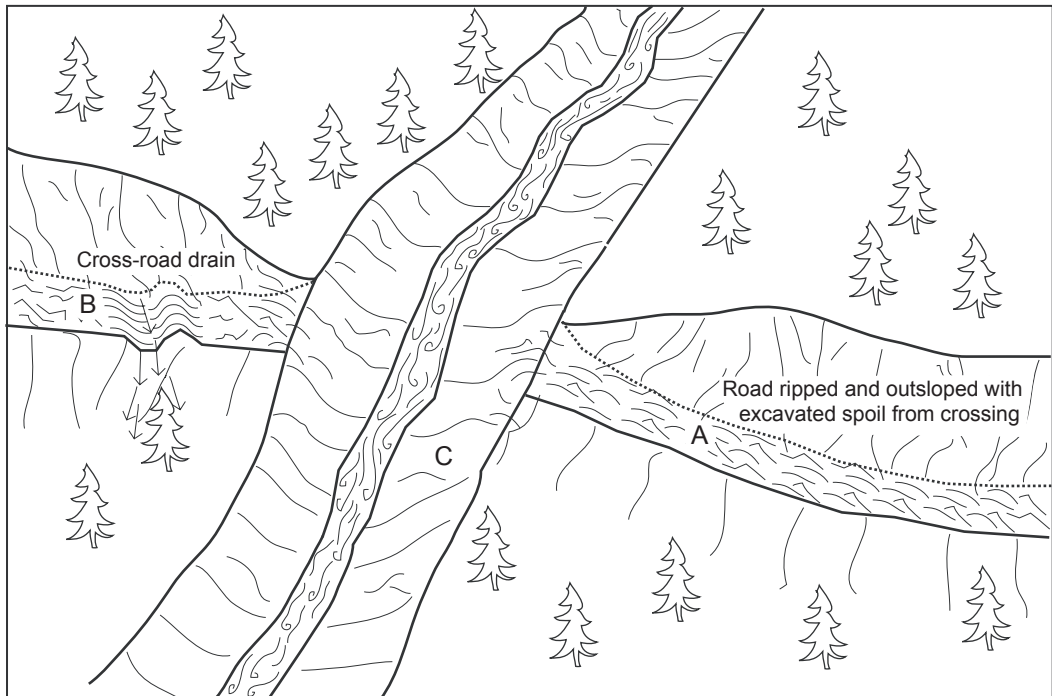
Treatment standards (after)

- A - Diversion prevented by road surface ripping and outsloping using excavated spoils
- B - Road surface and ditch disconnected from stream by road surface decompaction and cross-road drains
- C - Stream crossing fill completely excavated
