**2001 S. B. 271 Road Assessment and
Erosion Prevention Planning Project for the
Dry Creek Watershed,
Napa County, California**

**Napa County Resource Conservation District
and
California Department of Fish and Game**

Pacific Watershed Associates
Arcata, California
(707) 839-5130
January 10, 2003

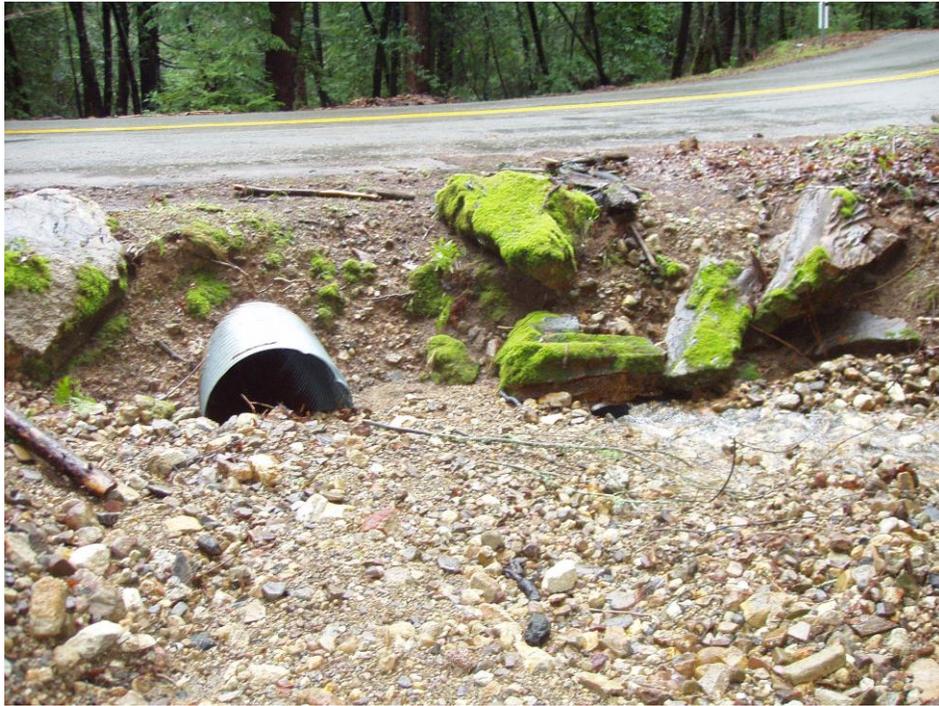
Photograph 1: Culvert plugged from heavy December 2002 rainfall.
(Mt. Veeder Road within the upper Montgomery Creek watershed.)

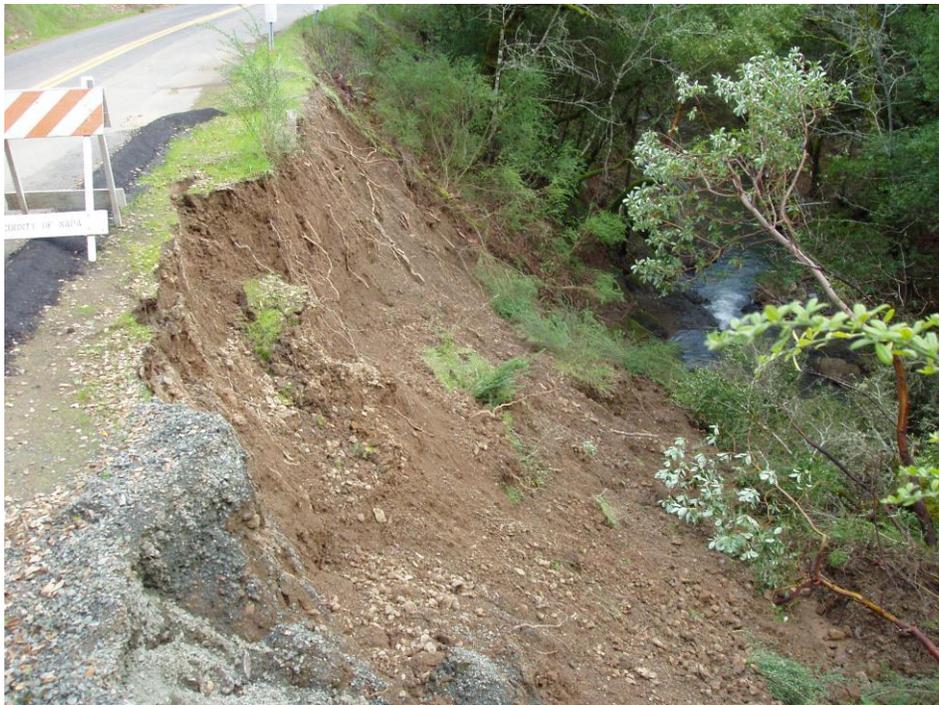
Photograph 2: Eroding road fillslope delivering sediment to Dry Creek.
(Dry Creek Rd. in the middle canyon region of the watershed)

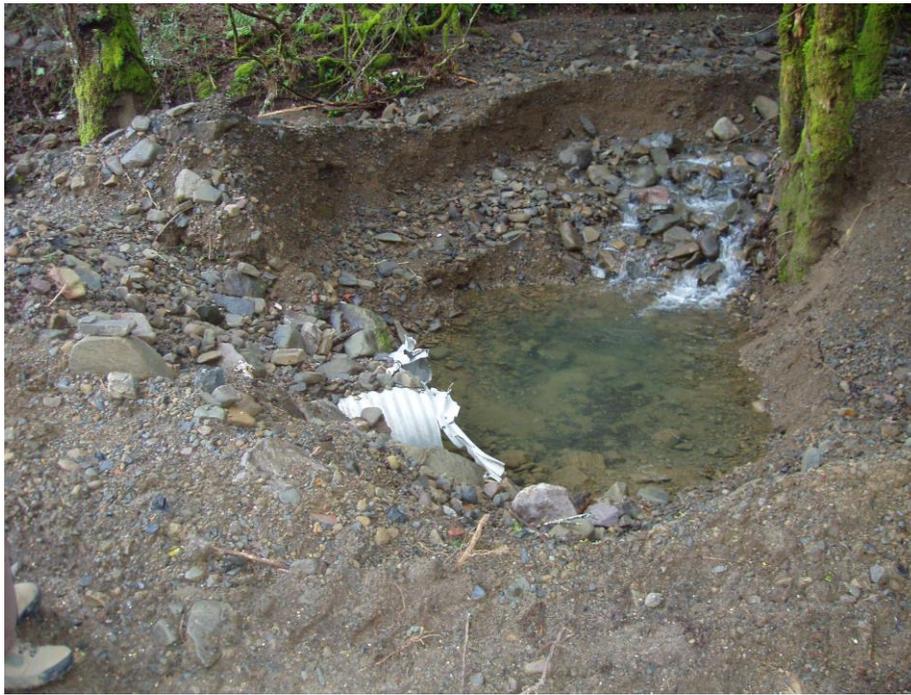
Photograph 3: Crushed culvert plugged with sediment (Mt. Veeder Road).

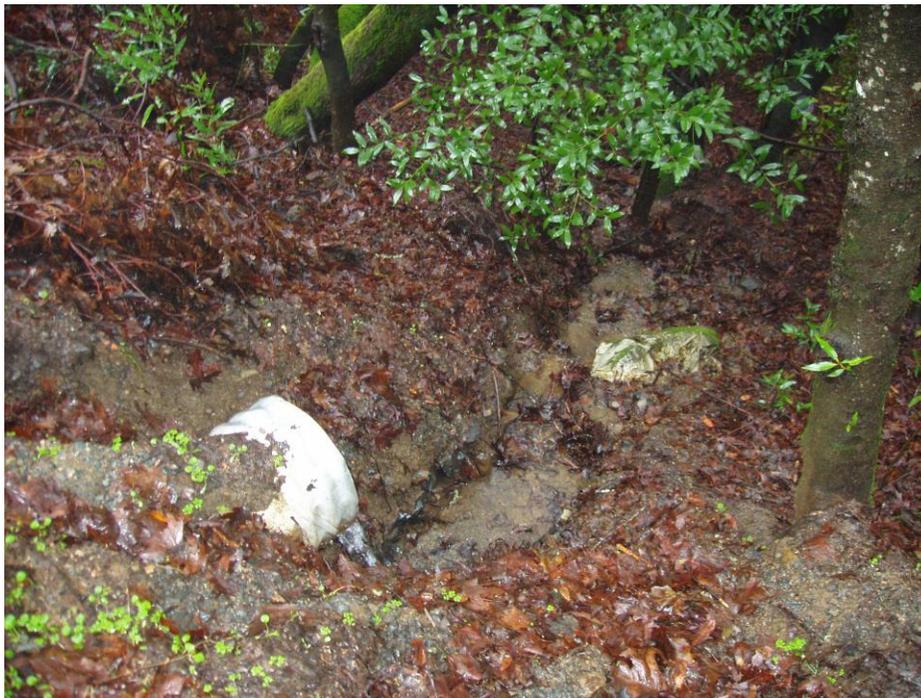
Photograph 4: Inadequately armored outlet of plugged culvert with newly deposited sediment from failing road cutbank and overland flow erosion. (Dry Creek Road).

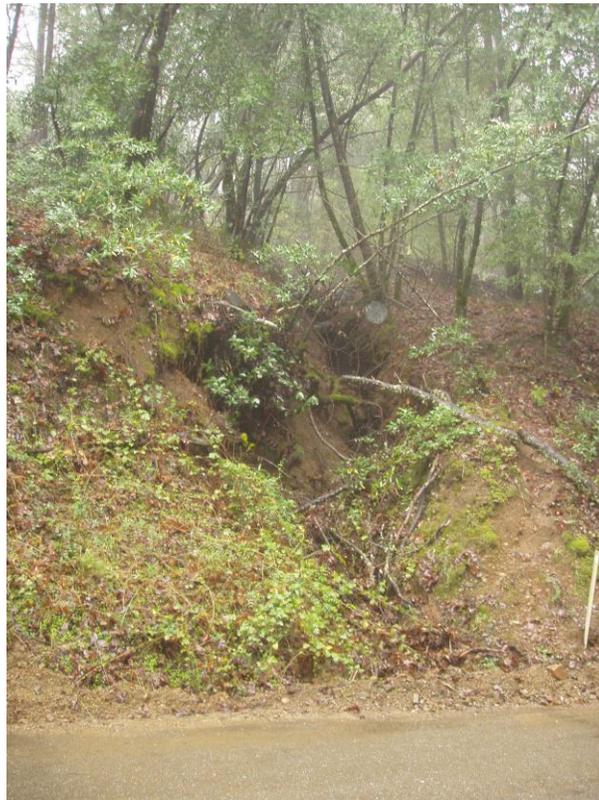
Photograph 5: Deeply cut erosional gully with undersized ditch relief culvert (Mt. Veeder Road, upper Wing Canyon watershed).

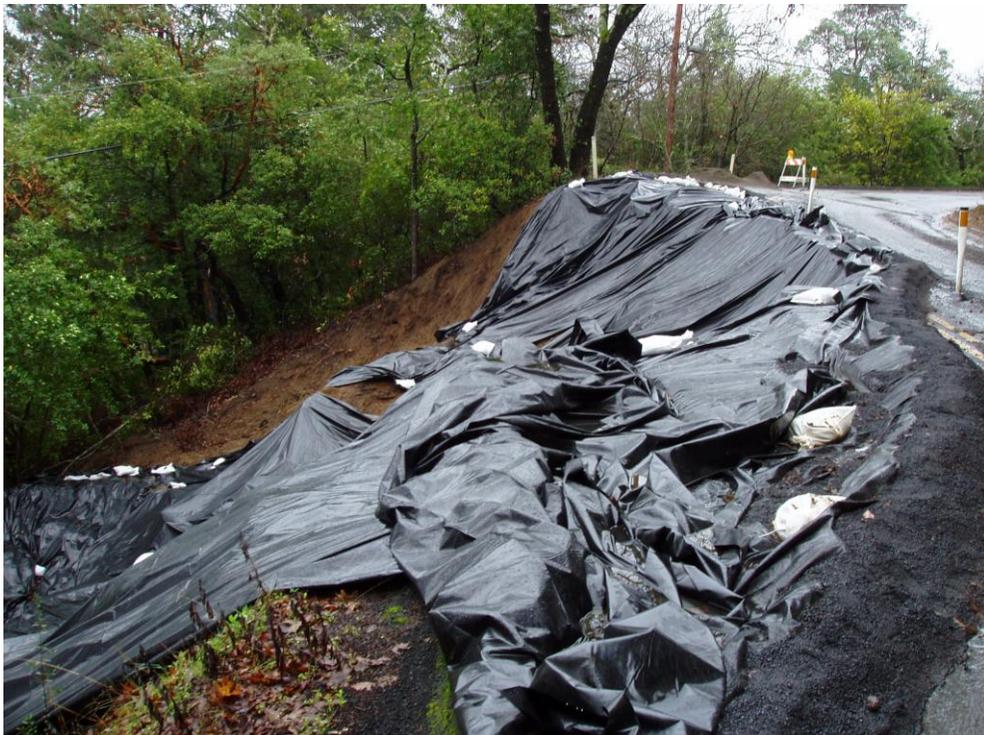
Photograph 6: Road failure from delivering landslide. (Mt. Veeder Road, upper Segassia Creek watershed).
