Northern Napa River Tributary Streams Survey Report May 2012

Prepared for:
City of St. Helena
1480 Main Street
St. Helena, CA 94574

NAPA COUNTY
RCD

PRUNUSKE CHATHAM, INC.

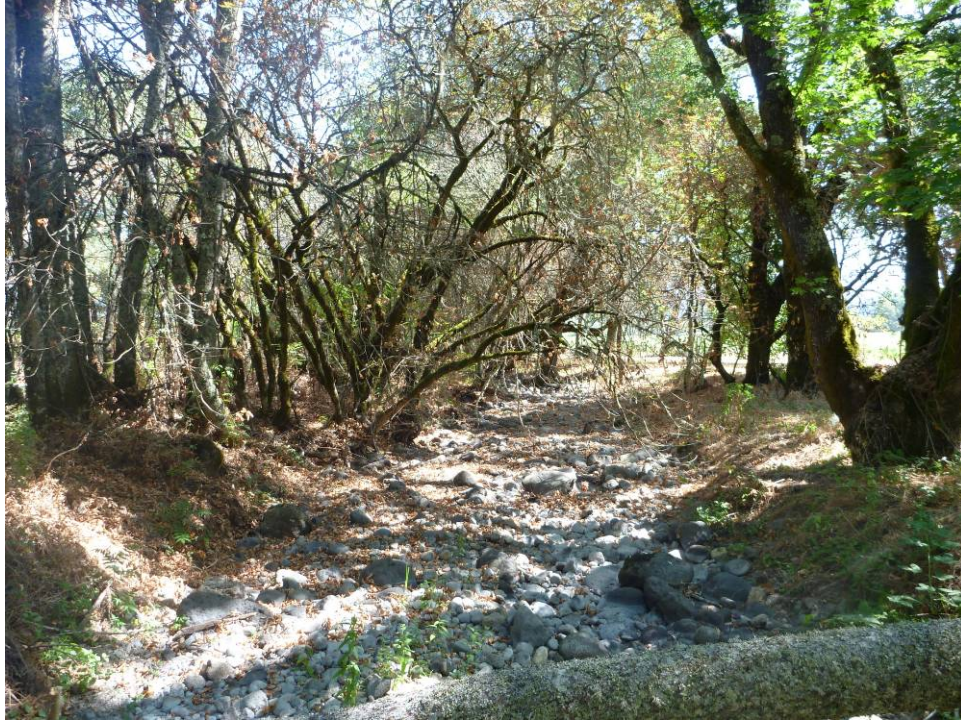
4.4a. Lower reach of Diamond Mountain Creek. 8/16/11

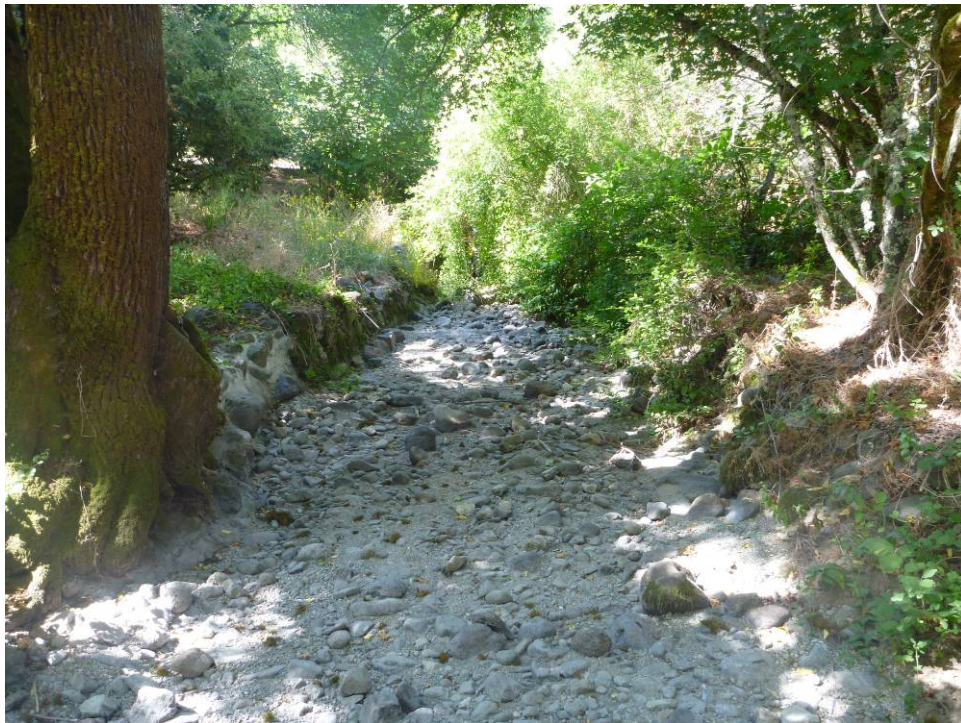
4.4b. Lower reach of Diamond Mountain Creek. 8/16/11

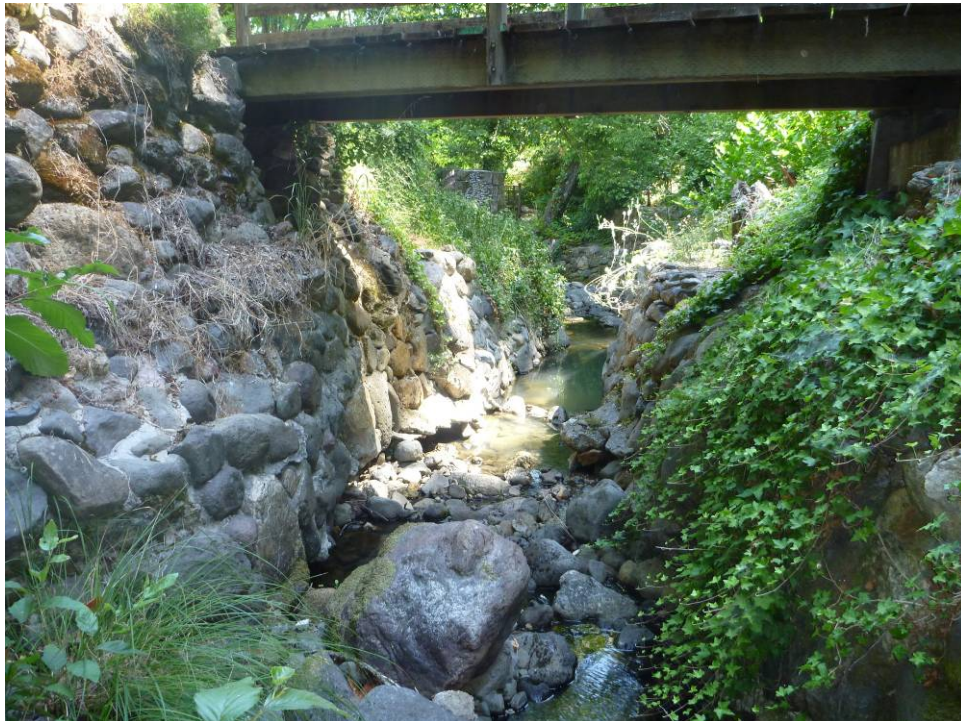
4.4d. Representative habitat. 8/16/11

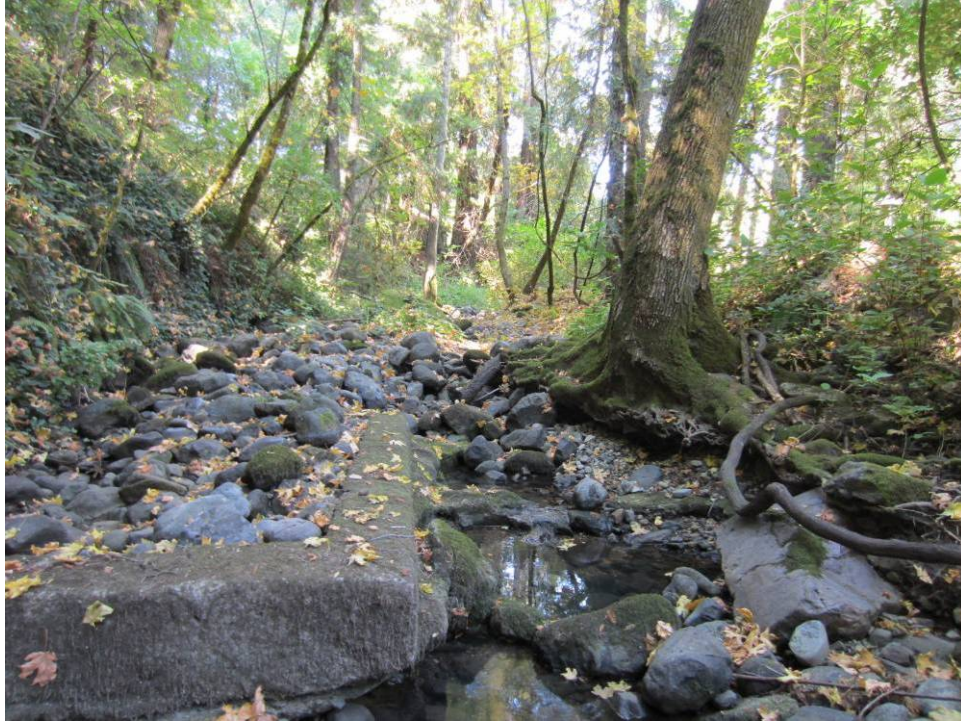
4.4e. Representative habitat. 9/28/11

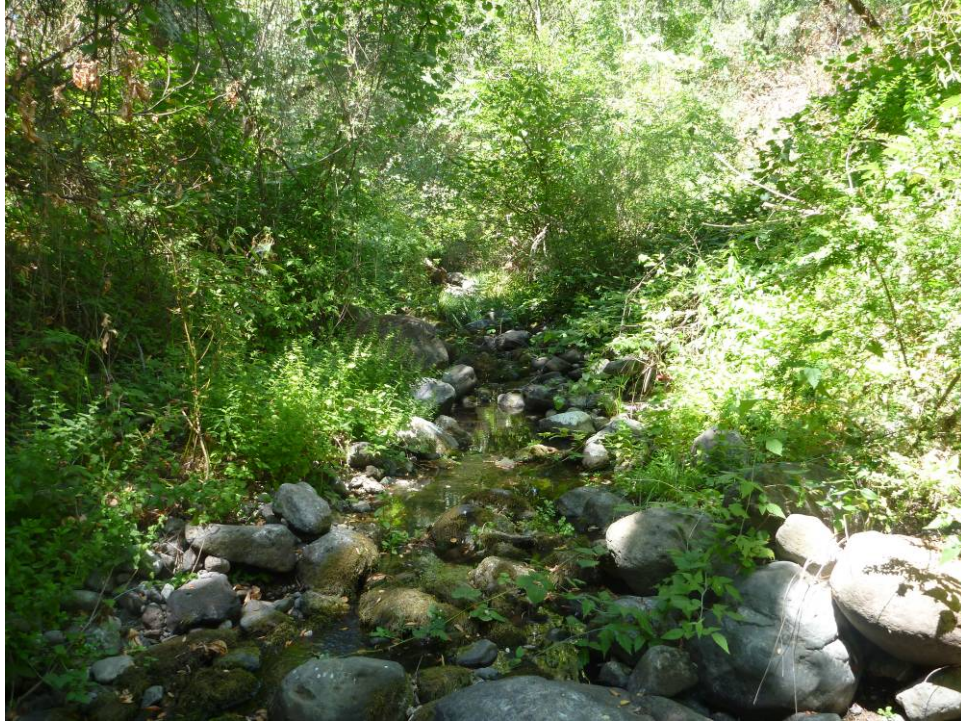
4.4g. High quality riffle habitat near end of survey limits. 8/16/11

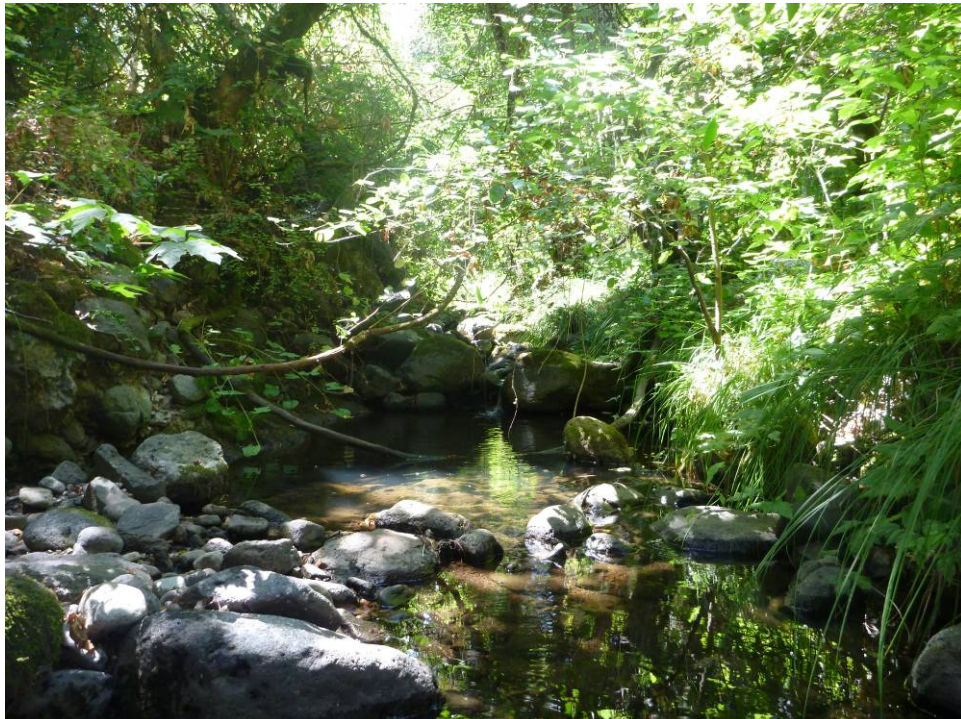
4.4h. High quality riffle/pool habitat near end of survey limits. 8/16/11

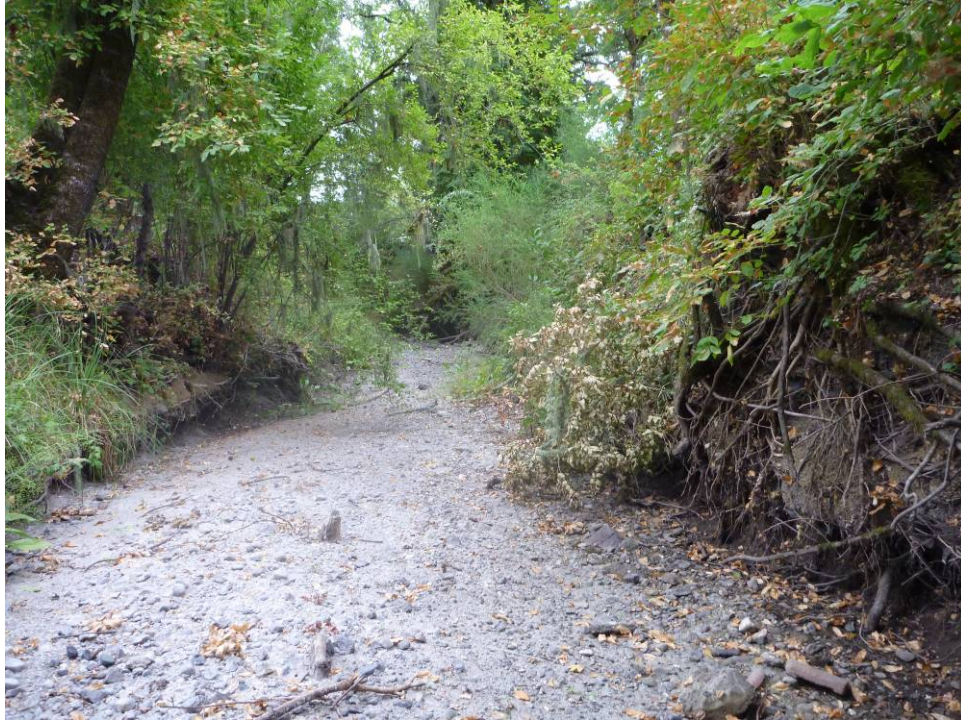
In August and September 2011, limited field surveys of Blossom Creek were completed. In the lower reach, dry conditions or isolated, stagnant pools were observed (see Photos 4.5a, 4.5b, and 4.5c). The upper reaches of both mainstem Blossom Creek and Bennett Creek were highly channelized and dry (see Photos 4.5e and 4.5f). No habitat for steelhead/rainbow trout was observed within the watershed. At the upper limits of the watershed, two in-stream reservoirs are present. There are no historical reports of fish within the watershed available. Photos of the existing conditions in the lower and upper reaches of the watershed are provided below.

4.5a. Dry stream bed in lower Blossom Creek. 8/22/11

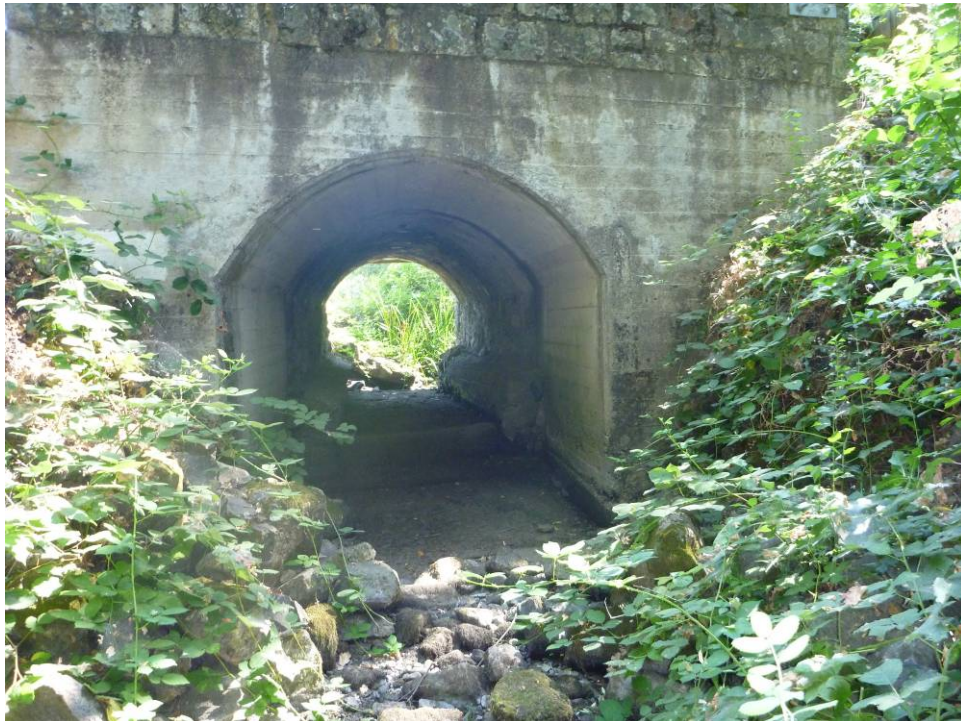
4.5d. Road crossing over Bennett Creek. 8/22/11

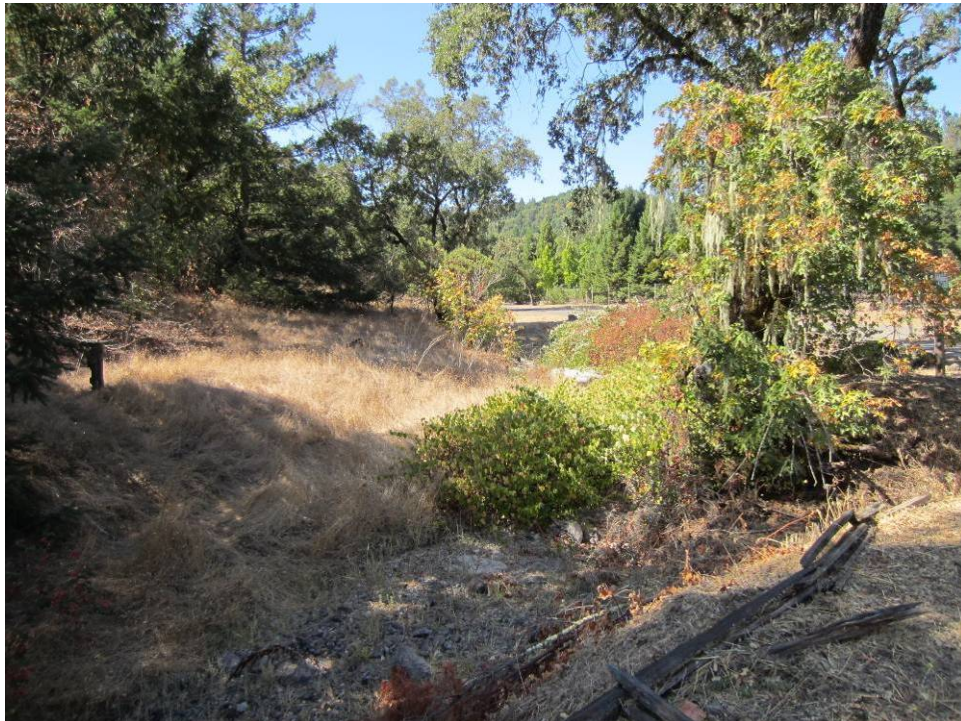
4.5f. Representative dry stream bed in Bennett Creek. 9/28/11

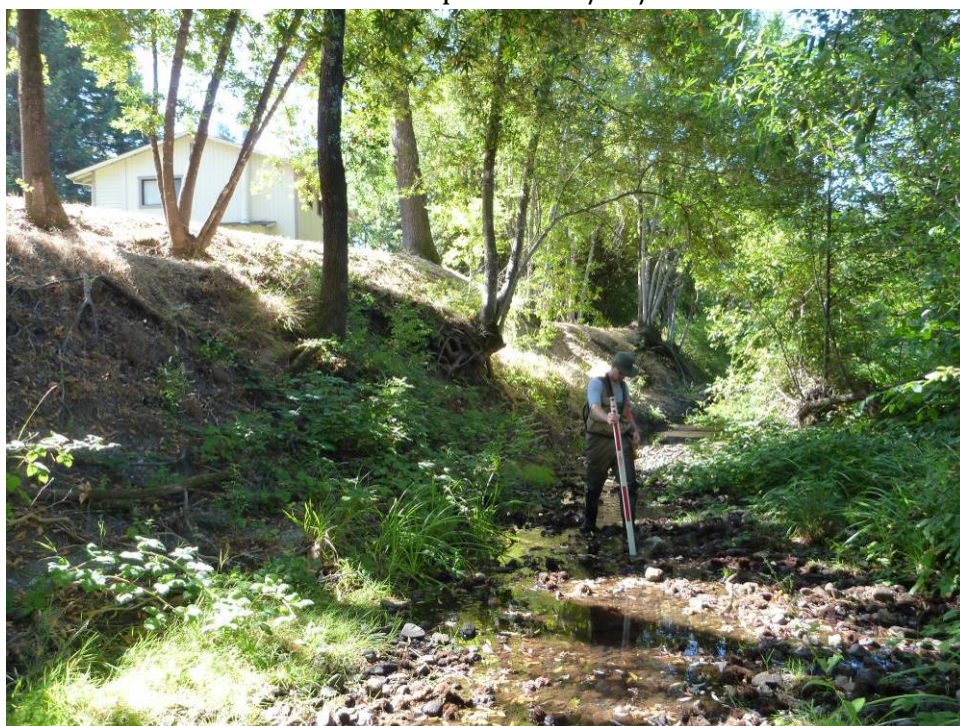
4.6b. Representative habitat in lower Garnett Creek below Greenwood Avenue. 8/25/11

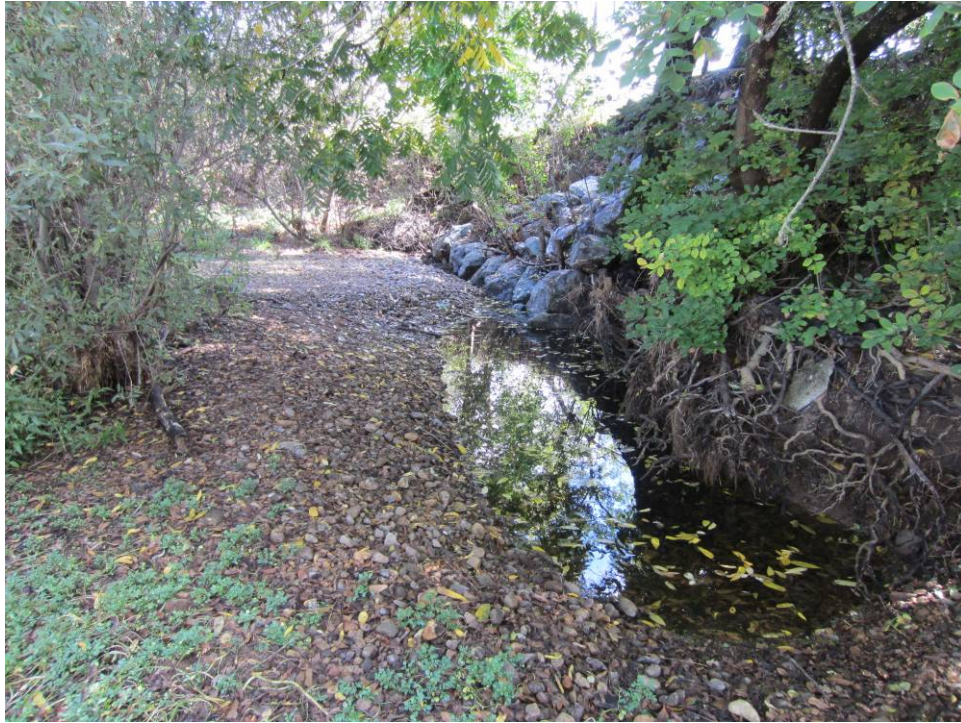
4.8a. Isolated pool in lower reach of Selby Creek. 10/11/11

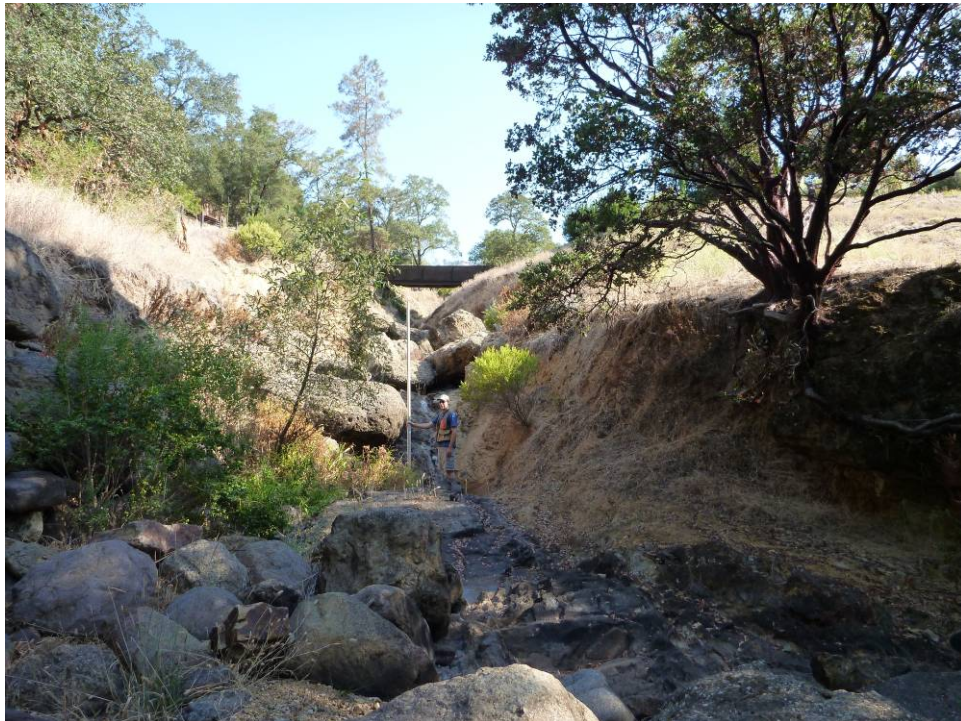
4.8f. Steep boulder cascade in Biter Creek. 9/13/11

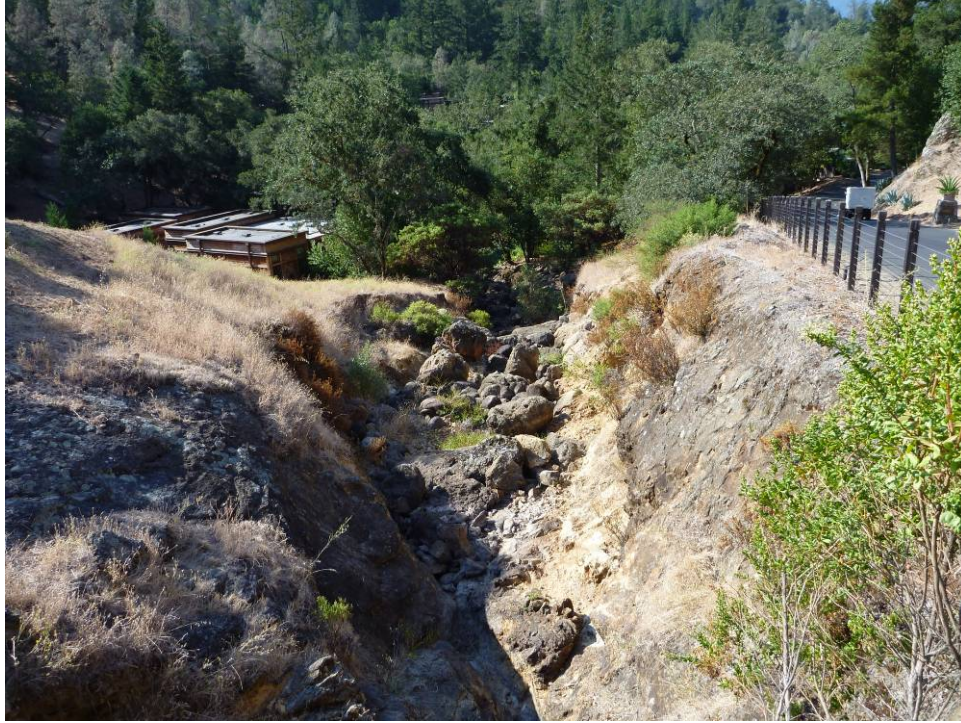
4.8g. Steep boulder cascade in Biter Creek. 9/13/11
